Inspection Report

Lynridge Dr
Yorba Linda, California
92886

Inspected By
David Salvato
California Inspection Authority INC.
(949) 981-8320
CIAHomeInspection@gmail.com
Inspecting The Finest Homes In California
www.CIAHomeInspection.com

Wednesday
December 27, 2023

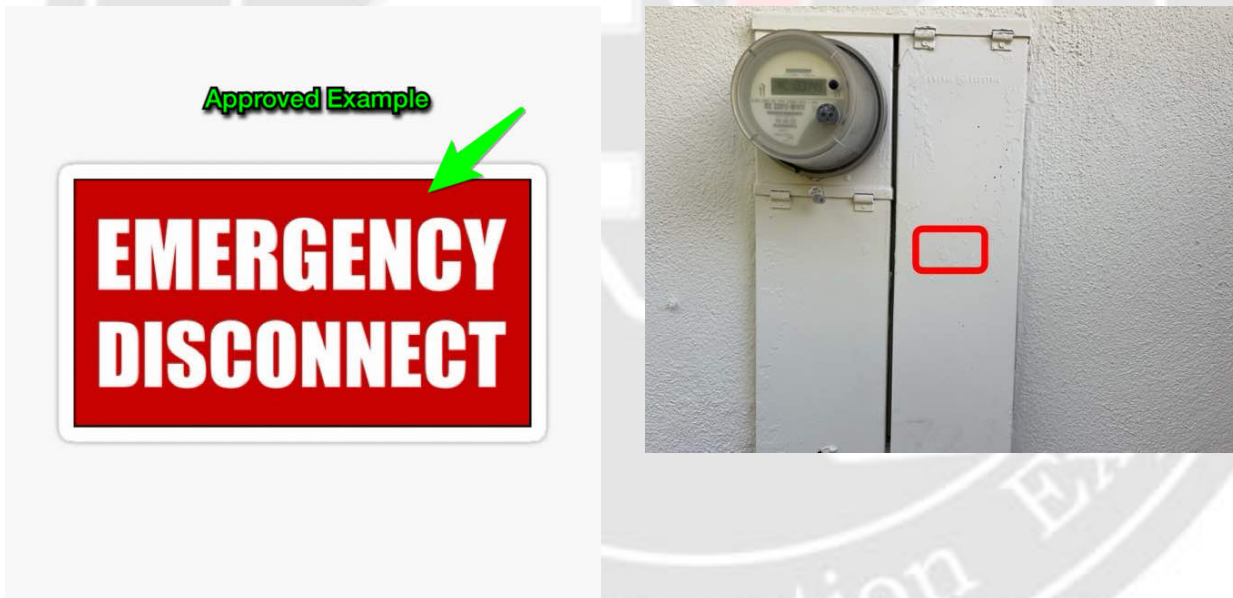
SAF s-68: All main electrical panels should have appropriate labeling so emergency responders can locate the emergency service disconnect. NEC 230.85 Service disconnects marked as follows: EMERGENCY DISCONNECT, SERVICE DISCONNECT

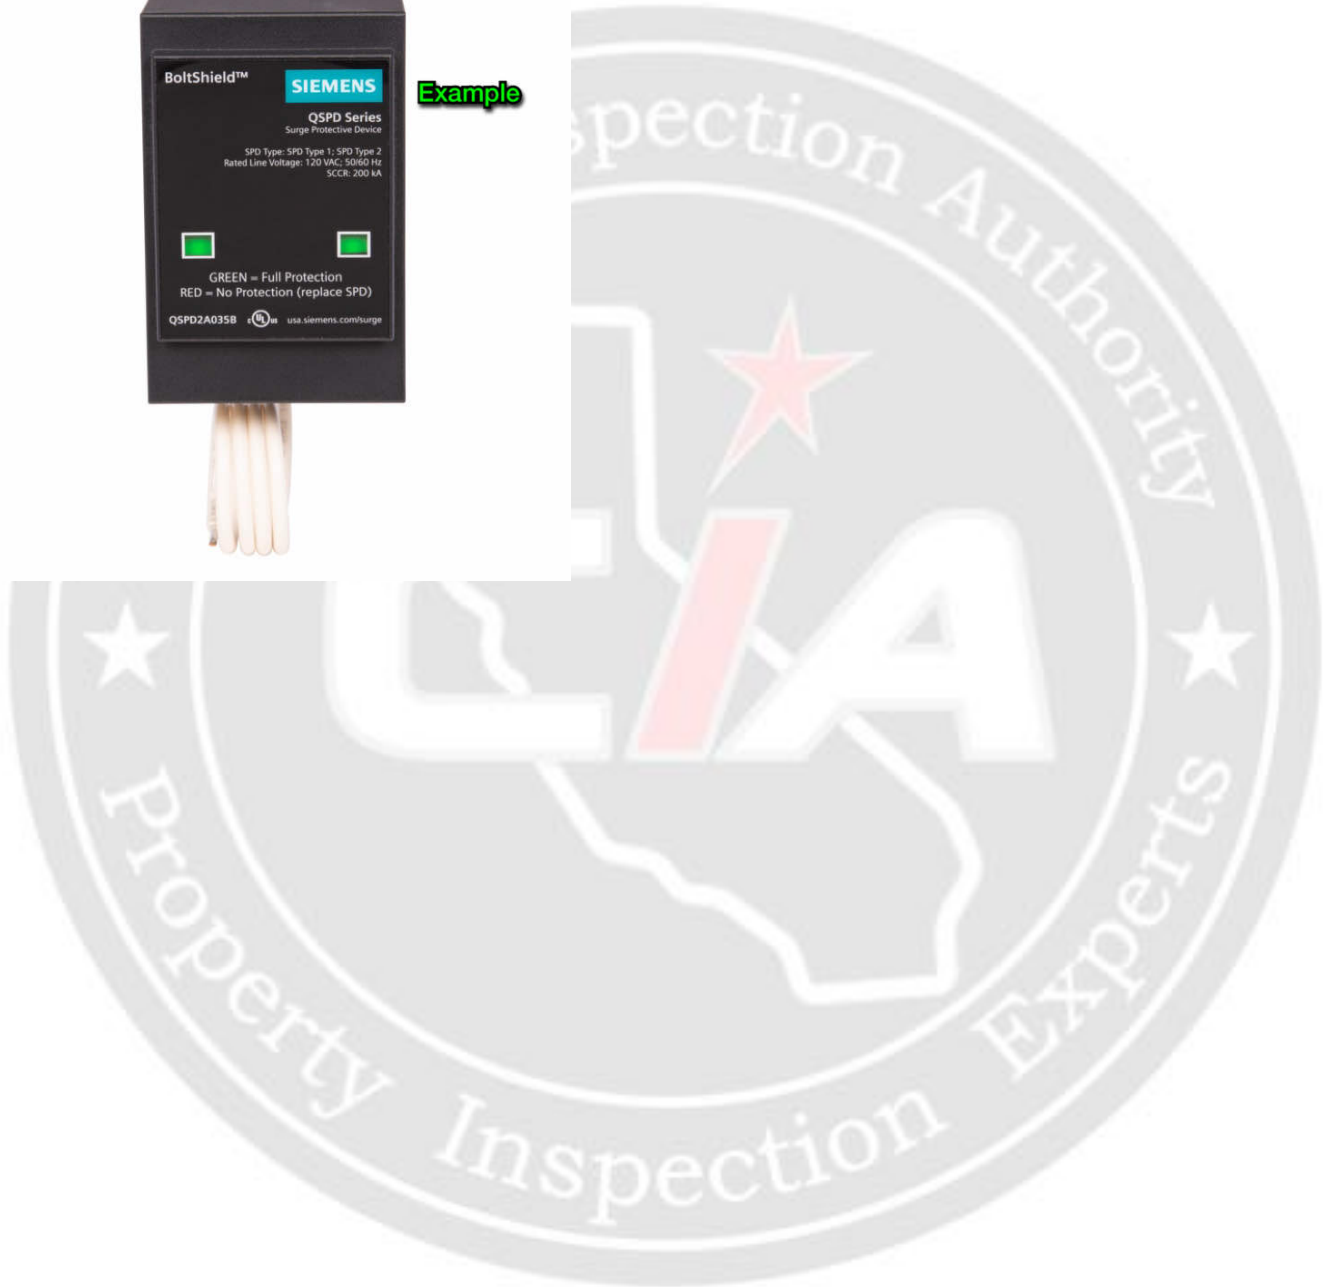
SAF s-72: There was no surge protection provided. Article 230.67 of the 2020 National Electrical Code® (NEC) now requires all services supplying dwelling units to be provided with a surge protective device (SPD), as an integral part of equipment or located immediately adjacent. The SPD must be a Type 1 or Type 2 SPD.

It is suggested that a "Licensed Electrical Contractor" be contacted for further evaluation and installation.

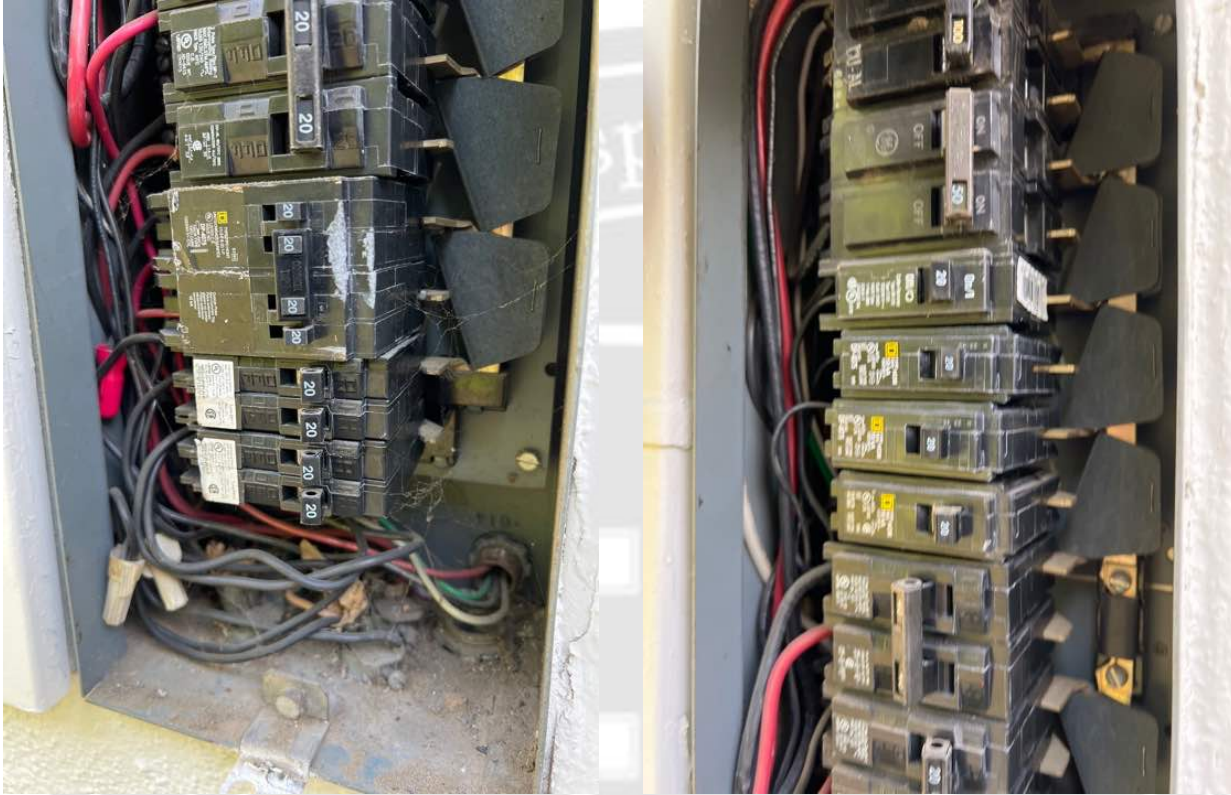
SAF s-76: In 2020 the National Electrical Code (NEC) required that all 120v 15 and 20 amp branch circuits feeding convenience outlets and devices be protected by an AFCI circuit breaker. Including but not limited to kitchen, family rooms, dining room, living room, parlors, libraries, dens, bedrooms, Sun rooms and patios, recreation rooms, closets, hallways, laundry areas and or similar rooms. The National Fire Protection Authority (NFPA) recognizes that AFCI circuit breaker's can greatly reduce the risk of fire at receptacles throughout the dwelling caused by arc fault conditions. It is for that reason we at California Inspection Authority recommend the client consult with a licensed electrical contractor for installation of such safety devices.

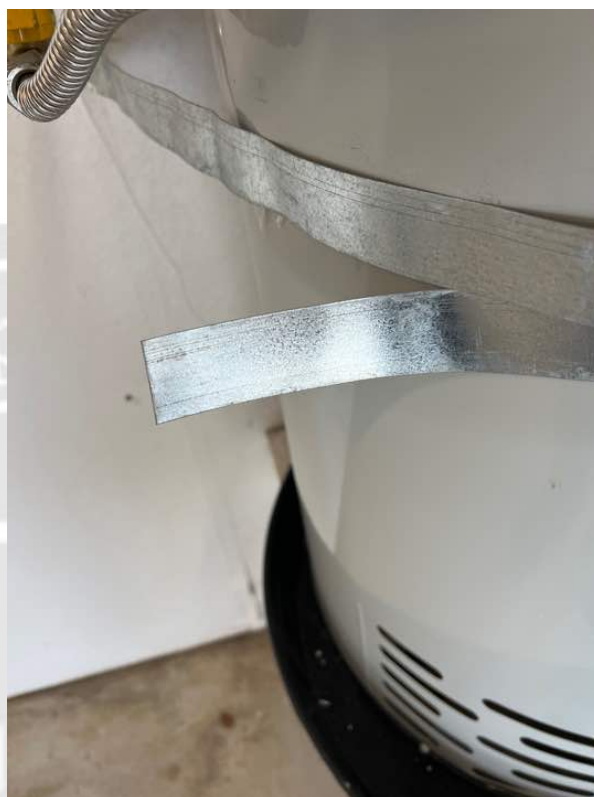
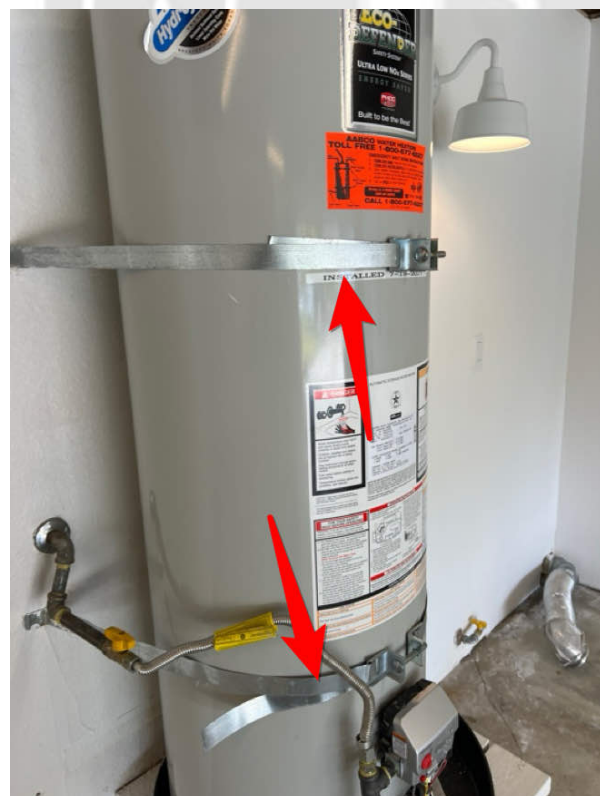
SAF s-103: Hot water heater seismic straps were not installed according to manufacturers guidelines. The hot water heater moves about freely. Consult with a plumbing contractor for proper blocking and bracing.

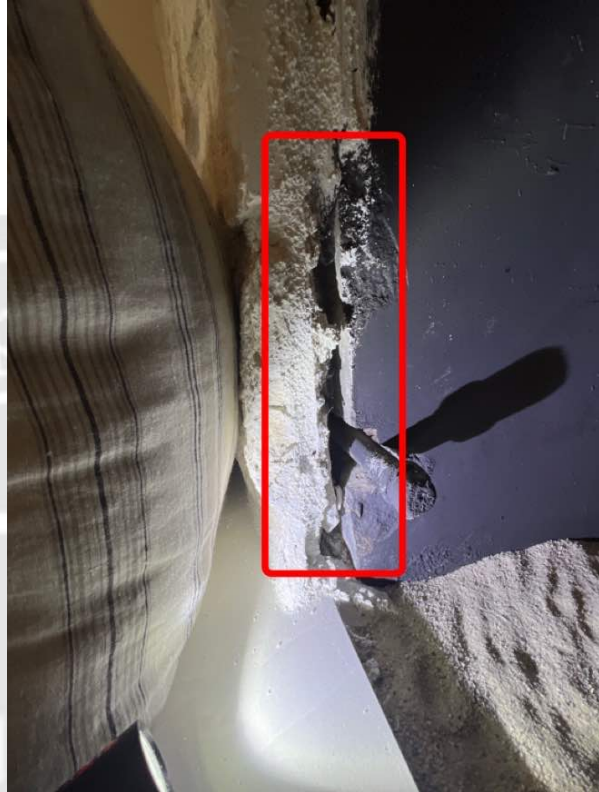
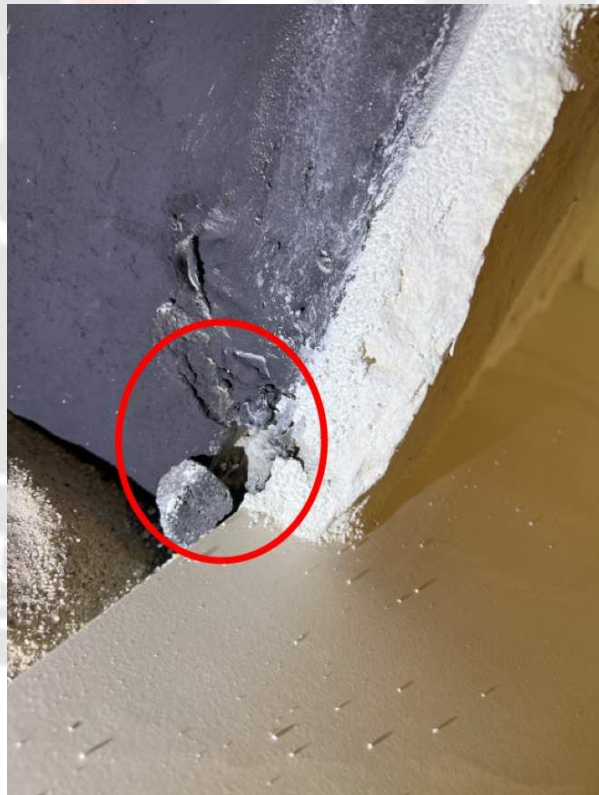
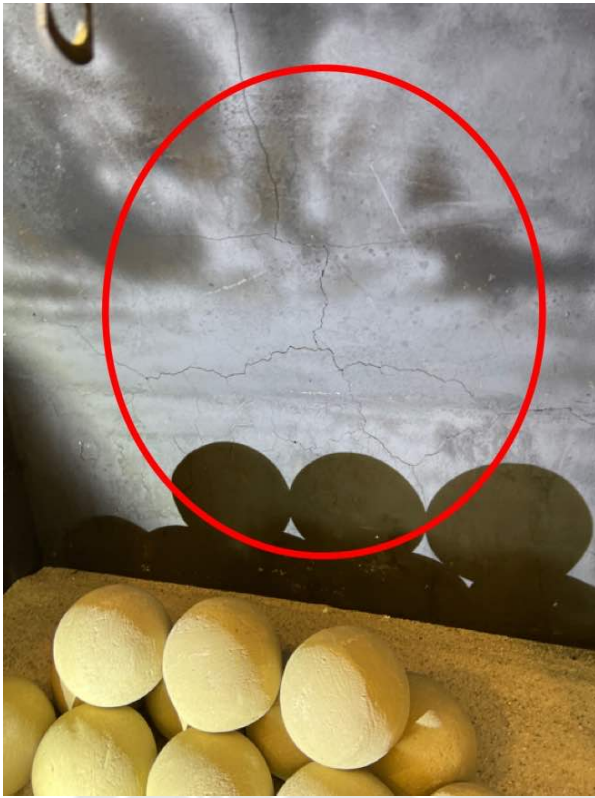
SAF s-136: Signs of alterations were made at the fireplace opening. The fireplace should not be used until a level two evaluation of the firebox has been made. Numerous hairline cracks were noted in the firebox. Fire and light safety concern.

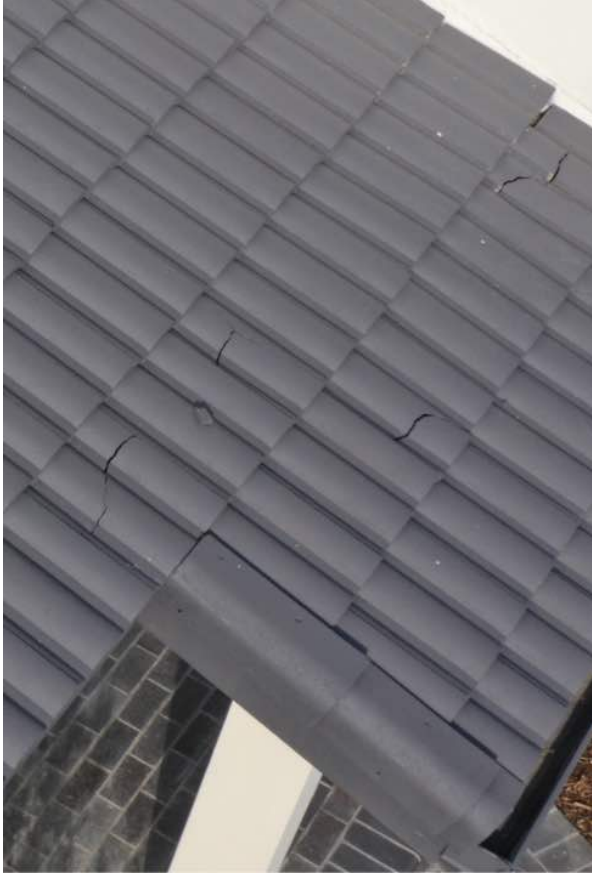
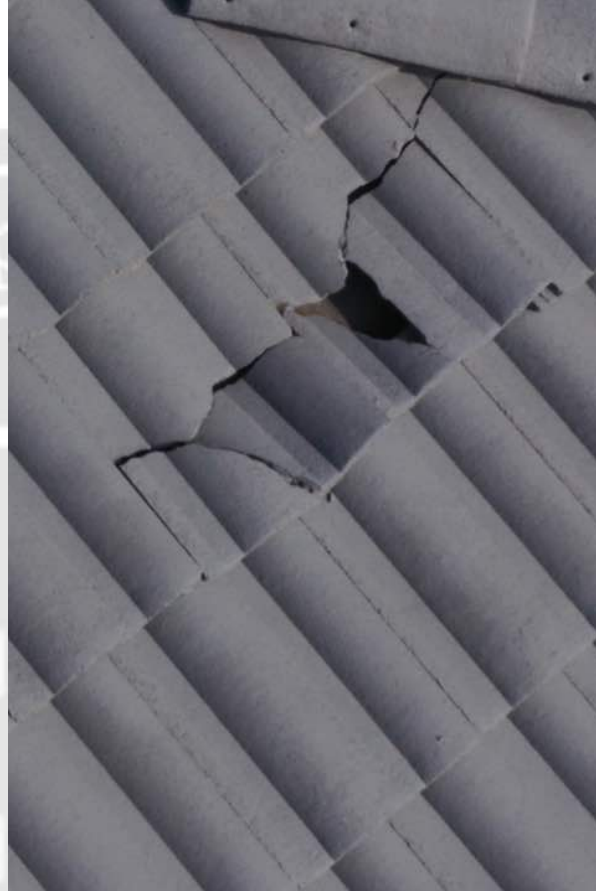
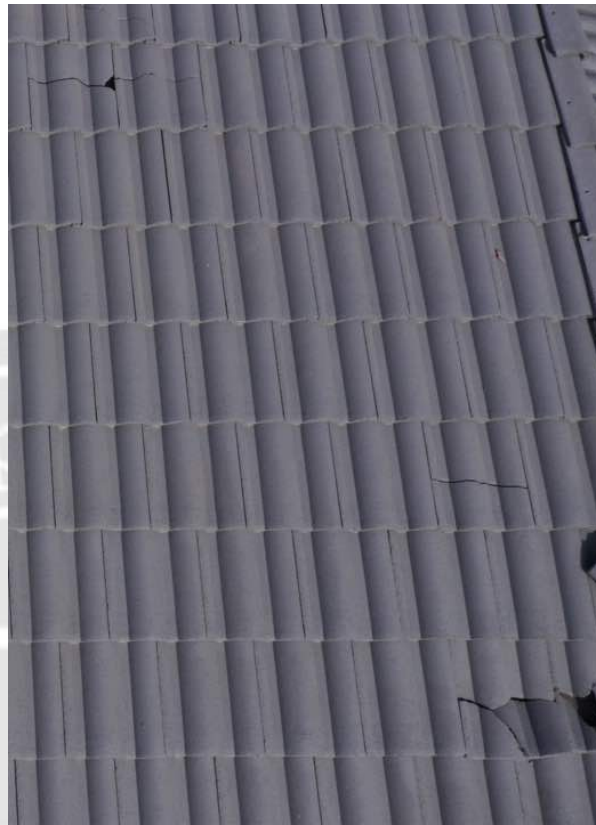
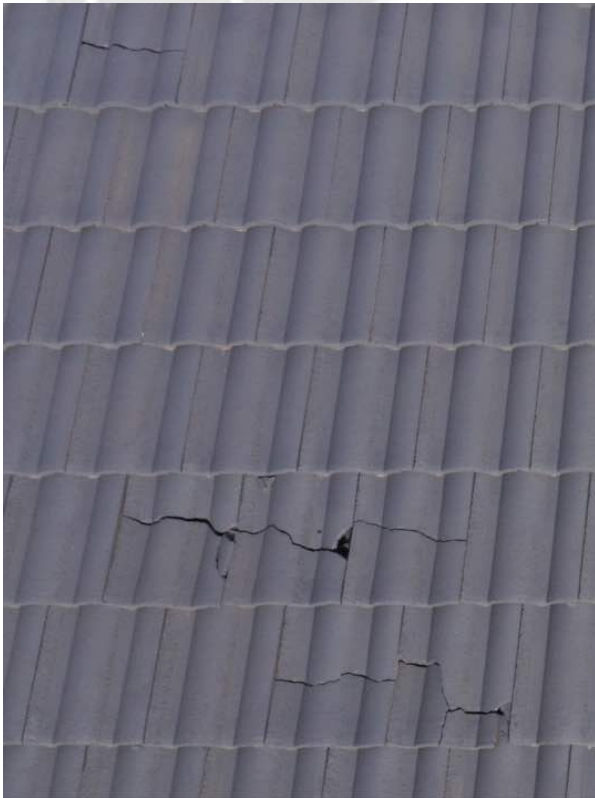
REP 12: Roofing tiles have been painted. Therefore, the actual condition of the tiles cannot be determined. Numerous broken roof tiles were noted. This is caused by foot traffic. The roof is subject to future leaks due to the quantity of broken roof tiles noted. Complete roof replacement recommended. There were no visible signs of leaks on the day of inspection.

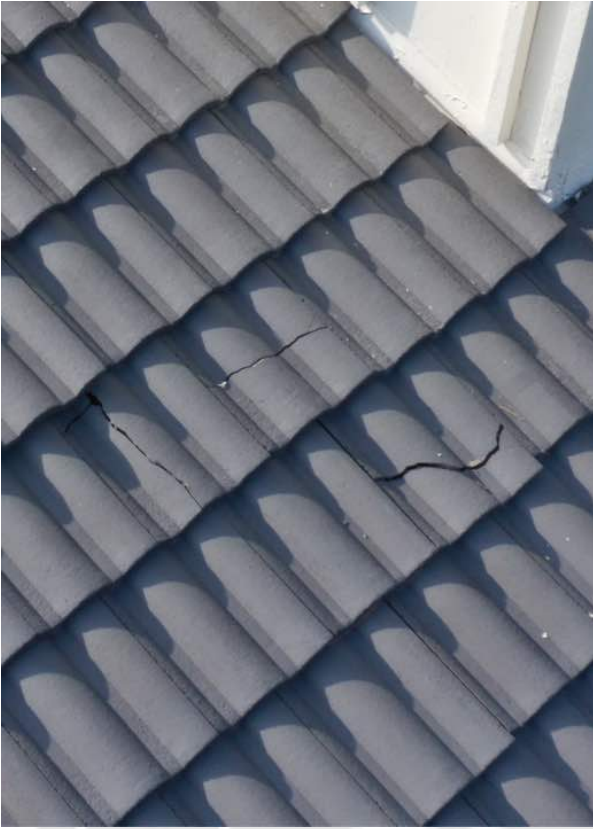
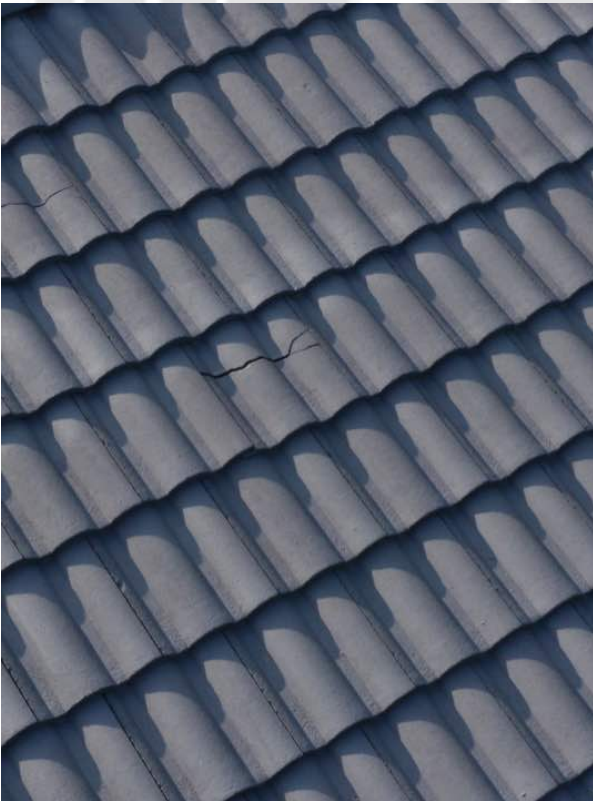
REP 13: Broken roof tiles continued.

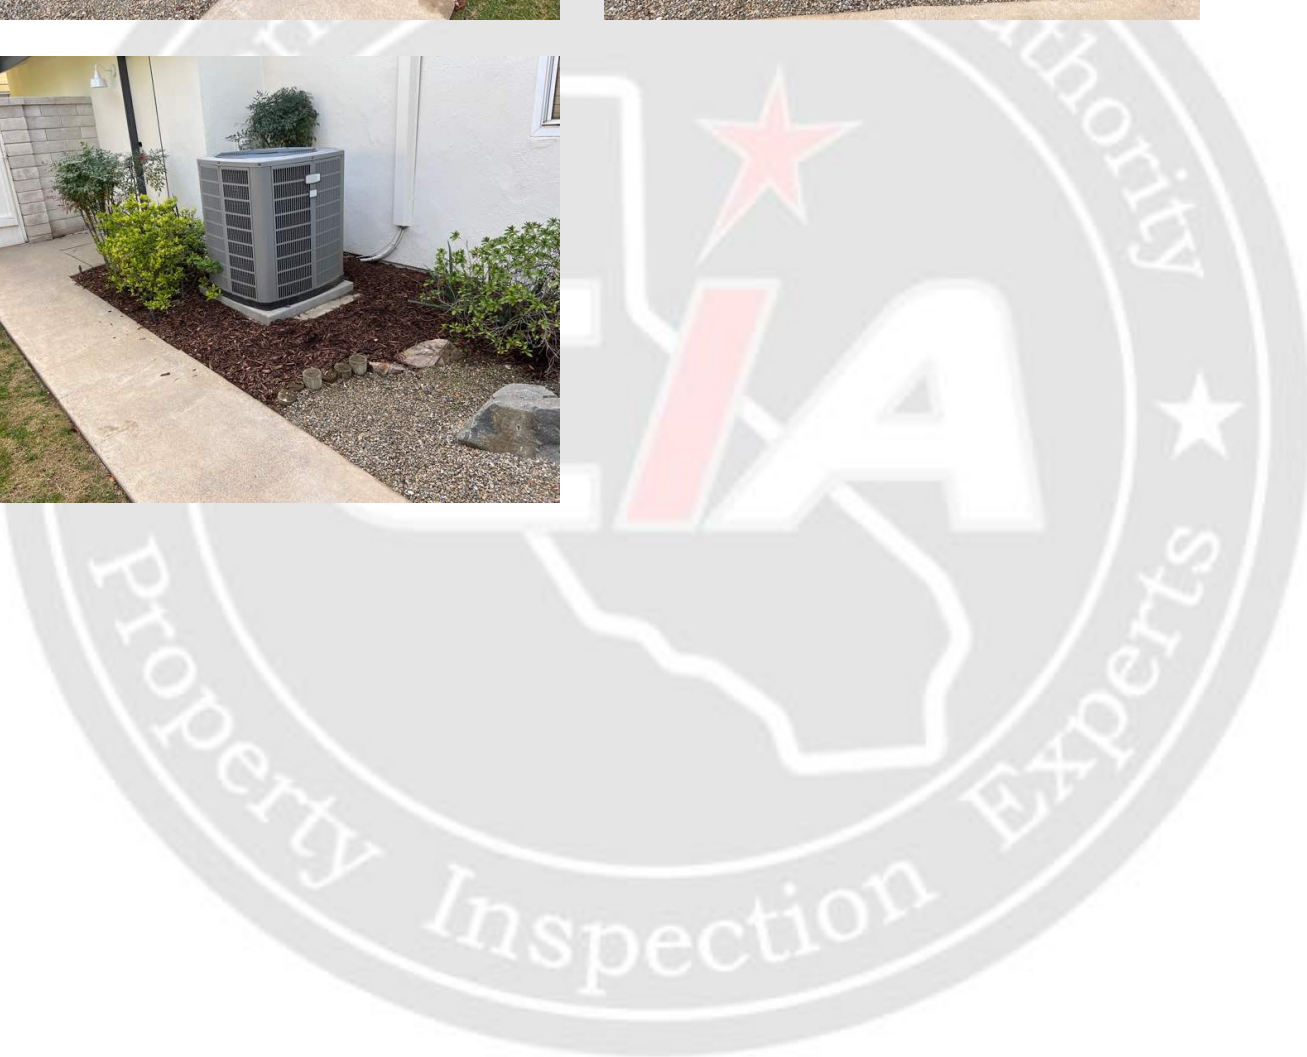
WARN 31: Caution should be used not to over water planters. There was no evidence of waterproofing along the foundation. Excessive watering can lead to deterioration of the foundation walls.

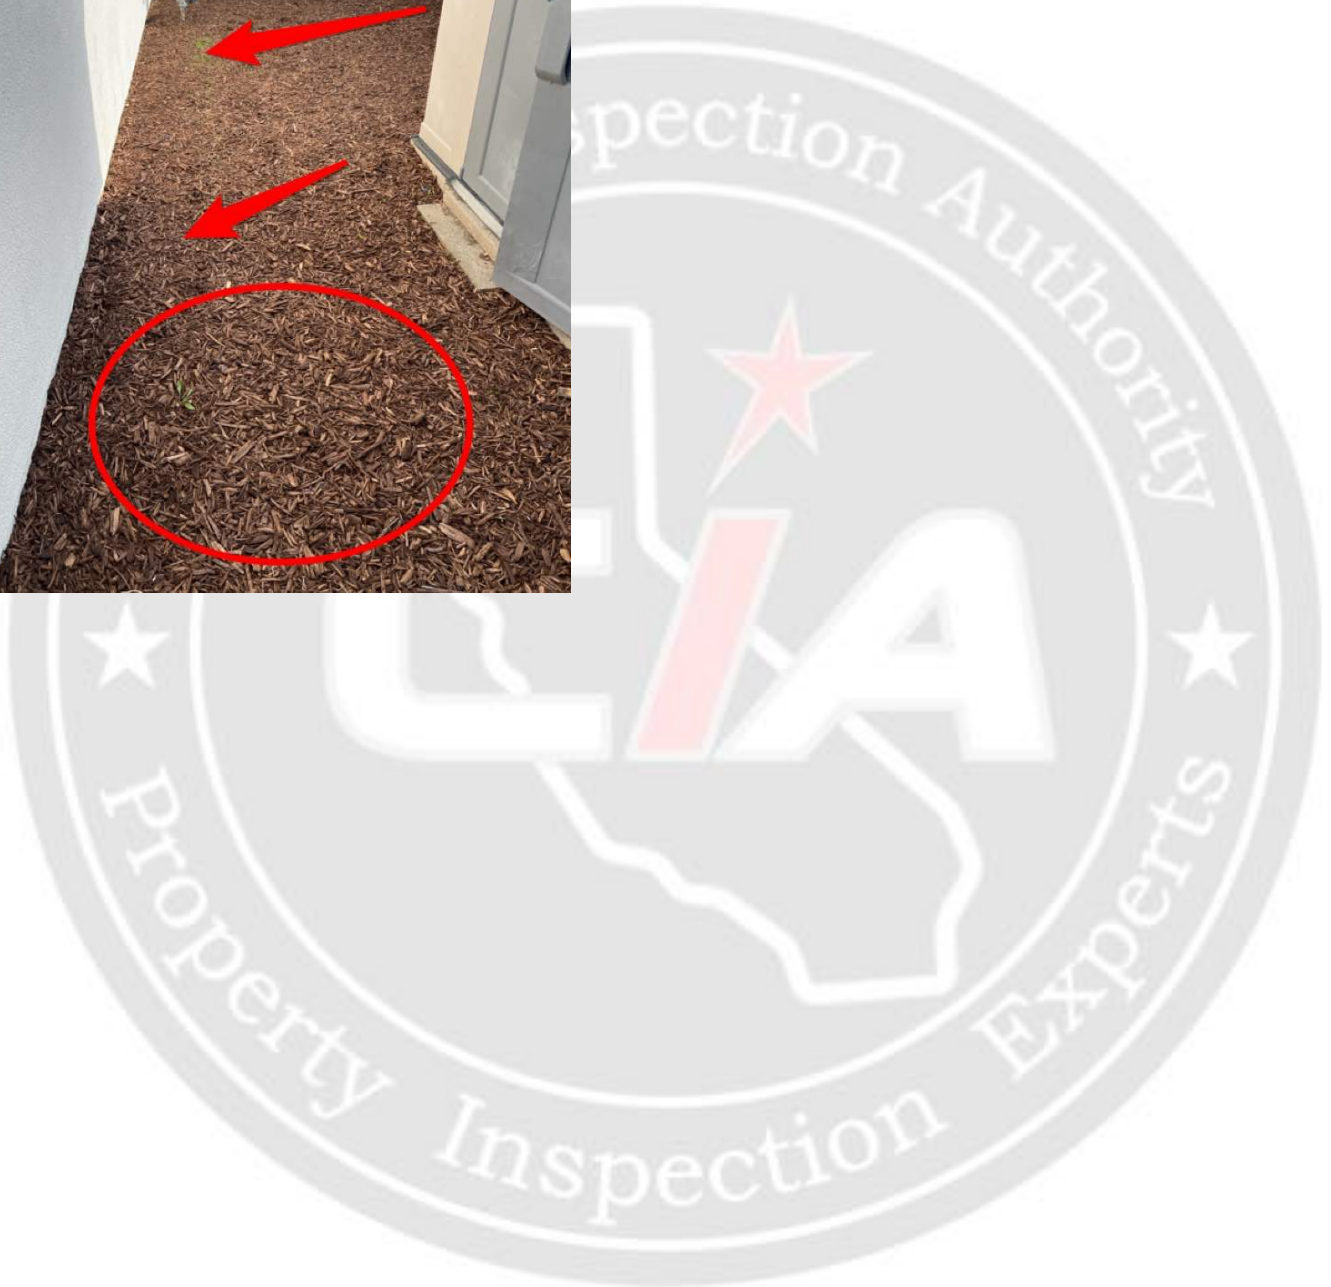
REP 32: Reverse drainage was noted at the side yard. Client should consult with a landscape contractor for further evaluation and resolution.

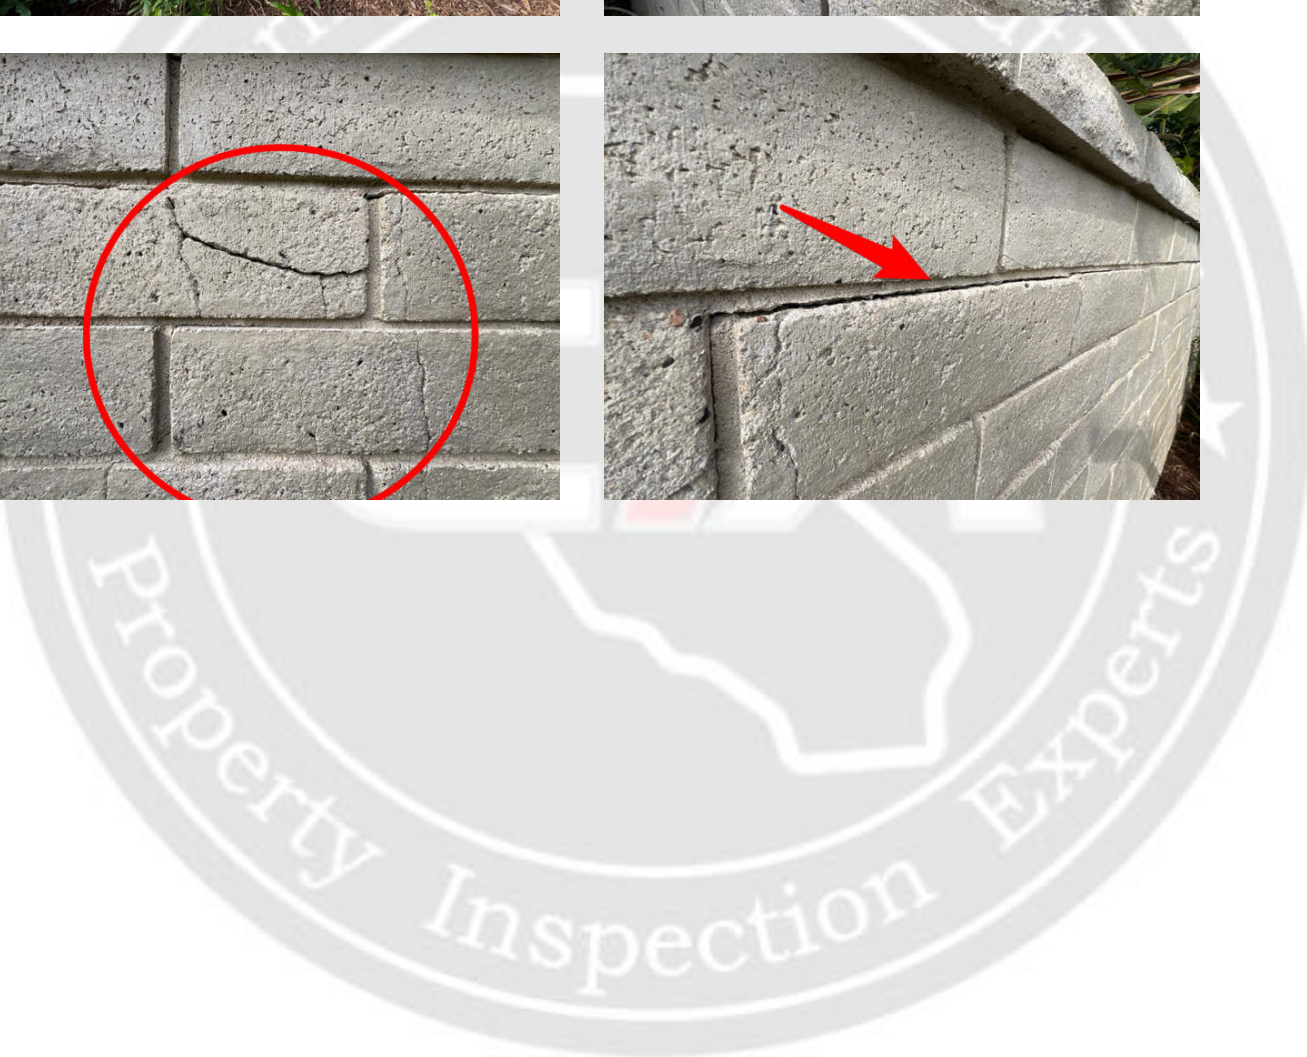
SAF s-45: Significant cracks were observed at the property wall. Repair recommend. Consult a mason for repairs.

SAF 45: Significant cracks were observed at the property wall. Repair recommend. Consult a mason for repairs.

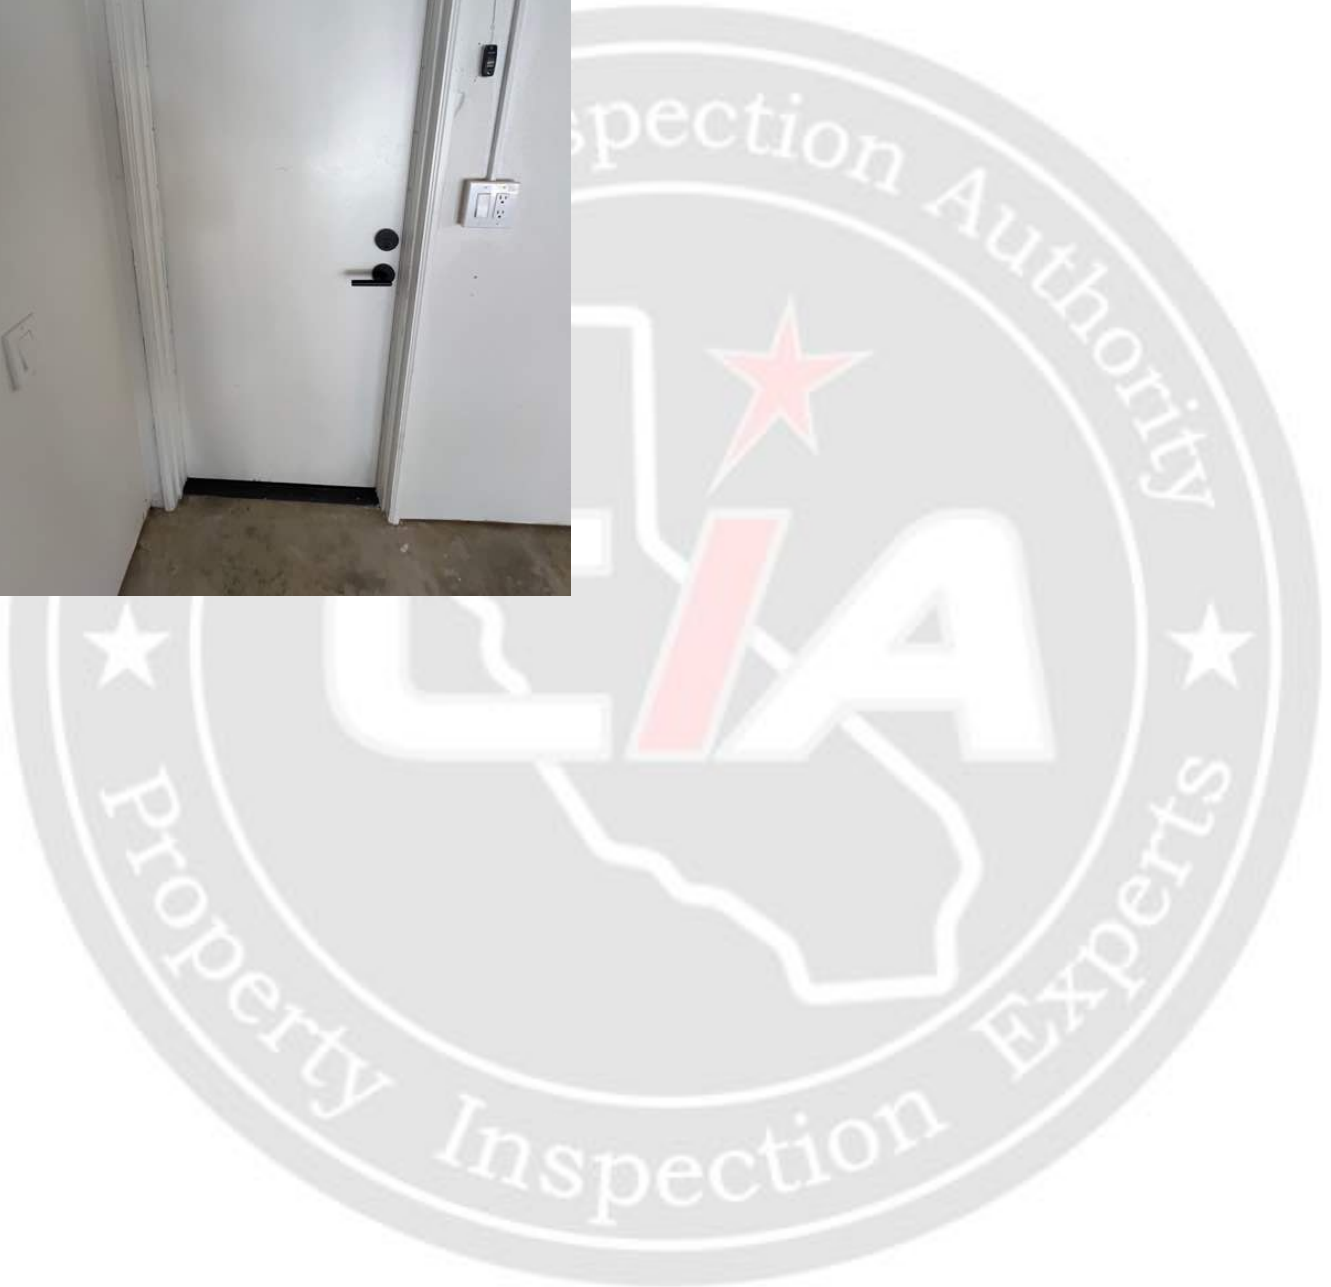
SAF s-51: A self-closing fire and smoke rated door is needed between the garage and habitable living space. Life safety concern. Consult a general contractor for installation.

SAF 51: A self-closing fire and smoke rated door is needed between the garage and habitable living space. Life safety concern. Consult a general contractor for installation.

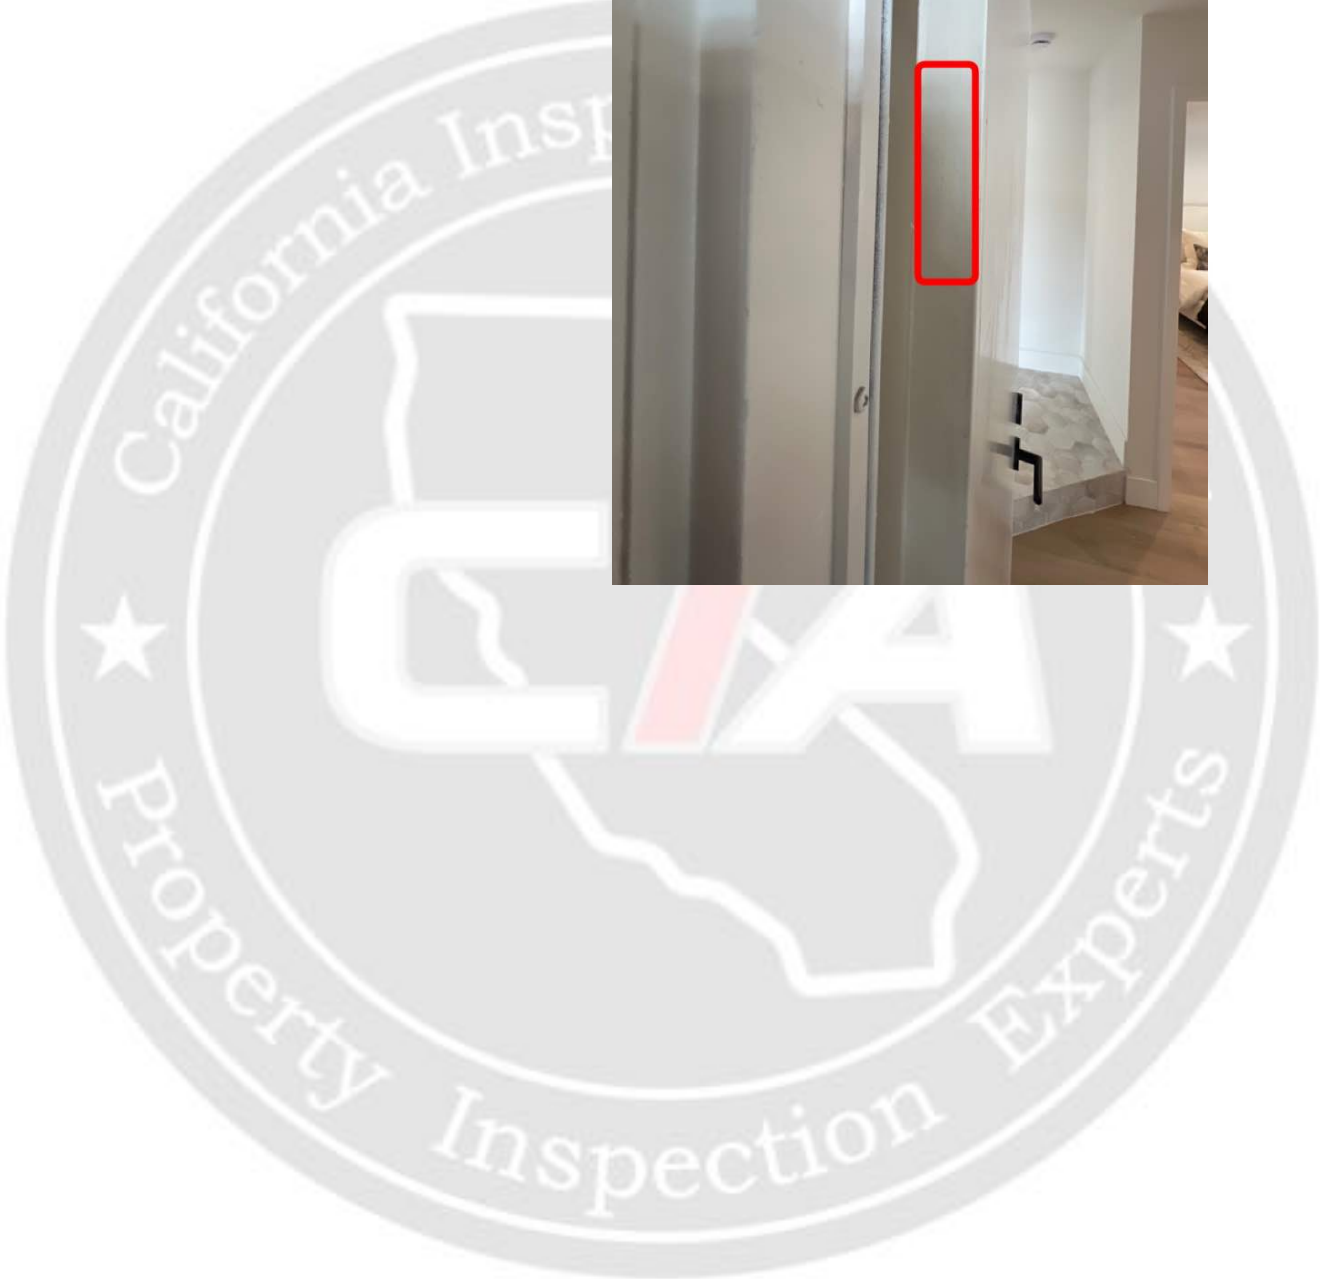
SAF s-52: The door between the garage and the habitable living space was missing a proper fire label. Thus the door's fire rating could not be determined.

SAF 52: The door between the garage and the habitable living space was missing a proper fire label. Thus the doors fire rating could not be determined.

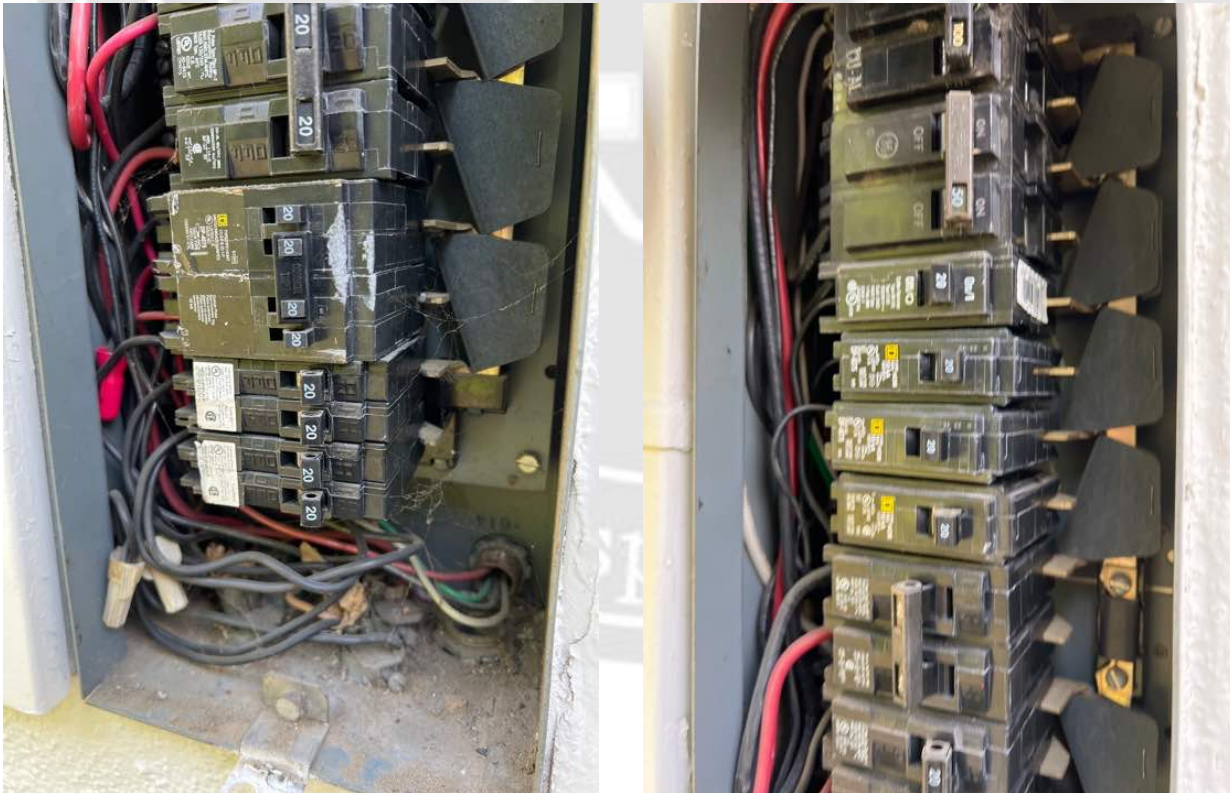
SAF 76: In 2020 the National Electrical Code (NEC) required that all 120v 15 and 20 amp branch circuits feeding convenience outlets and devices be protected by an AFCI circuit breaker. Including but not limited to kitchen, family rooms, dining room, living room, parlors, libraries, dens, bedrooms, Sun rooms and patios, recreation rooms, closets, hallways, laundry areas and or similar rooms. The National Fire Protection Authority (NFPA) recognizes that AFCI circuit breaker's can greatly reduce the risk of fire at receptacles throughout the dwelling caused by arc fault conditions. It is for that reason we at California Inspection Authority recommend the client consult with a licensed electrical contractor for installation of such safety devices.

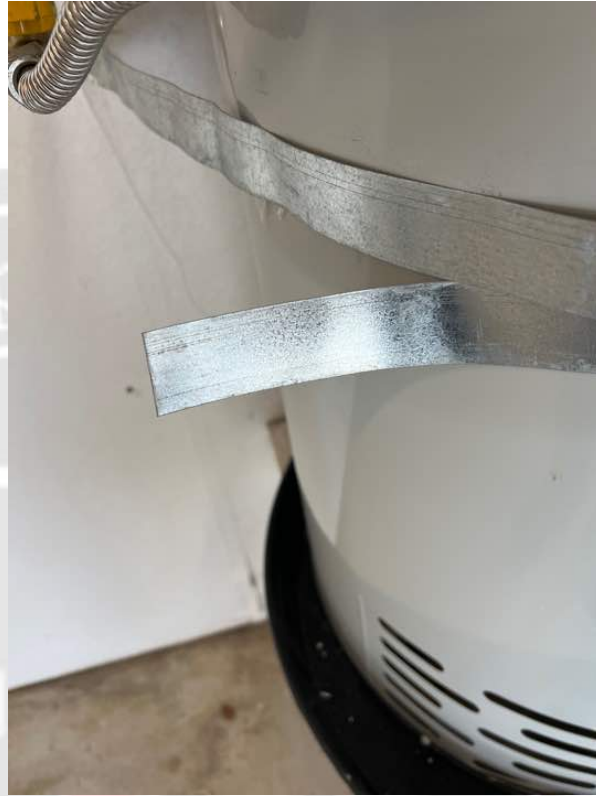
SAF 103: Hot water heater seismic straps were not installed according to manufacturers guidelines. The hot water heater moves about freely. Consult with a plumbing contractor for proper blocking and bracing.

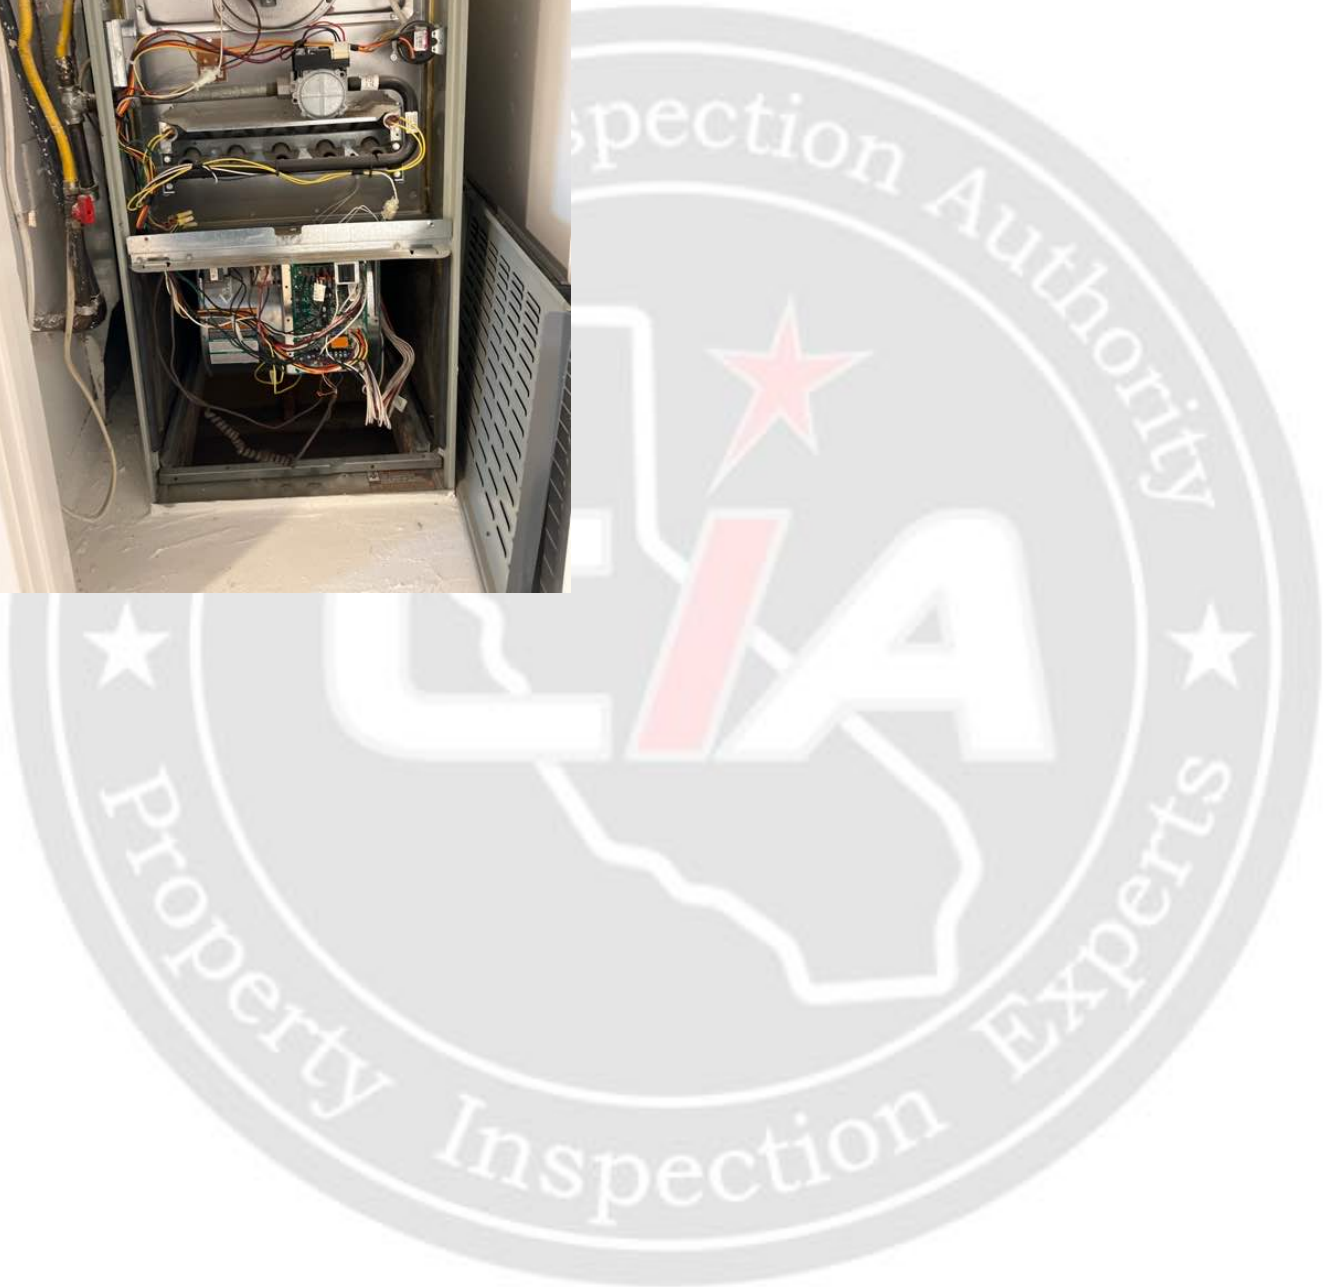
REP 110: The furnace system was nonresponsive on the day of the inspection. Consult with a licensed HVAC contractor for complete evaluation prior to the close of escrow.

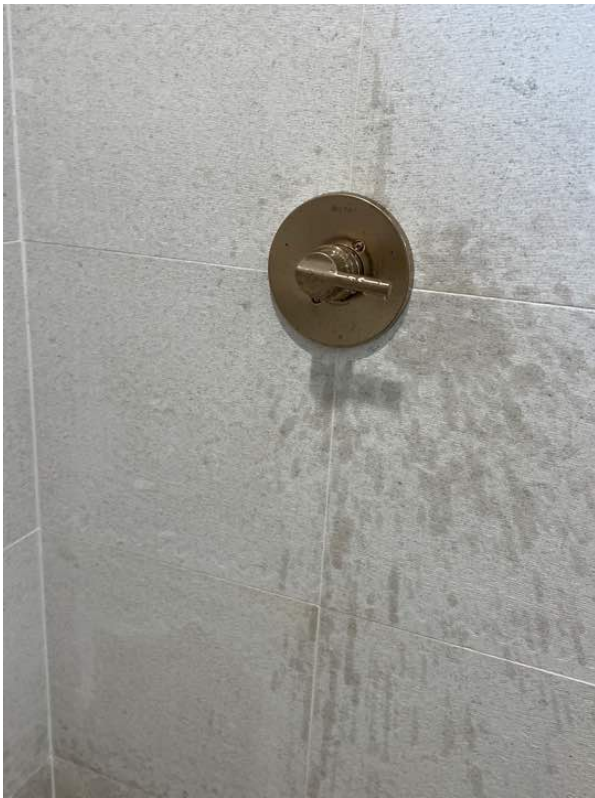
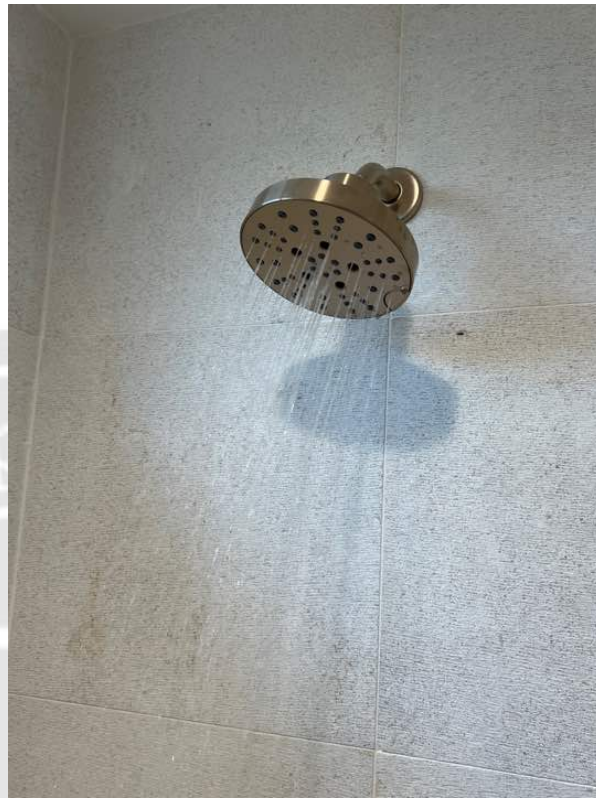
SAF 176: Shower was functional. It should be noted that during the testing of the shower water was splashing onto the flooring outside of the shower enclosure. This poses a slip and fall hazard. A shower door is recommended. Drain assembly cover did not flush within the shower. This is a safety hazard for tender feet.

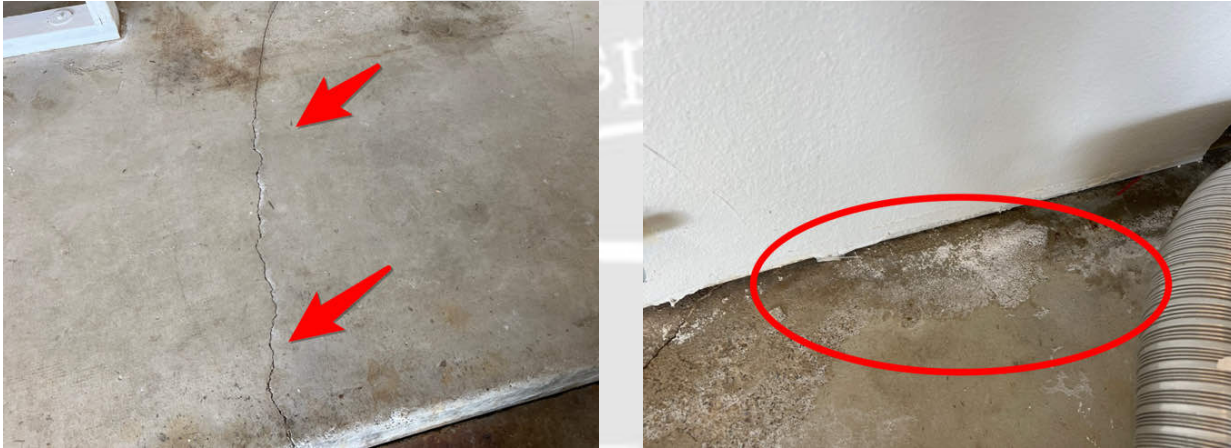
REP 188: Cracks were observed in the concrete at the laundry area. Additionally, there were signs of water inclusion at the Foundation line.
