# Confidential Inspection Report

INSPECTED ON:  
Wednesday, January 13, 2021

Inspector, [David@CiaHomeInspection.com](mailto:David@CiaHomeInspection.com)  
California Inspection Authority INC.  
(833) 242-4968 Ext 101  
[www.CIAhomeinspection.com](http://www.CIAhomeinspection.com)  
[David@ciahomeinspection.com](mailto:David@ciahomeinspection.com)

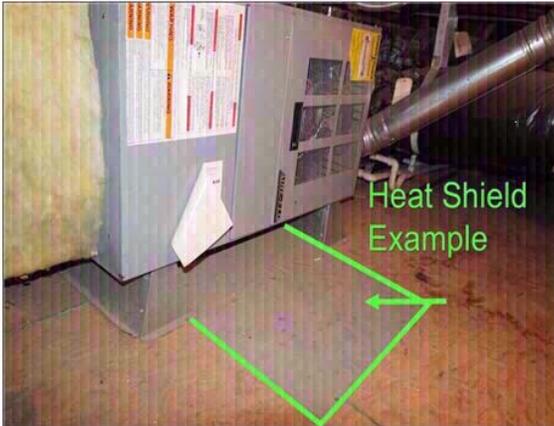
**SAF s-103:** A heat shield is recommended below all horizontal gas furnaces. This will help prevent fires at wood platforms.

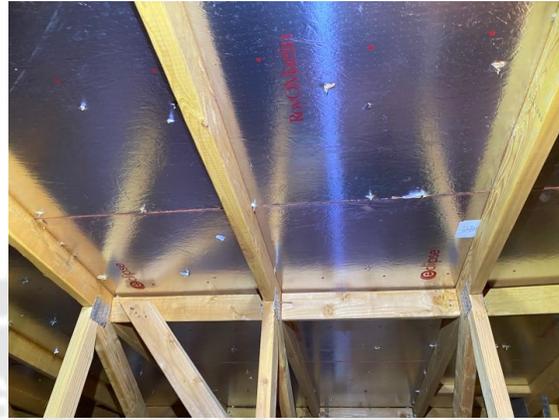
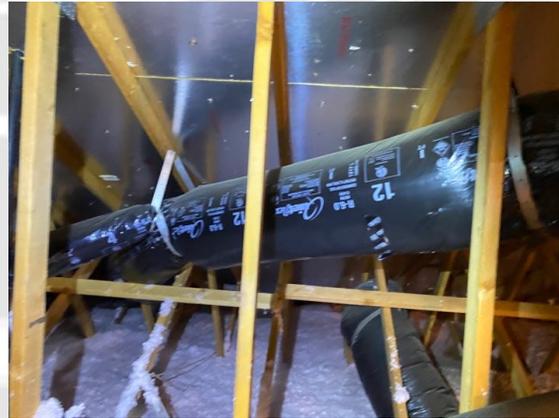
**14:** Approximately 20% of the roof deck was visible from the attic areas. There was no damage to the roof deck in the visible areas.

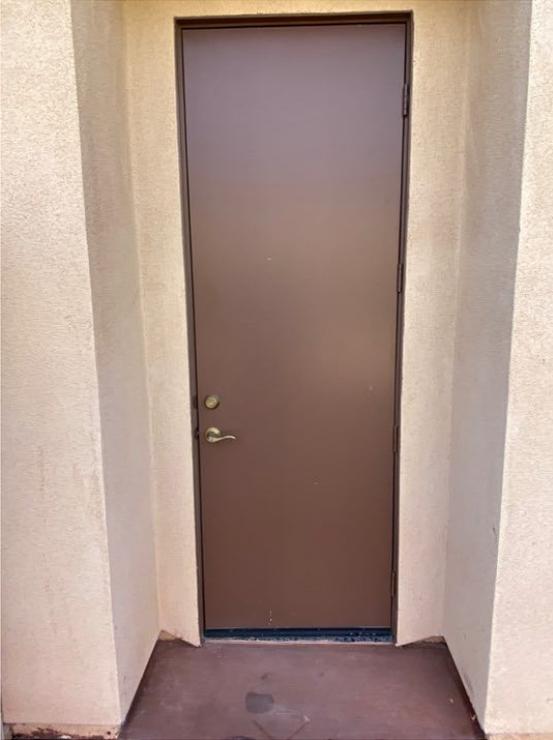
**33:** The garage pedestrian door was functional. The door shows signs of normal wear and tear.

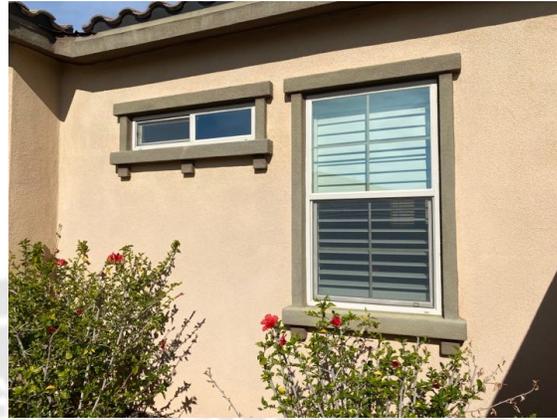
**53:** The stucco was in satisfactory condition. Minor hairline cracks were noted. But are considered a normal part of the curing and settling.

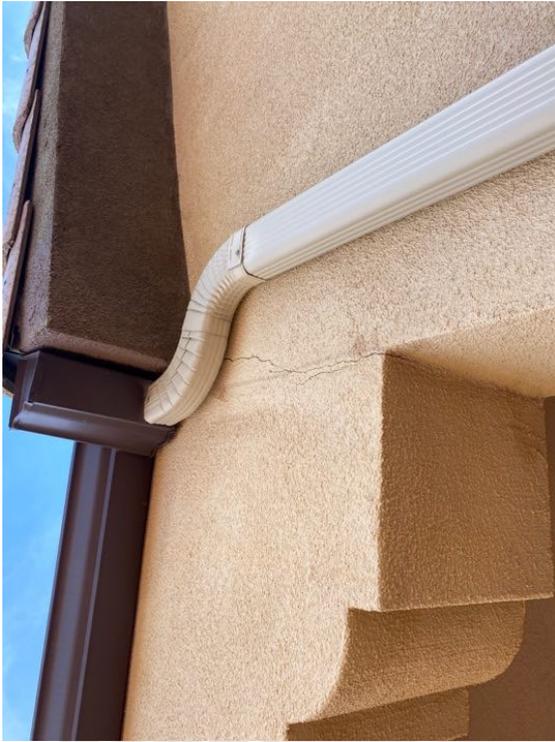
**REP 55:** Small to medium size cracks were noted at the rear of the home at the rear patio. Client should consult with a contractor prior to the close of escrow for review and needed repairs.

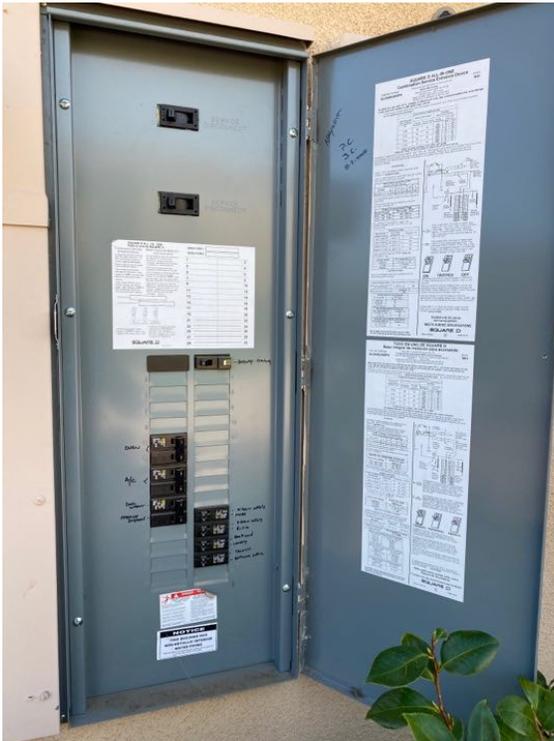
**63:** The main electrical panel was manufactured by Square D Corporation. The panel is rated for 125/250 Volts and is in good condition. Voltage was tested and well within guidelines.

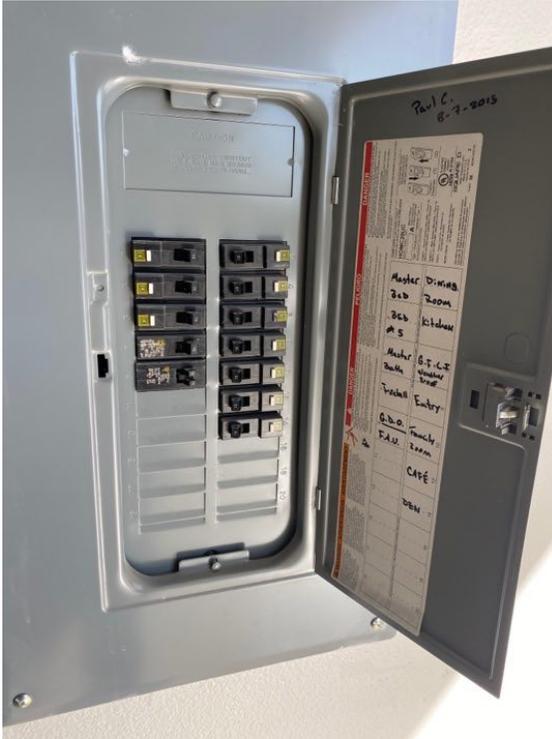
71: The sub panel was manufactured by Square D Corporation. The panel is rated for 125/250 Volts and is in good condition. Voltage was tested and well within guidelines.

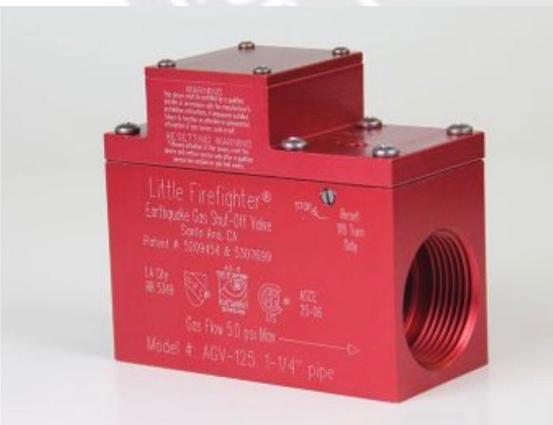
**WARN 79:** Seismic shut off valve is a recommended safety device. The seismic shut off valve functions during an earthquake to help prevent hazardous gas leaks that could result in fires and other hazardous conditions.

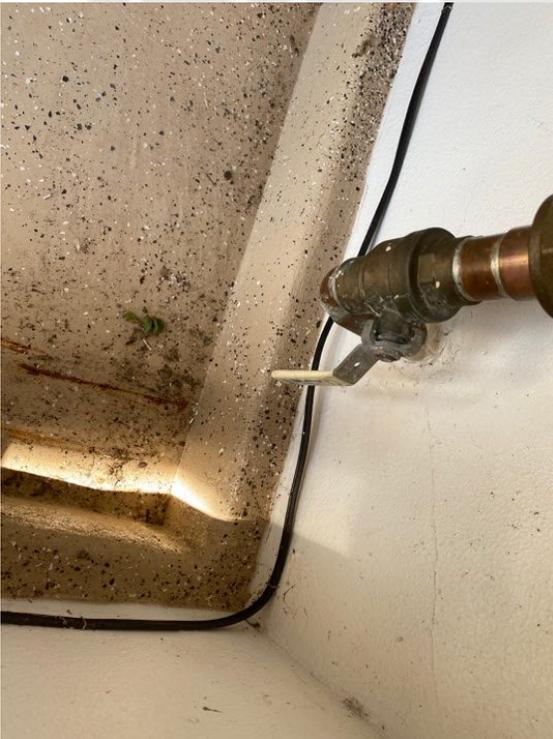
**81:** The main shutoff valve is located in the garage.

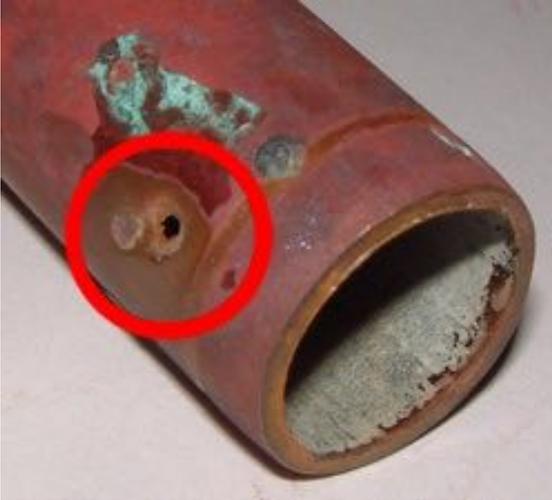
**WARN 93:** Client should be aware that homes of this age with copper plumbing running below grade, under the concrete slab and in walls are subject to pinhole leaks. These leaks go undetected for the most part but can cause significant damage. Client should understand the monetary risks involved with purchasing a home with plumbing systems of this nature.

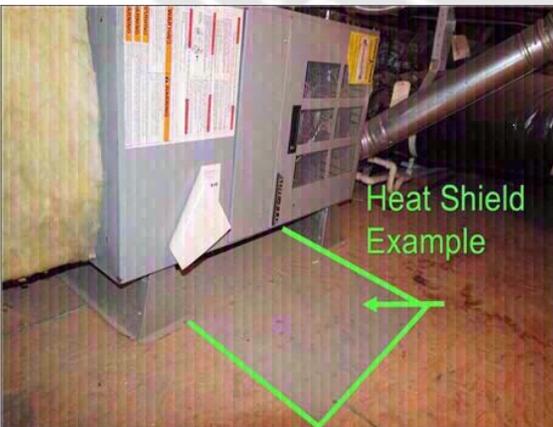
**SAF** 103: A heat shield is recommended below all horizontal gas furnaces. This will help prevent fires at wood platforms.

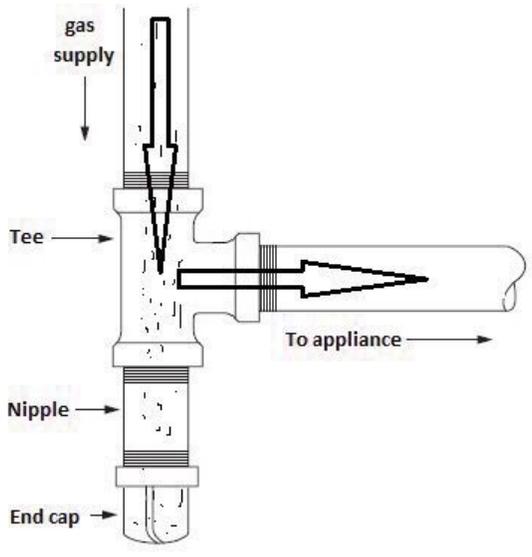
**WARN 104:** We recommended that a sediment leg be installed at the gas heater. The sediment leg will help contain sediment and debris from clogging gas valves and orifices.

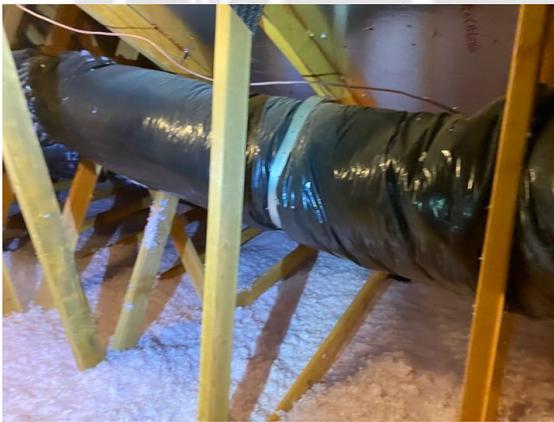
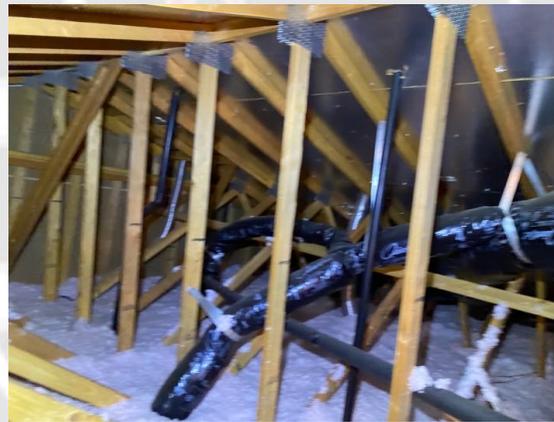
**107:** Flexible insulated duct work was utilized. The duct work was in satisfactory condition where visible.

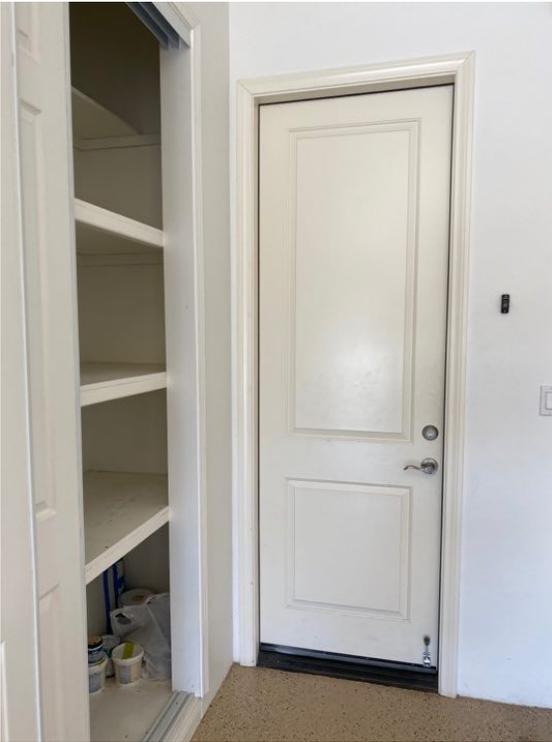
**124:** The fire door was tested and found to be functional on the day of inspection.

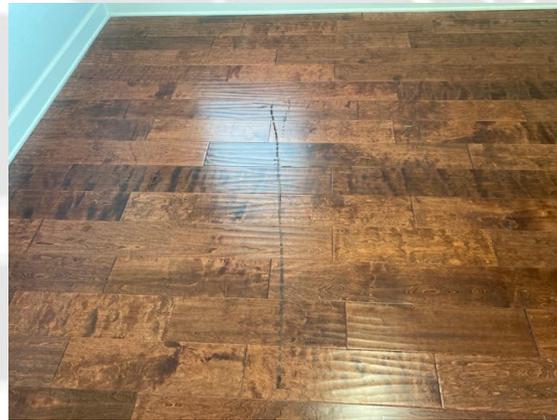
**REP 192:** Damage/scratching was observed at the flooring within the bedroom. Consult with a licensed flooring contractor for further evaluation and repairs.

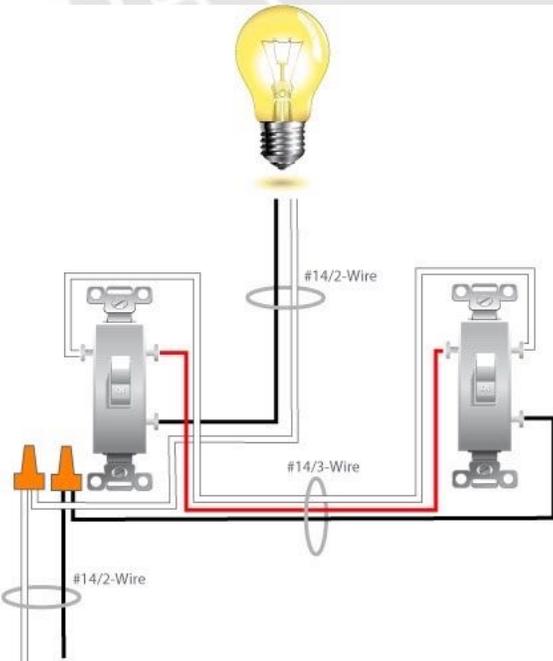
**REP 217:** Deficiencies at the three-way switch located in bathroom #2 were preventing the light from being turned on. Consult with a licensed electrician for further evaluation and resolution.

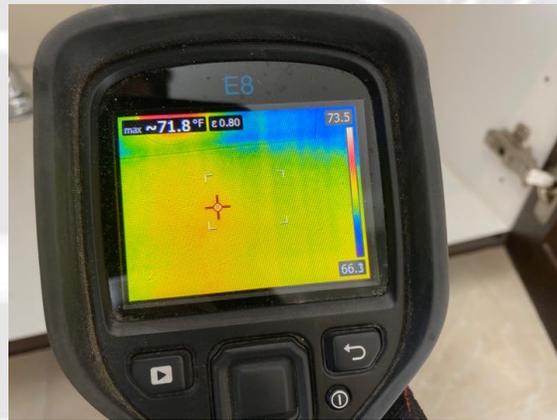
**WARN 249:** Stains were noted in the cabinet below the bathroom sink. The cause of the stains is unknown. There was no moisture on the day of inspection
