Inspection Report

Lynridge Dr
Yorba Linda, California
92886

Inspected By
David Salvato
California Inspection Authority INC.
(949) 981-8320
CIAHomeInspection@gmail.com
Inspecting The Finest Homes In California
www.CIAHomeInspection.com

Wednesday
December 27, 2023

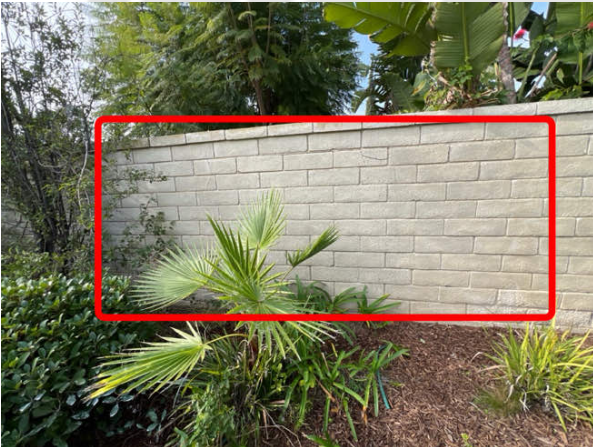
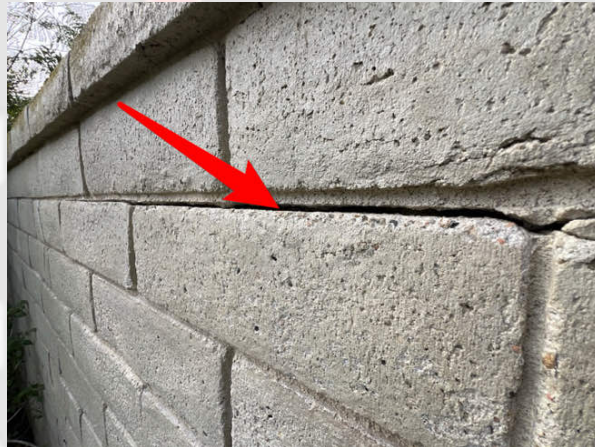
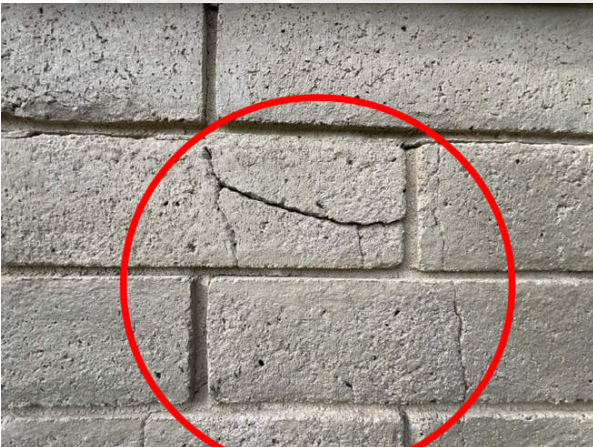
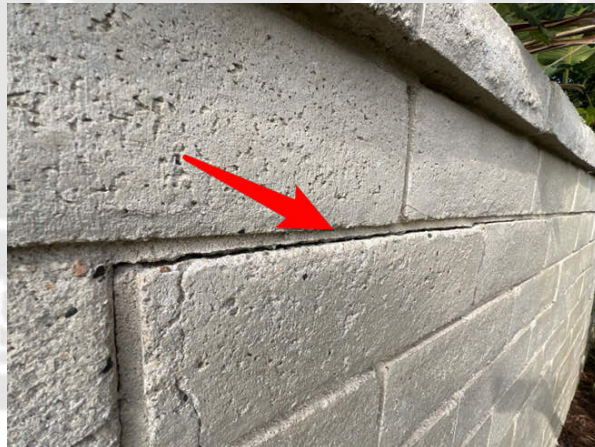
REAR OF HOME PROPERTY WALL CONDITIONS

SAF s-45: Significant cracks were observed at the property wall. Repair recommend. Consult a mason for repairs.

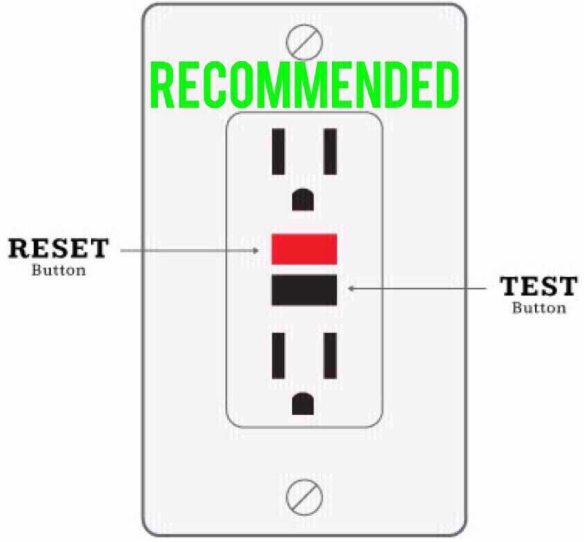
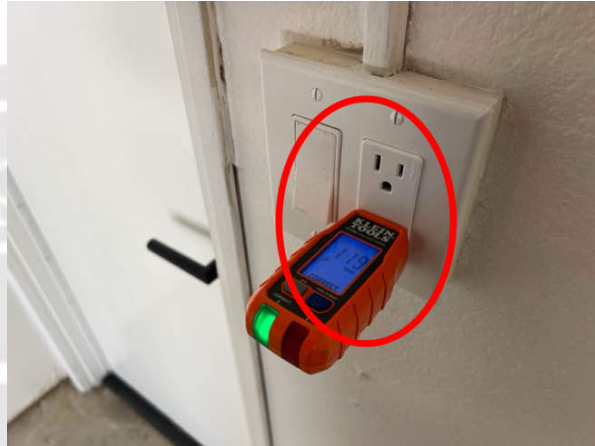
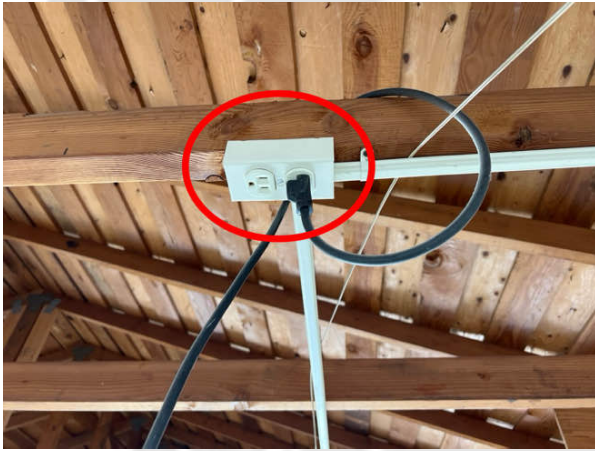
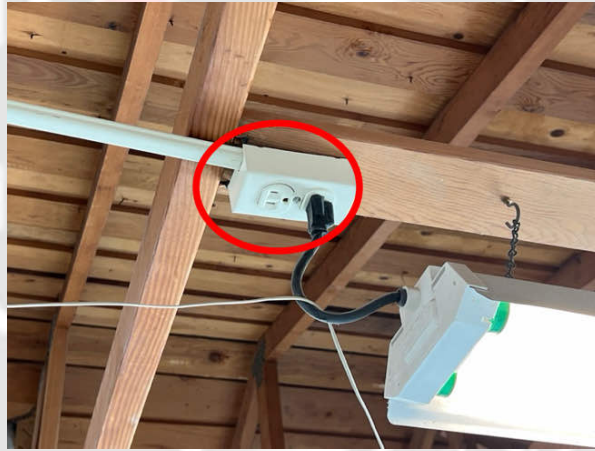
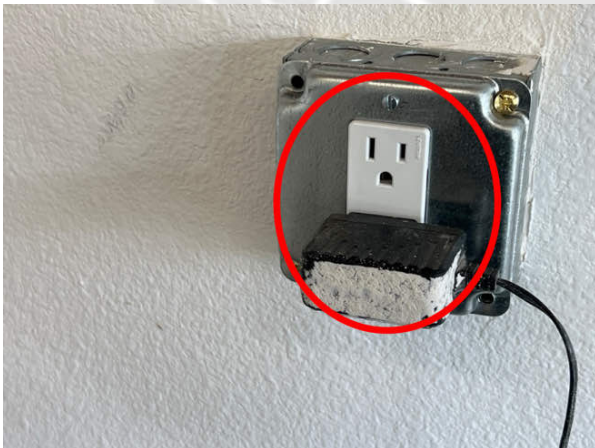
GARAGE ELECTRICAL

SAF s-50: All garage receptacles must be GFCI protected for occupant safety. Consult with a licensed electrician for installation.

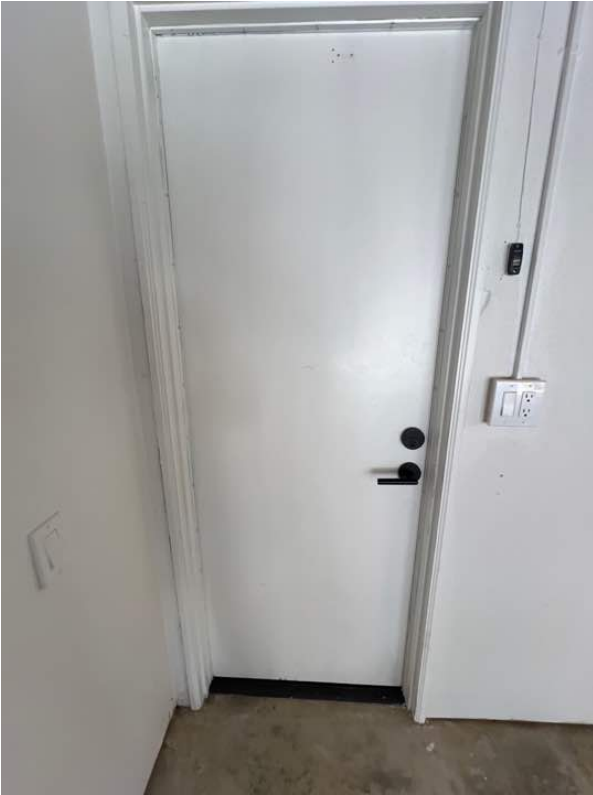
GARAGE FIRE DOOR

SAF s-51: A self-closing fire and smoke rated door is needed between the garage and habitable living space. Life safety concern. Consult a general contractor for installation.

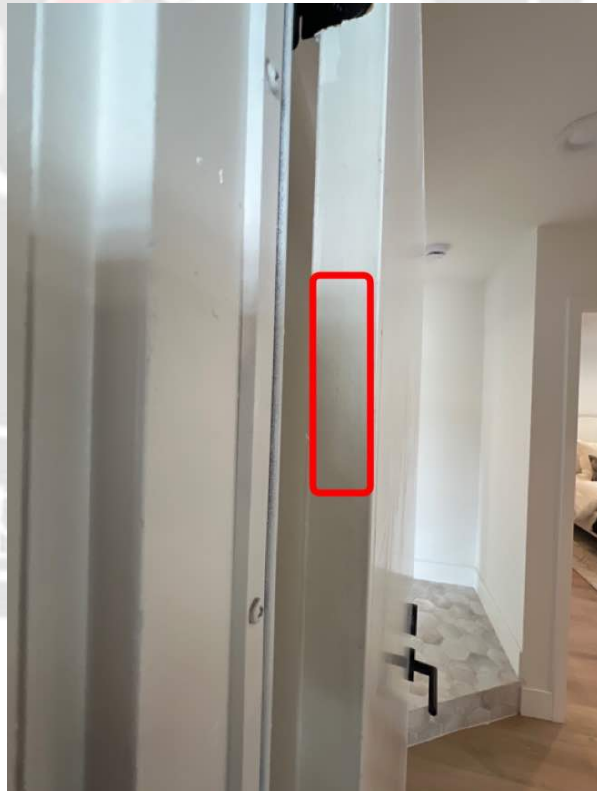
SAF s-52: The door between the garage and the habitable living space was missing a proper fire label. Thus the door's fire rating could not be determined.

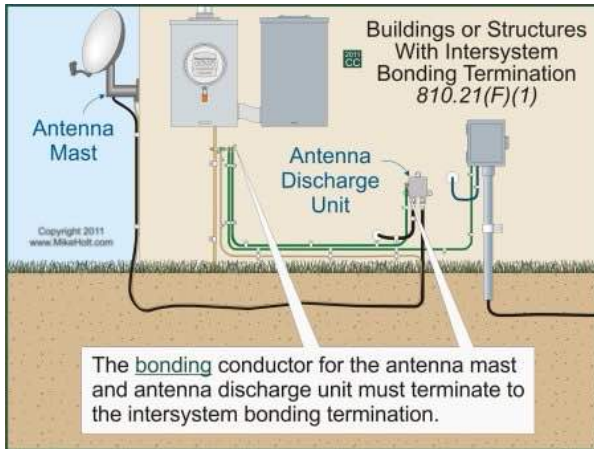
COMMUNICATION UTILITY COMMUNICATION UTILITY

SAF s-66: Missing intersystem bonding termination device. (IBT) Bonding of communication systems. A bonding termination device must be provided for communication systems in accordance with article 250.94 A and B of the national electrical code. It is suggested that a "Licensed Electrical Contractor" be contacted for further evaluation and installation.

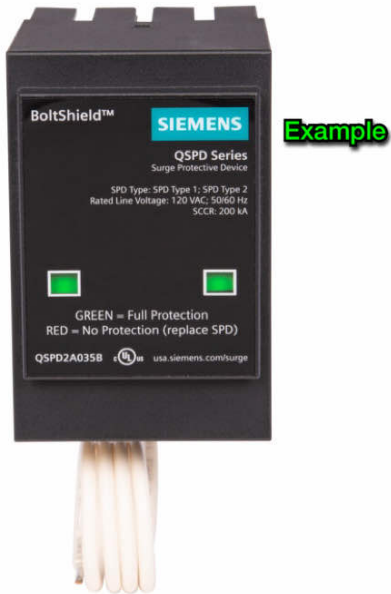
MAIN ELECTRICAL PANEL GENERAL CONDITION

SAF s-72: There was no surge protection provided. Article 230.67 of the 2020 National Electrical Code® (NEC) now requires all services supplying dwelling units to be provided with a surge protective device (SPD), as an integral part of equipment or located immediately adjacent. The SPD must be a Type 1 or Type 2 SPD.

It is suggested that a "Licensed Electrical Contractor" be contacted for further evaluation and installation.

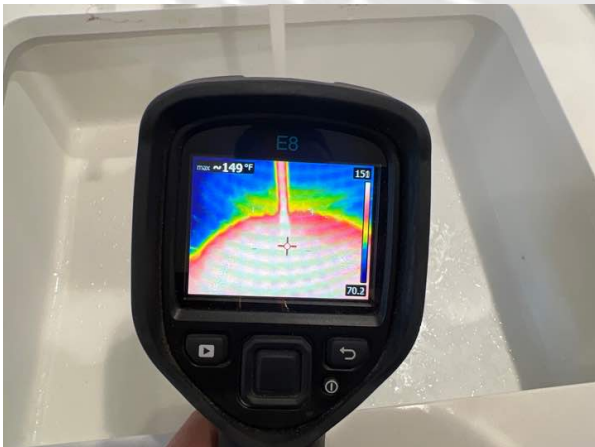
WATER HEATER(S) GENERAL CONDITION

SAF s-96: The hot water heater temperature exceeded 120°. While this temperature may be tolerable to most individuals. Anything over 120° could be considered scolding. We recommend the hot water heater temperature be lowered to a nominal safe level.

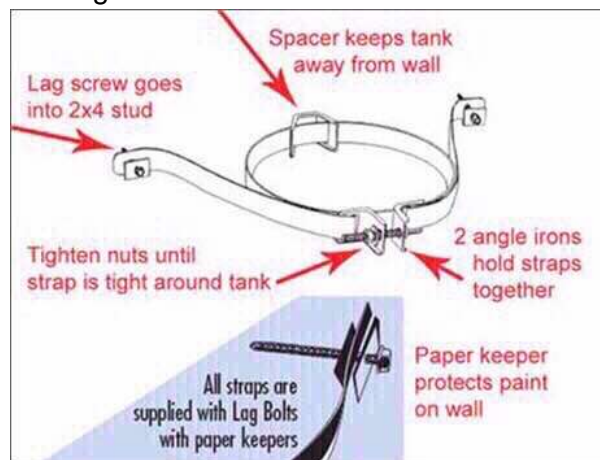
WATER HEATER(S) SEISMIC STRAPS

SAF s-103: Hot water heater seismic straps were not installed according to manufacturers guidelines. The hot water heater moves about freely. Consult with a plumbing contractor for proper blocking and bracing.

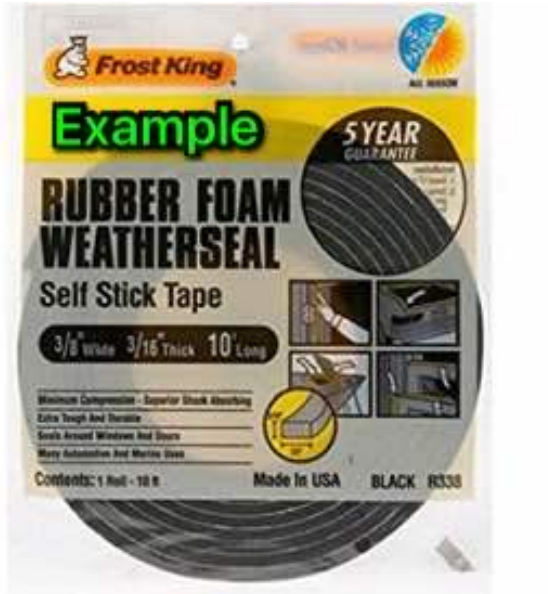
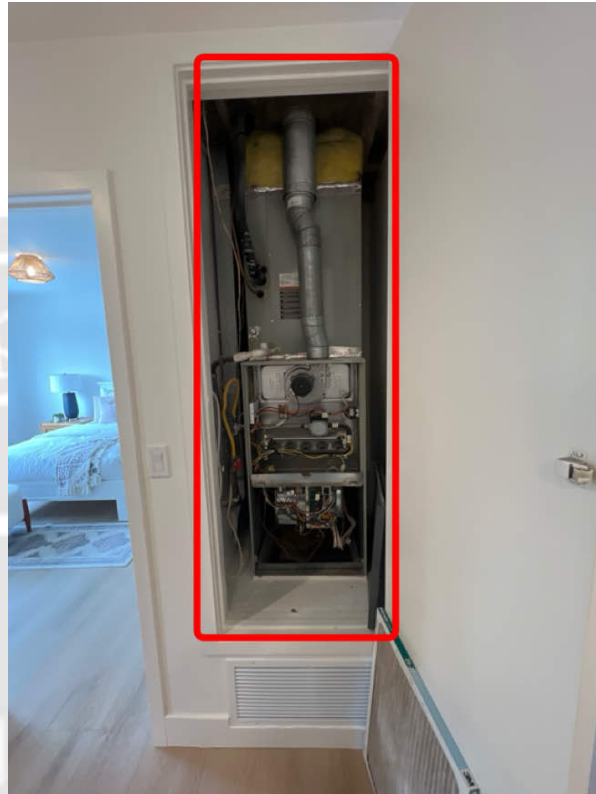
HEATING SYSTEM HEATING SYSTEM CONDITION

SAF s-109: Because of the close proximity to the return air register. It is strongly recommended that the door to the heating system be properly sealed. This will prevent air scavenging from the furnace closet.

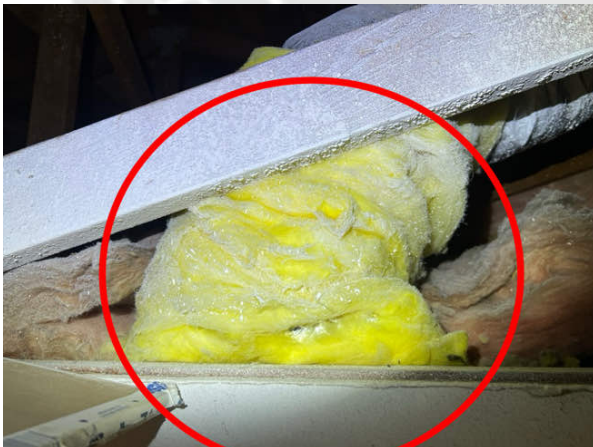
HEATING SYSTEM DISTRIBUTION CONDITIONS

SAF s-116: Asbestos like materials were noted at register heads. These materials were commonly used during the time of construction. It is highly recommended that the air distribution lines be tested for asbestos content prior to the close of escrow. Client should consider the cost of upgrades. Consult with a licensed HVAC contractor for full evaluation and cost of encapsulation or other resolution.

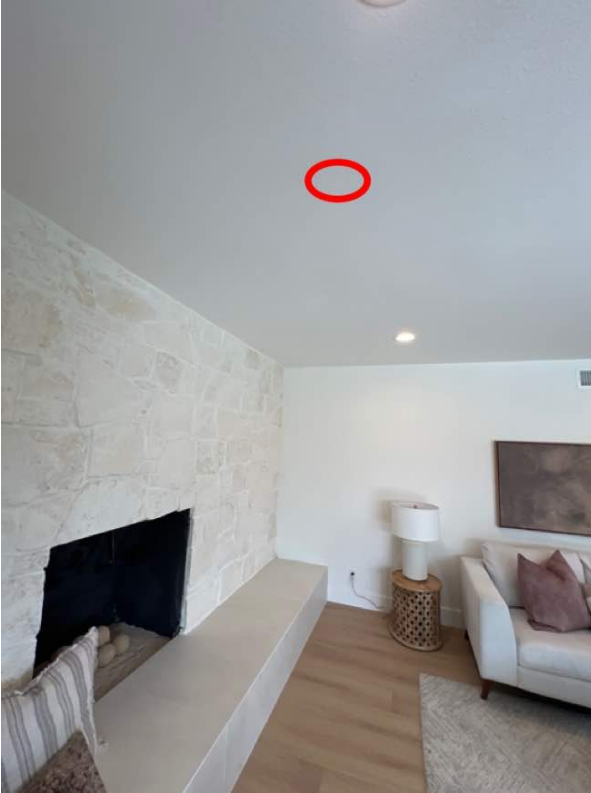
FIREPLACE DETECTORS

SAF s-135: Combination/smoke and carbon monoxide detectors are recommended in rooms that have installed fireplaces. Detectors will function as an early warning device in the event of a fireplace with drafting issues.

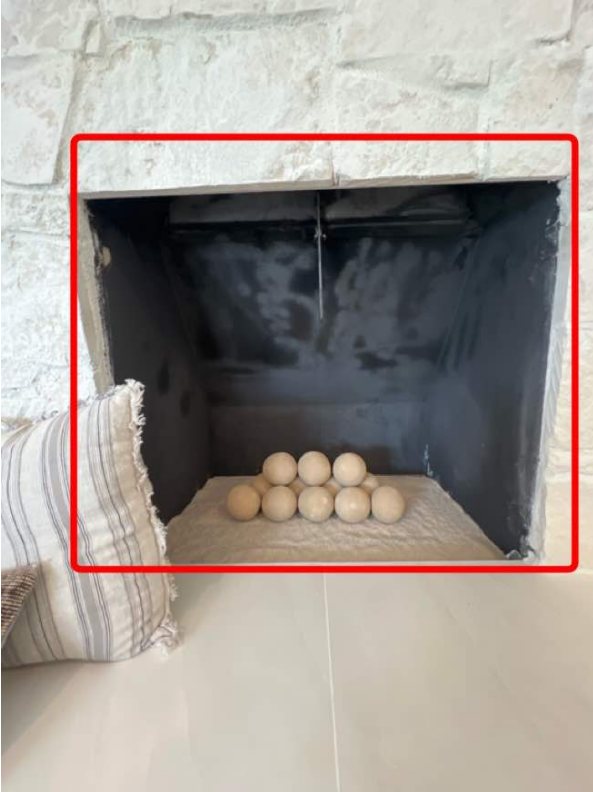
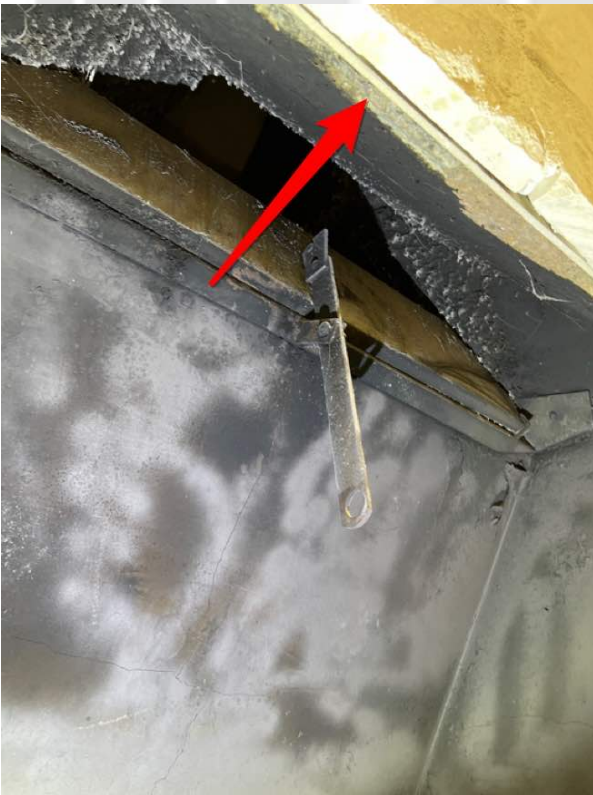
FIREPLACE GENERAL CONDITIONS

SAF s-136: Signs of alterations were made at the fireplace opening. The fireplace should not be used until a level two evaluation of the firebox has been made. Numerous hairline cracks were noted in the firebox. Fire and light safety concern.

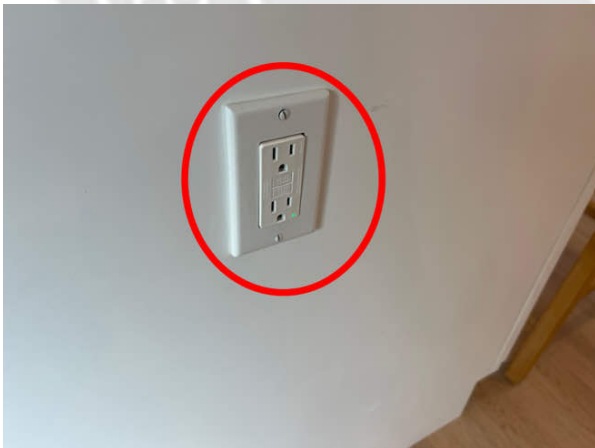
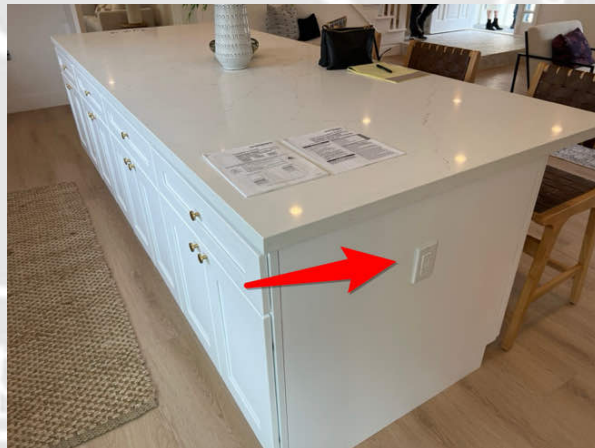
ELECTRICAL CONDITIONS ELECTRICAL CONDITIONS

SAF s-142: 1F" receptacles are installed to serve an island or peninsular countertop or work surface, they must be installed in accordance with the rules in Section 210.52(C)(3) below:

Installed on or above the countertop or work surface, but not higher than 20 inches above the countertop or work surface. Installed in a countertop using receptacle assemblies listed for use in countertops.

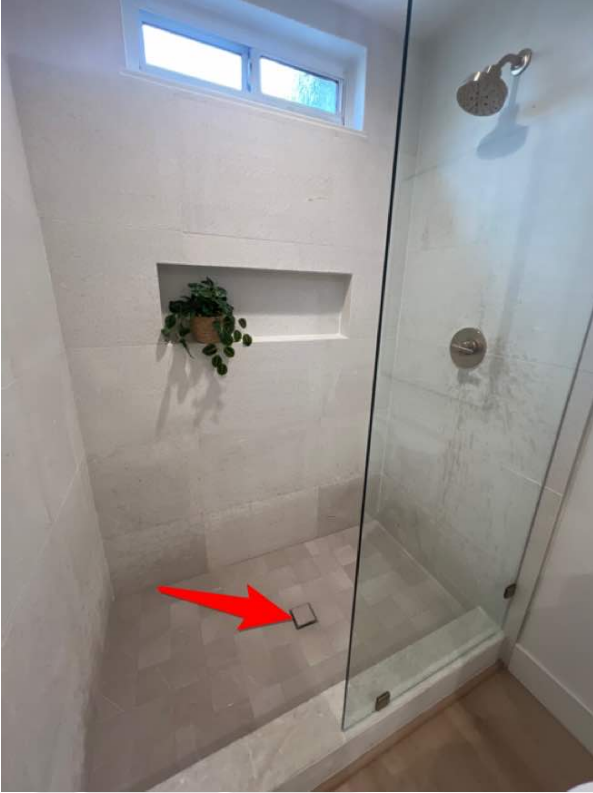
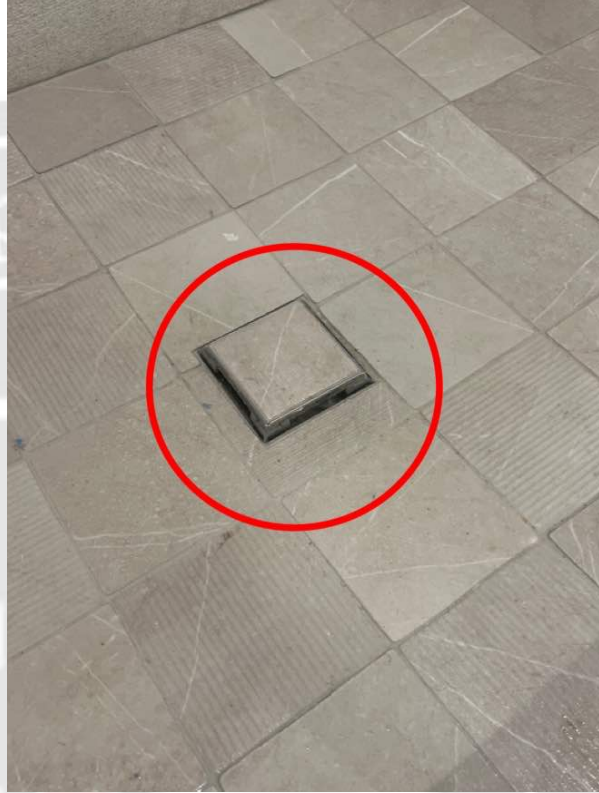
BATHROOM #1 TUB AND SHOWERS

SAF s-176: Shower was functional. It should be noted that during the testing of the shower water was splashing onto the flooring outside of the shower enclosure. This poses a slip and fall hazard. A shower door is recommended. Drain assembly cover did not flush within the shower. This is a safety hazard for tender feet.

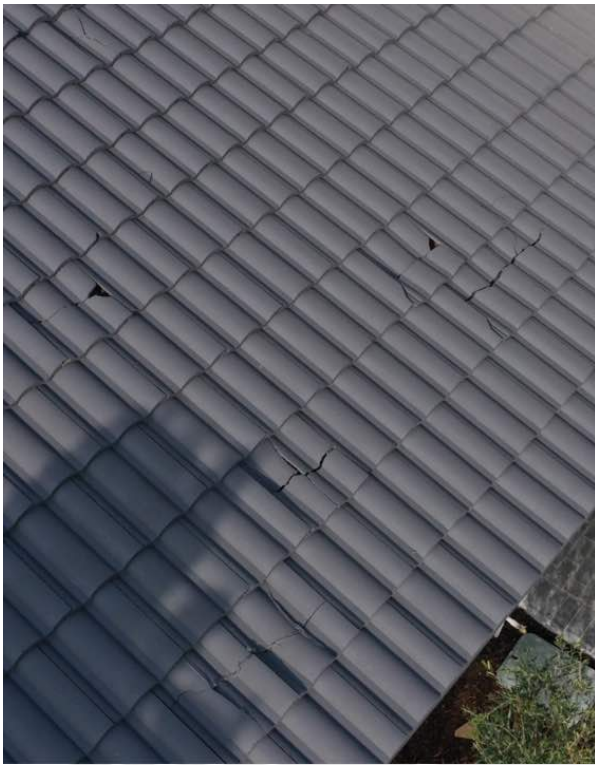
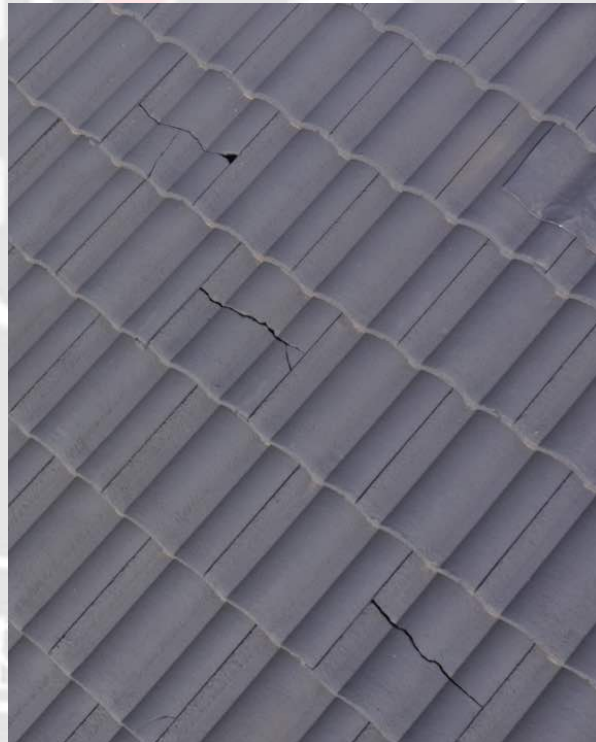
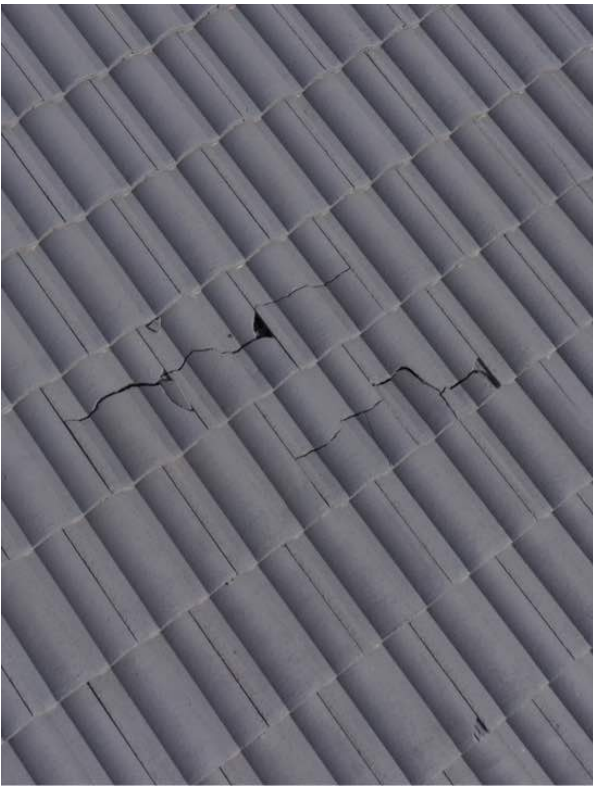
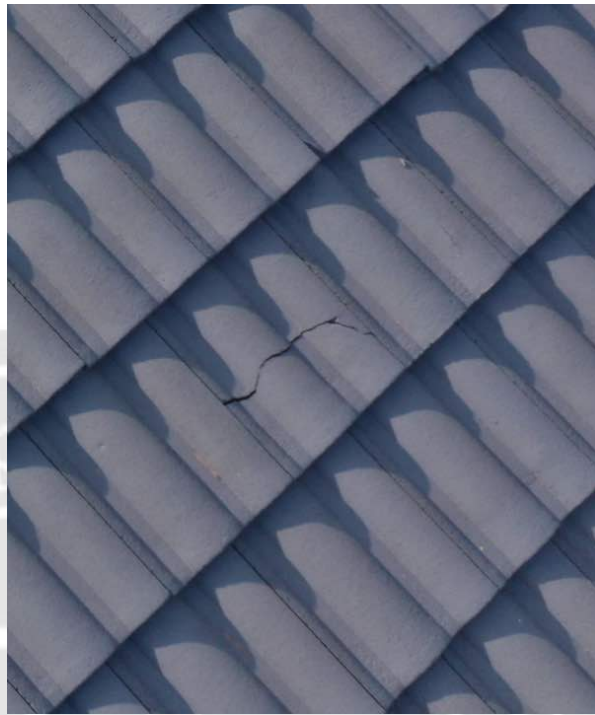
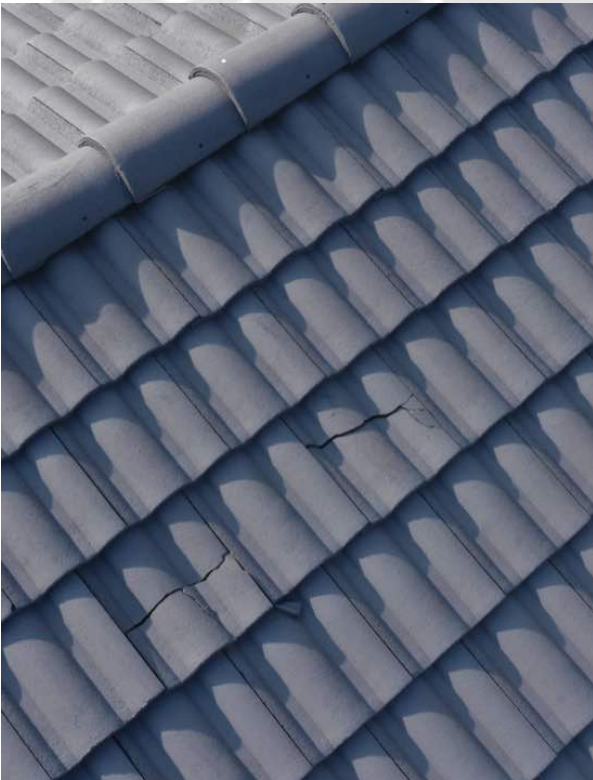
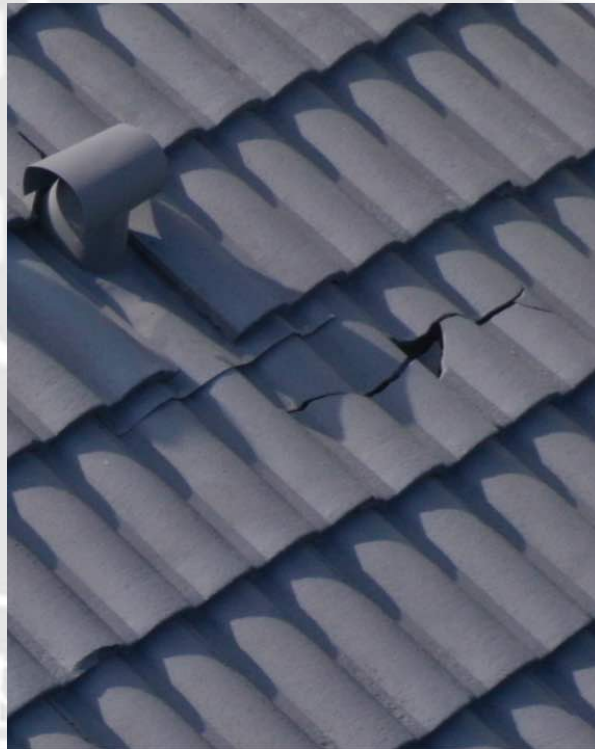
ROOF GENERAL CONDITION

REP 12: Roofing tiles have been painted. Therefore, the actual condition of the tiles cannot be determined. Numerous broken roof tiles were noted. This is caused by foot traffic. The roof is subject to future leaks due to the quantity of broken roof tiles noted. Complete roof replacement recommended. There were no visible signs of leaks on the day of inspection.

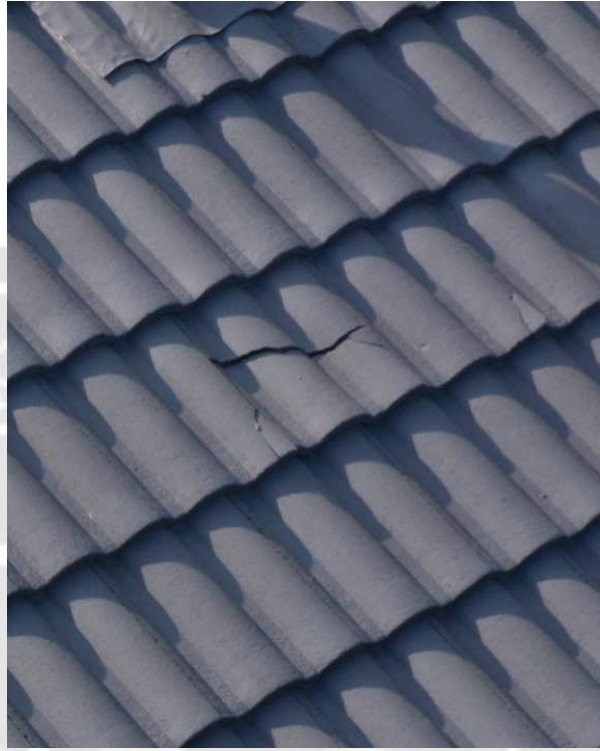
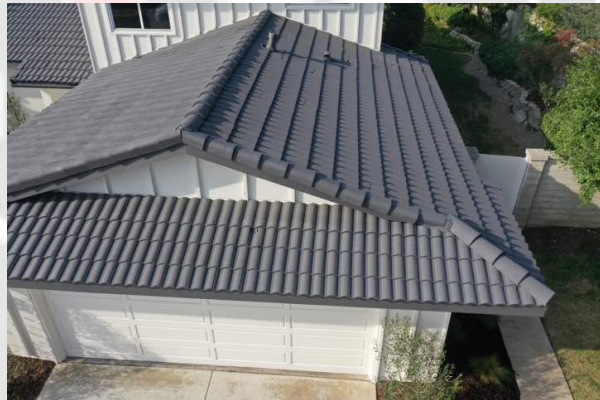
REP 13: Broken roof tiles continued.

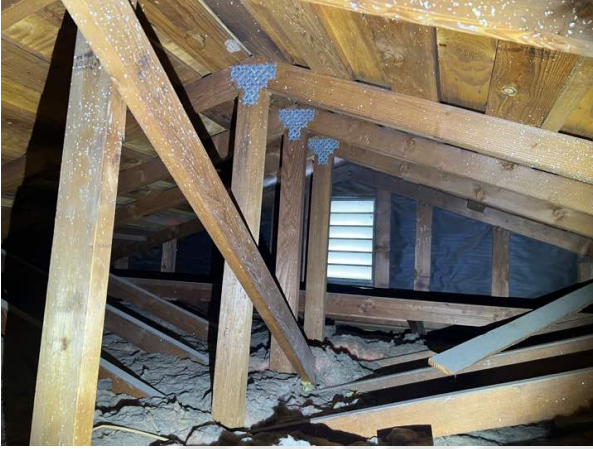
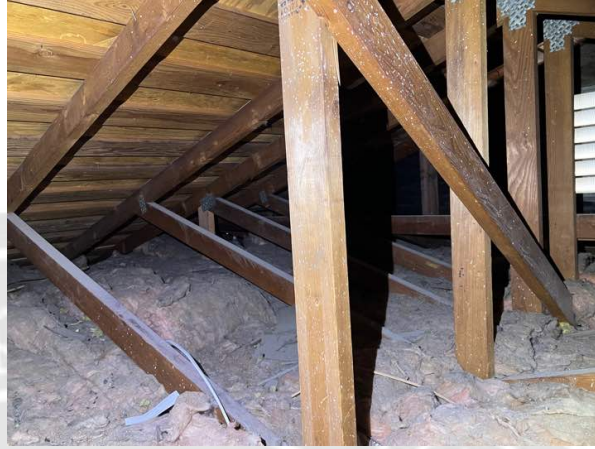
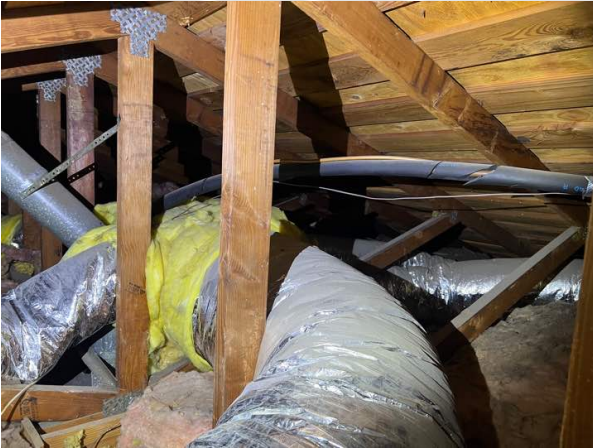
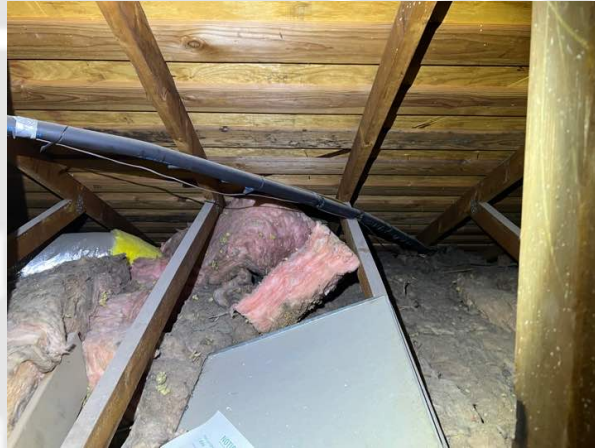
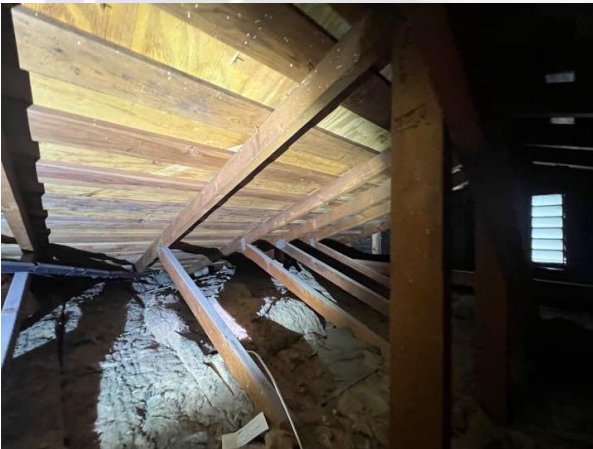
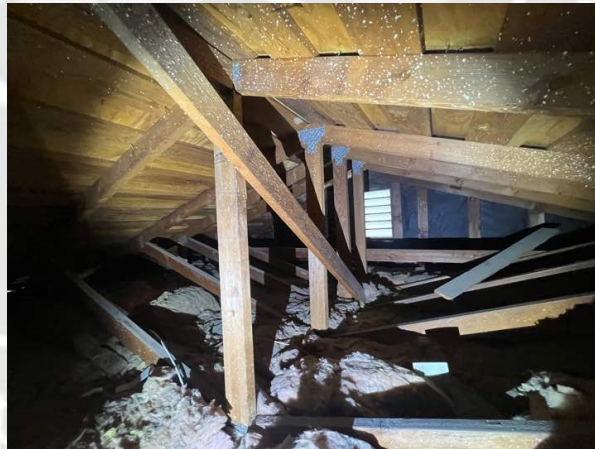
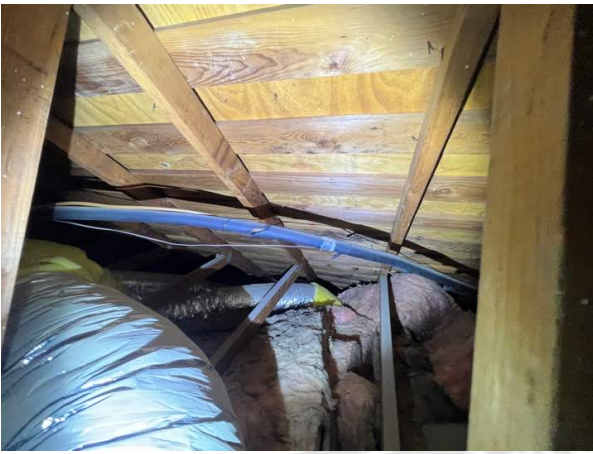
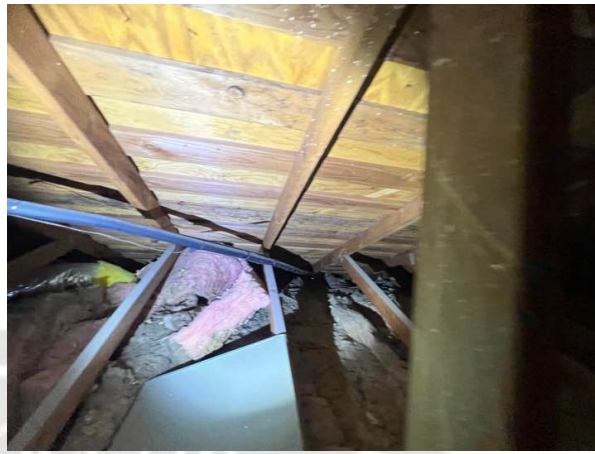
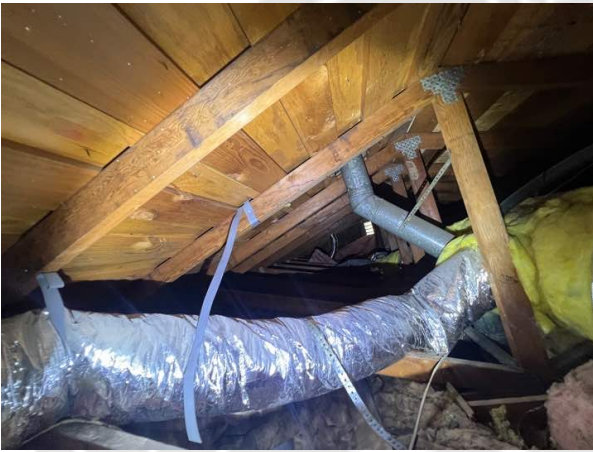
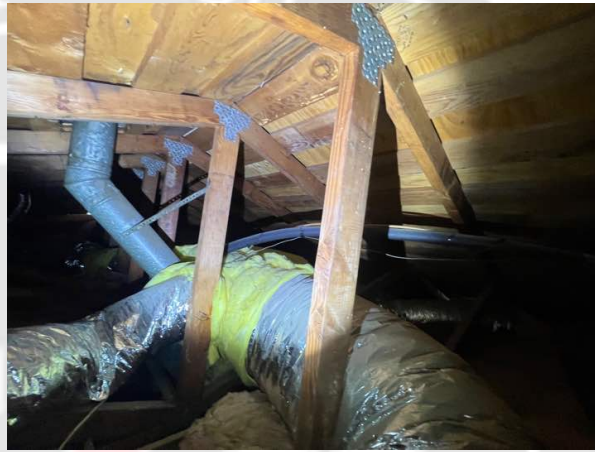
ROOF DECKING

15: Approximately 40% of the roof deck was visible from the attic areas. There was no damage to the roof deck in the visible areas.

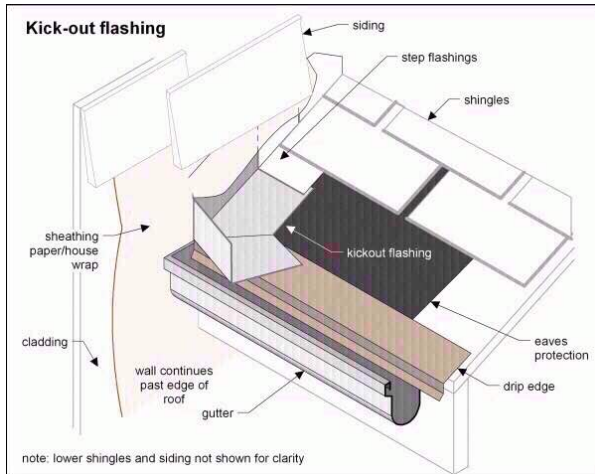
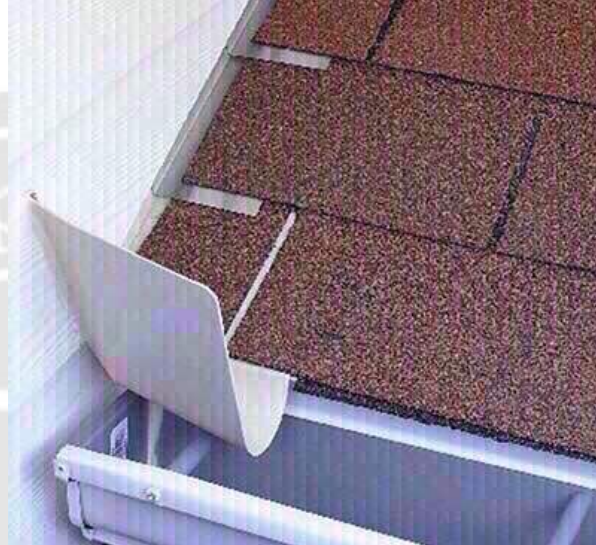
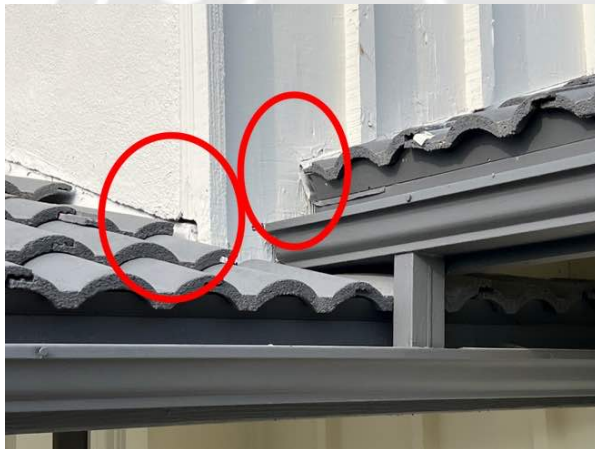
ROOF FLASHING CONDITIONS

REP 17: Kick out flashings were missing. Kick out flashings help to divert water away from the sidewall. Missing kick out flashings have been connected to water infiltration, water damage and mold concealed within wall cavities.

Consult with a licensed roofing contractor for complete review and repair. These details can be found at the rear of the home.

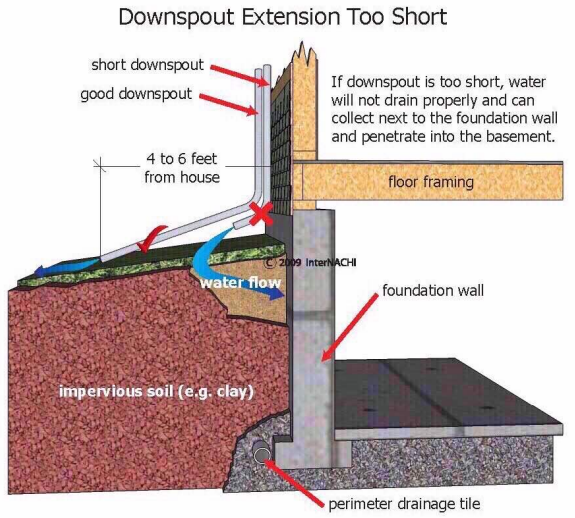
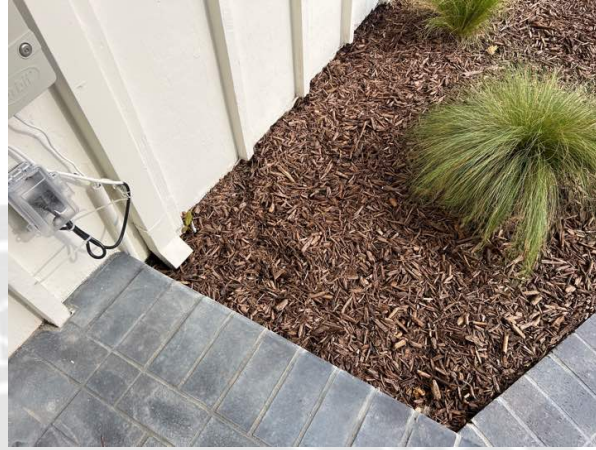
ROOF RAIN GUTTER AND DOWNSPOUT CONDITIONS

REP 18: Downspouts should extend a minimum of 36 inches away from the homes foundation where practical. This will help prevent water from infiltrating the foundation walls and crawlspaces/slab.

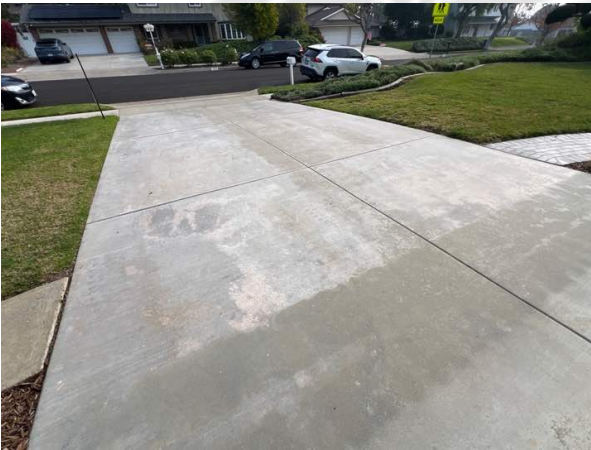
FRONT OF HOME DRIVEWAY OBSERVATIONS

19: The driveway appeared to be in satisfactory and usable condition at the time of the inspection.

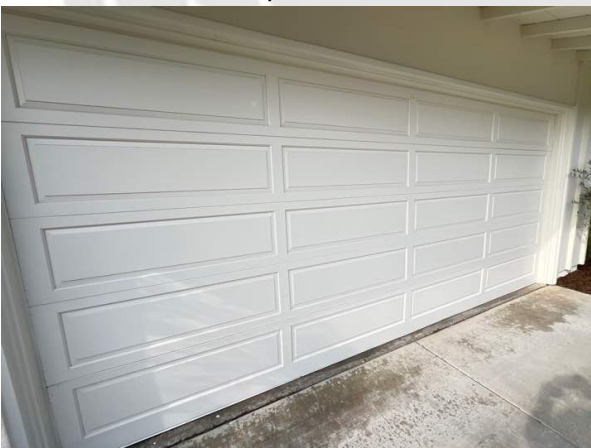
FRONT OF HOME GARAGE DOOR CONDITION

20: The garage door was tested and found to be functional on the day of inspection. Signs of normal wear and tear were present.

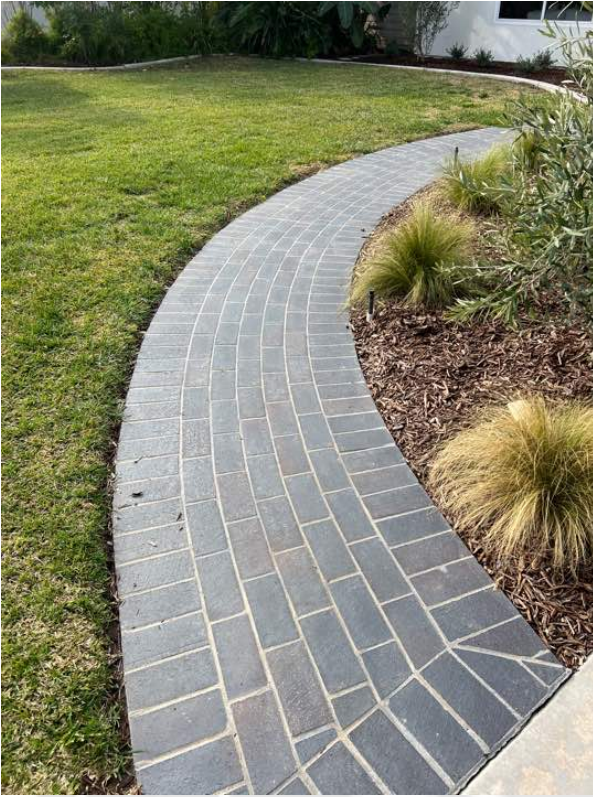
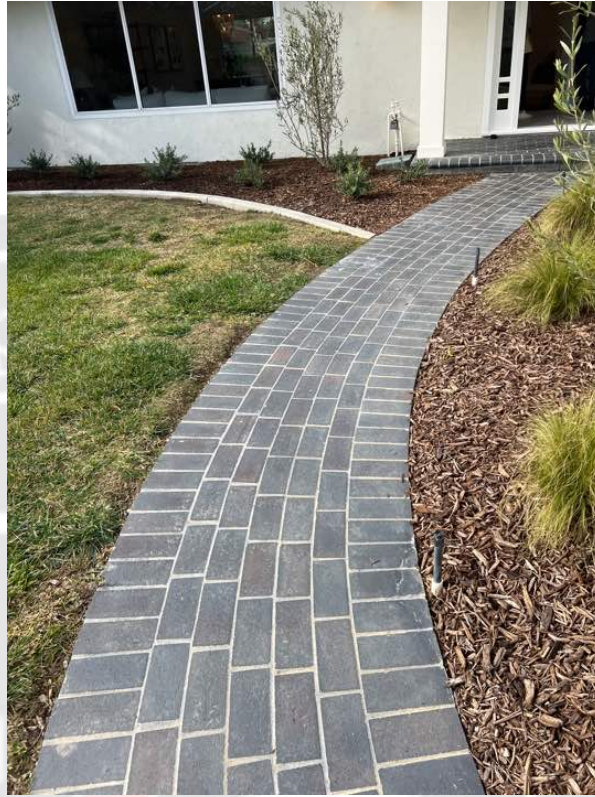
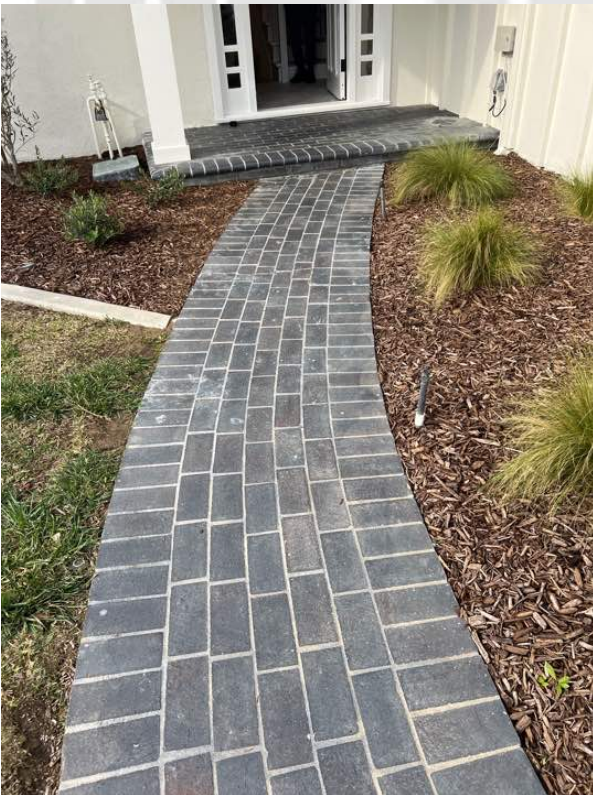
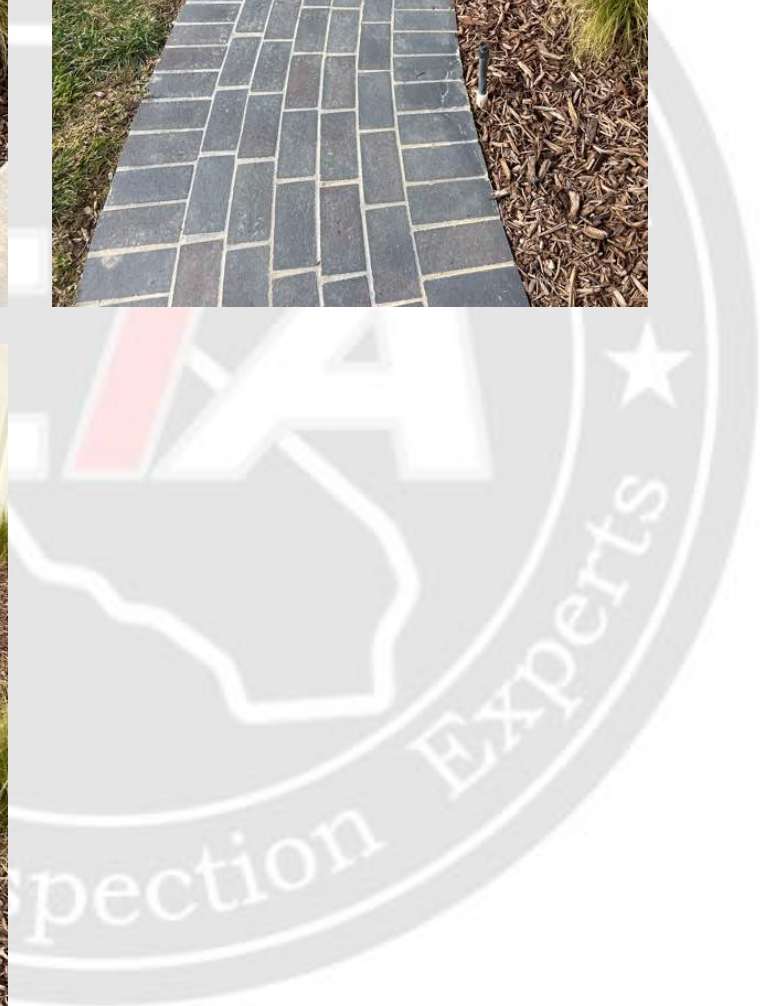
FRONT OF HOME SIDEWALK OBSERVATIONS

21: The visible areas of the sidewalk appeared to be in serviceable condition at the time of the inspection.

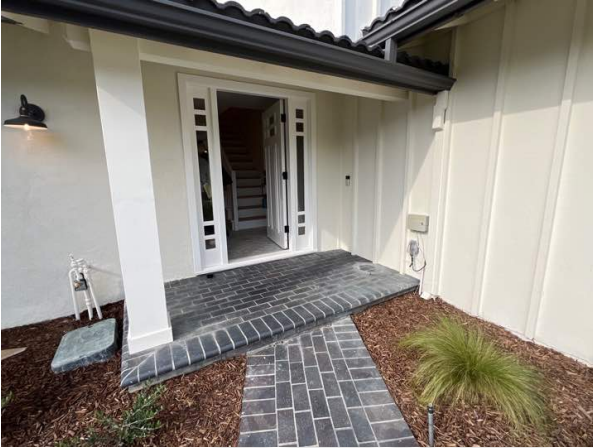
FRONT OF HOME FRONT PORCH

22: Front porch was in satisfactory condition.

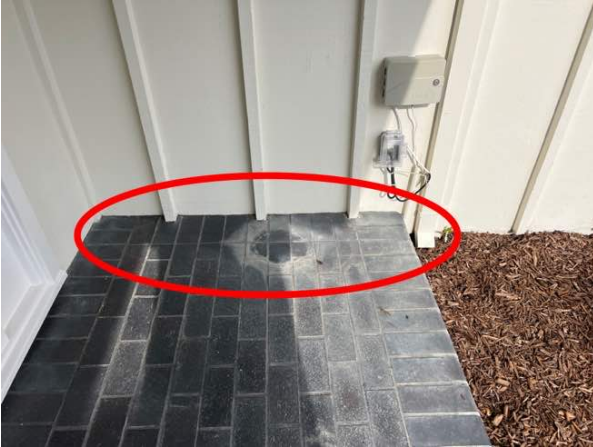
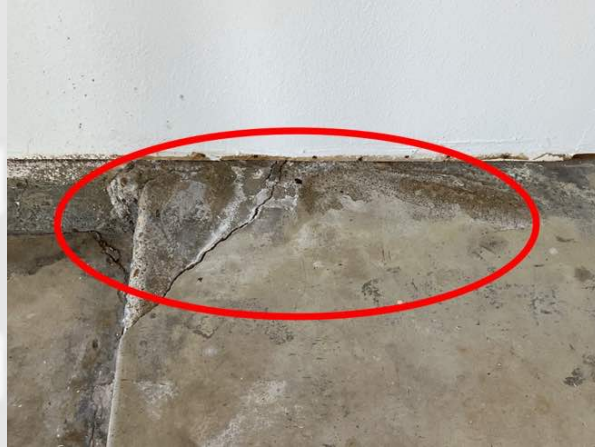
REP 23: Signs of missing flashing noted at the front porch. This can allow for water intrusion. Signs of water intrusion were noted in the garage. Long-term moisture has caused damage to the concrete components. Potential location for concealed microbial growth. Repair needed.

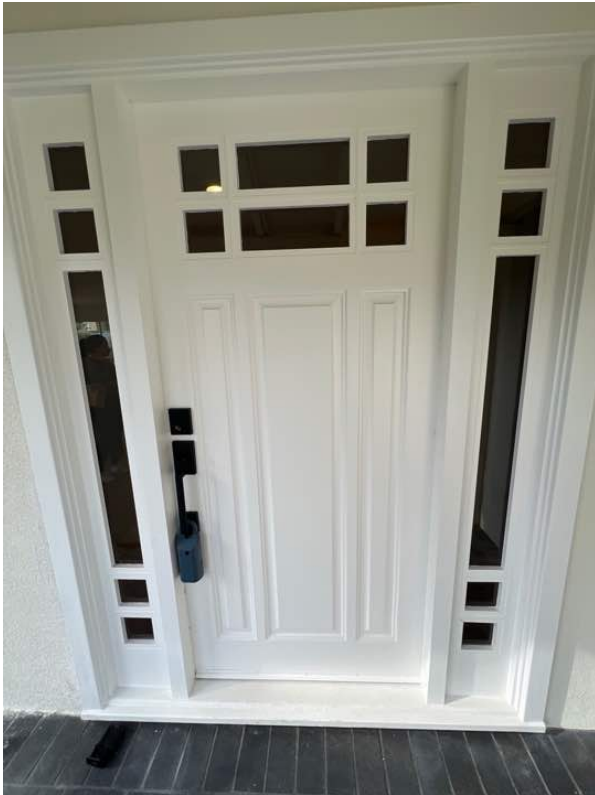
FRONT OF HOME MAIN ENTRANCE

24: The front main entry door was functional. There were no signs of water infiltration.

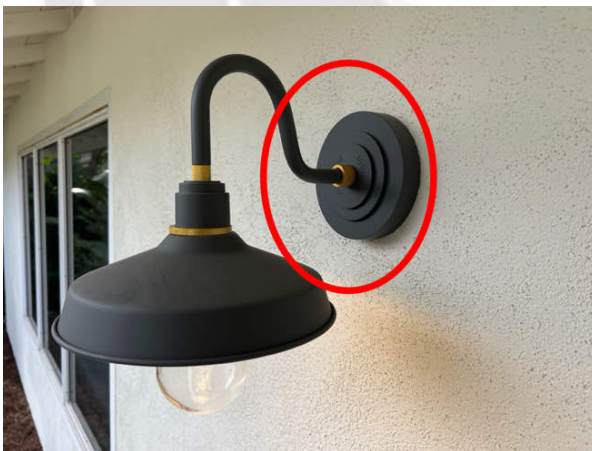
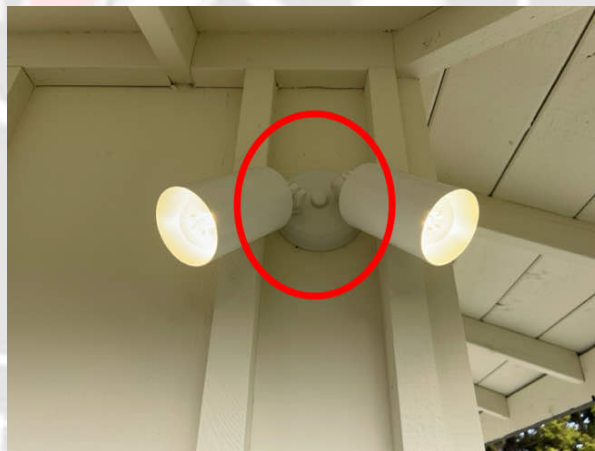
FRONT OF HOME LIGHT FIXTURE CONDITIONS

MANT 25: All light fixtures should be properly caulked and sealed to the structure to help prevent water intrusion.

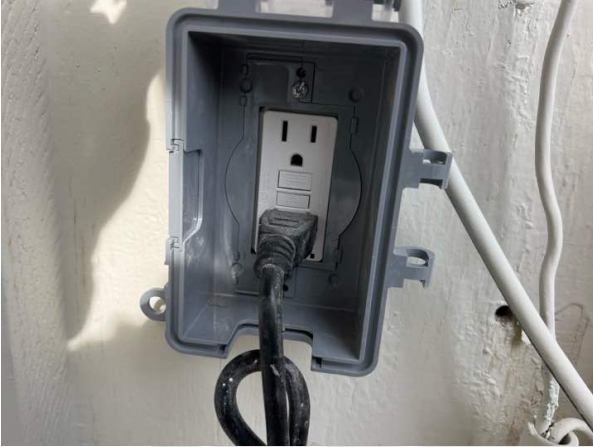
FRONT OF HOME RECEPTACLE CONDITIONS

26: The receptacle photographed was tested and found to be GFCI protected. The inspector will make an attempt to verify that all outlets are GFCI protected. However, some receptacles such as those hidden in flower planters or those that are outside view may-not be tested.

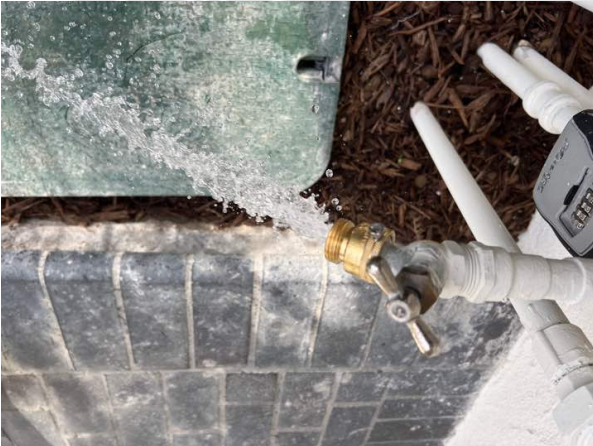
FRONT OF HOME HOSE BIB CONDITION

27: Hose bibs were in satisfactory condition.
