Inspection Report

Lynridge Dr
Yorba Linda, California
92886

Inspected By
David Salvato
California Inspection Authority INC.
(949) 981-8320
CIAHomeInspection@gmail.com
Inspecting The Finest Homes In California
www.CIAHomeInspection.com

Wednesday
December 27, 2023

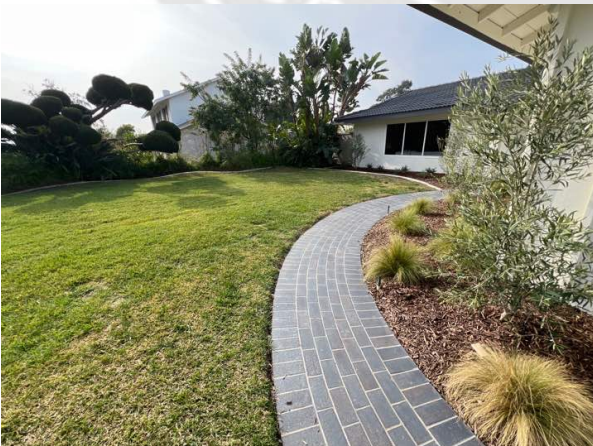
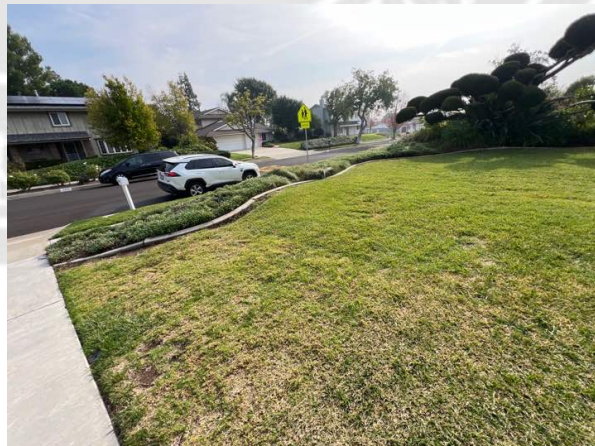
FRONT OF HOME YARD CONDITIONS

28: Drainage at the front of the home is satisfactory.

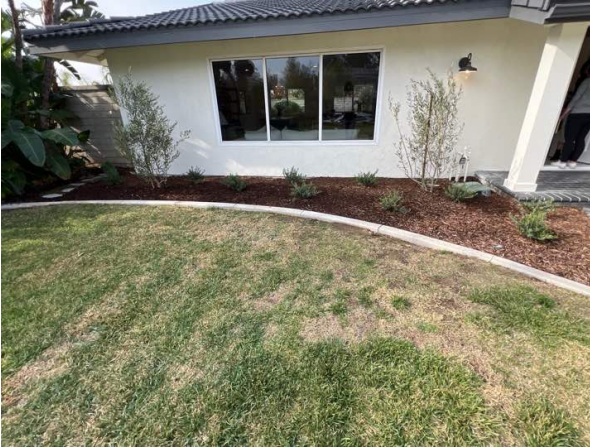
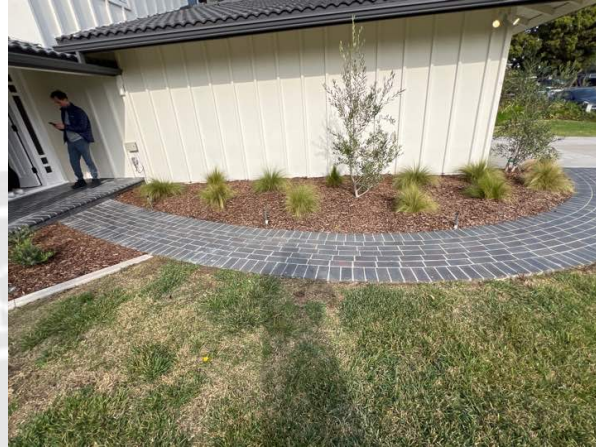
WARN 29: Caution should be exercised not to over water planters at the front of the home. There was no evidence of water proofing against the foundation at the planters. Excessive watering can lead to water intrusion and deterioration of the foundation walls.

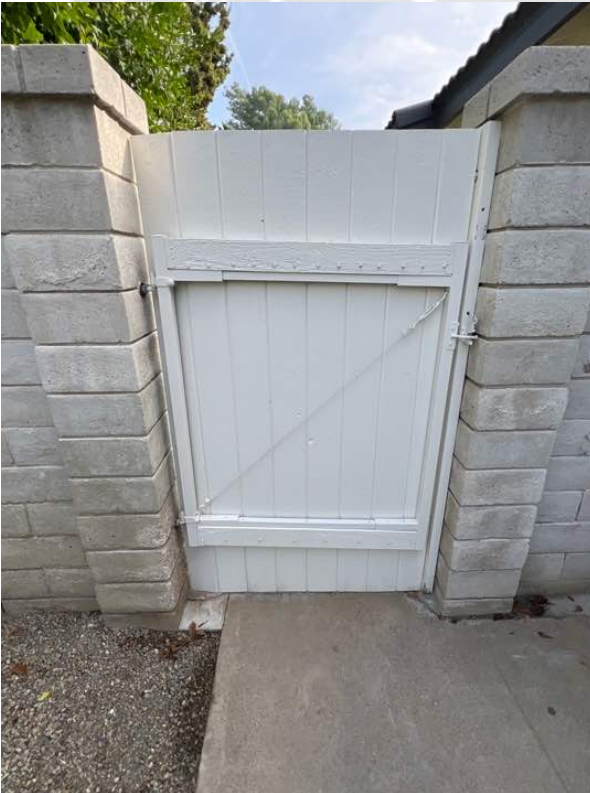
SIDE OF HOME GATES

30: Gates were in satisfactory condition.

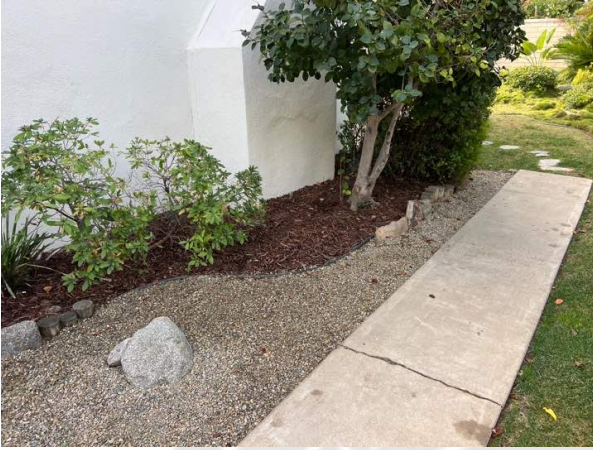
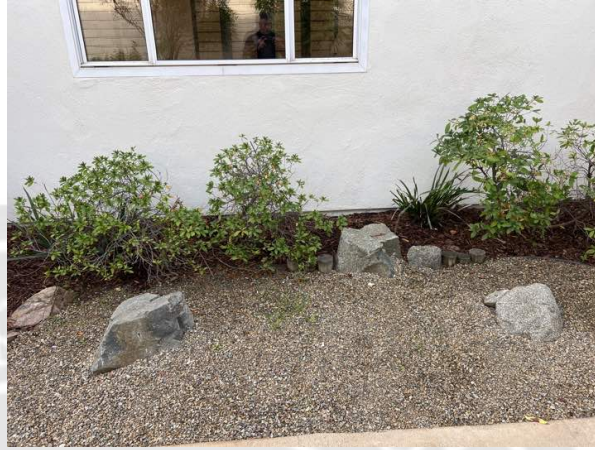
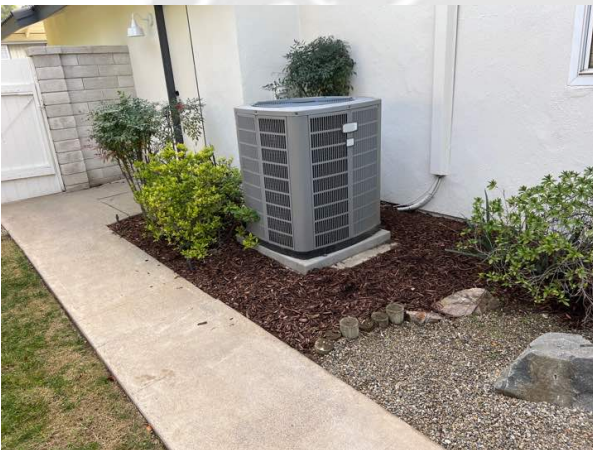
SIDE OF HOME SIDE YARDS CONDITIONS

WARN 31: Caution should be used not to over water planters. There was no evidence of waterproofing along the foundation. Excessive watering can lead to deterioration of the foundation walls.

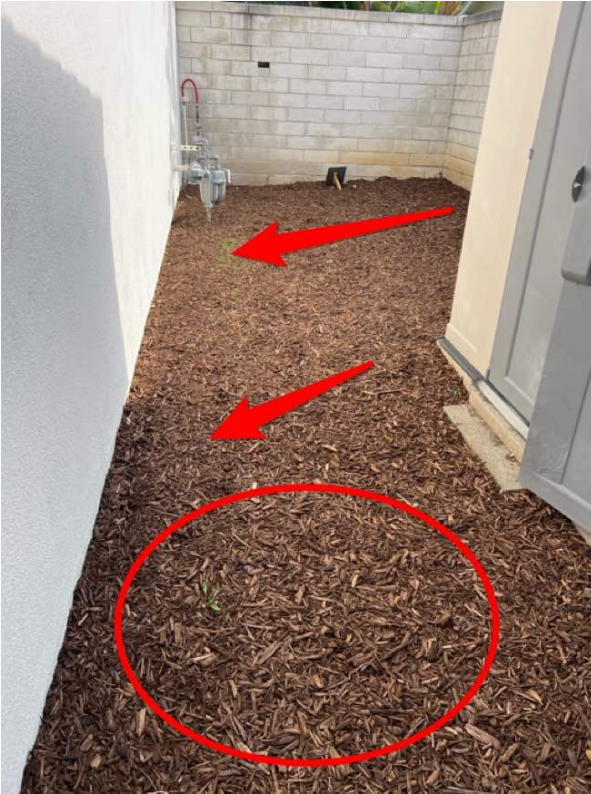
REP 32: Reverse drainage was noted at the side yard. Client should consult with a landscape contractor for further evaluation and resolution.

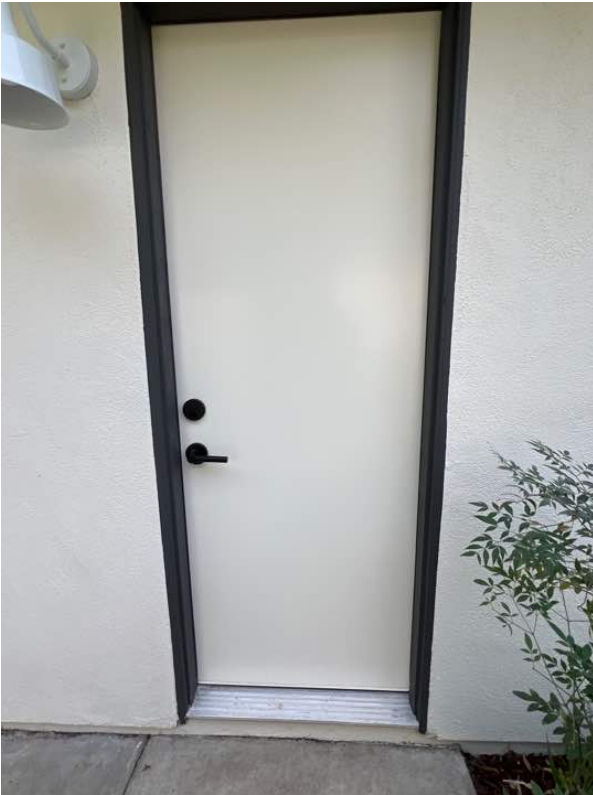
SIDE OF HOME GARAGE PEDESTRIAN DOOR

33: The garage pedestrian door was functional. The door shows signs of normal wear and tear.

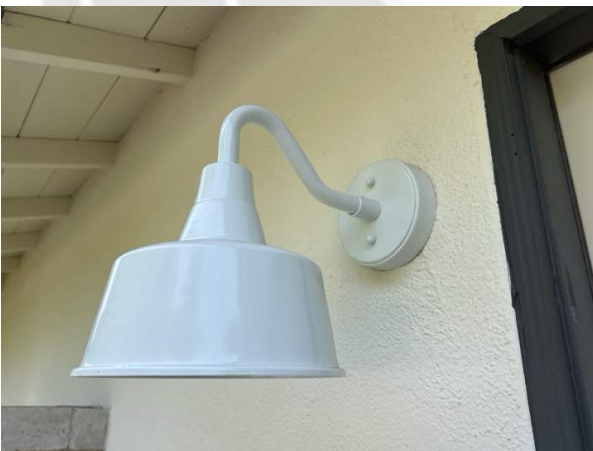
SIDE OF HOME LIGHT FIXTURE CONDITIONS

MANT 34: All light fixtures should be properly caulked and sealed to the structure to help prevent water intrusion.

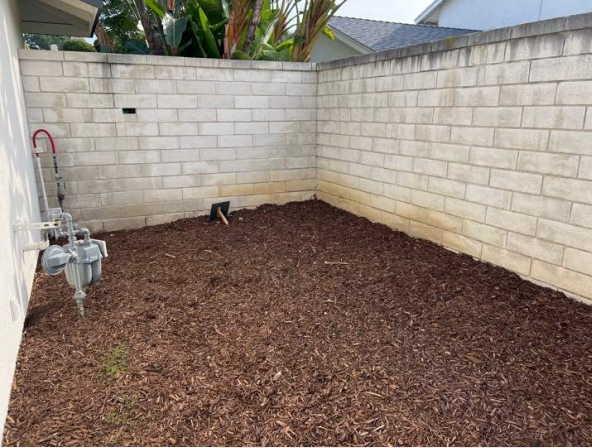
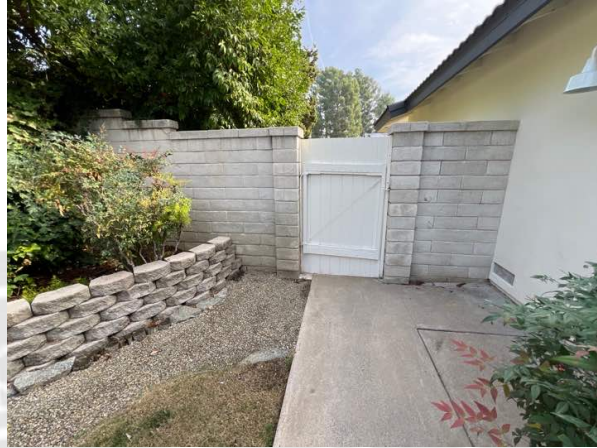
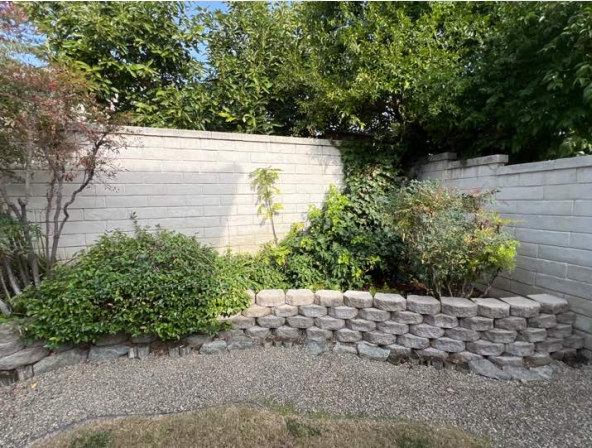
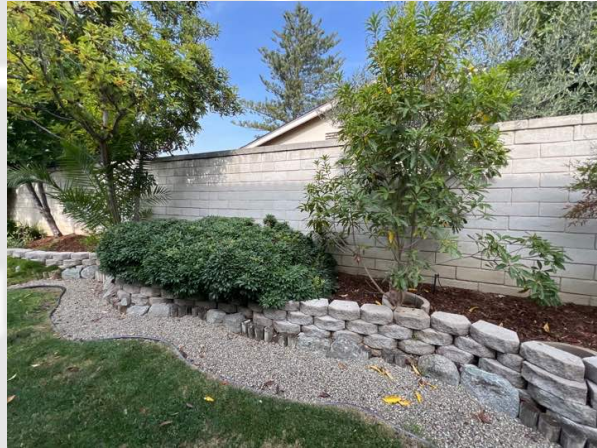
SIDE OF HOME PROPERTY WALL CONDITIONS

36: The block wall was in satisfactory condition. No significant cracks or settling was noted.

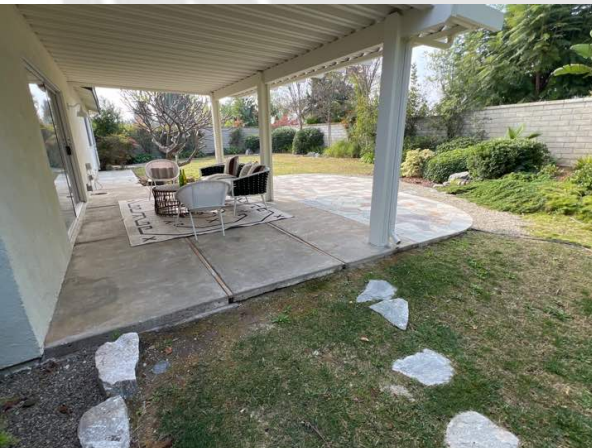
REAR OF HOME BACKYARD CONDITIONS

37: Drainage for the rear of the home was satisfactory. There were no signs of water infiltration.

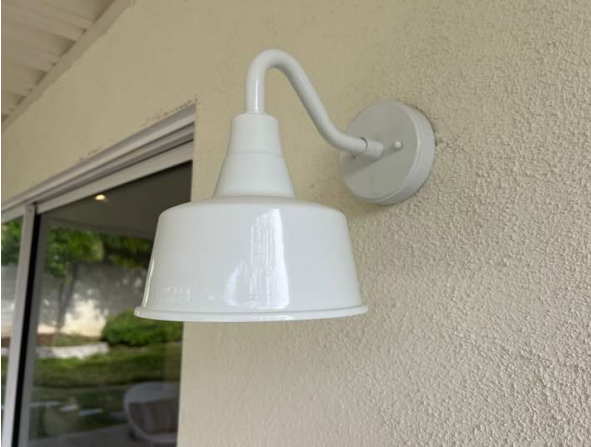
REAR OF HOME LIGHT FIXTURE CONDITIONS

MANT 38: All light fixtures should be properly caulked and sealed to the structure to help prevent water intrusion.

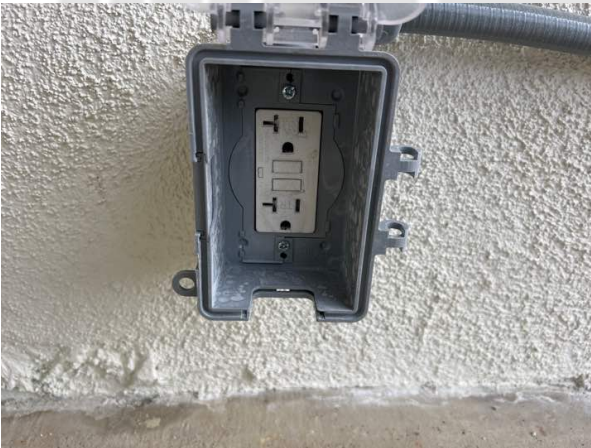
REAR OF HOME RECEPTACLE CONDITIONS

39: The receptacle photographed was tested and found to be GFCI protected. The inspector will make an attempt to verify that all outlets are GFCI protected. However, some receptacles such as those hidden in flower planters or those that are outside view may-not be tested.

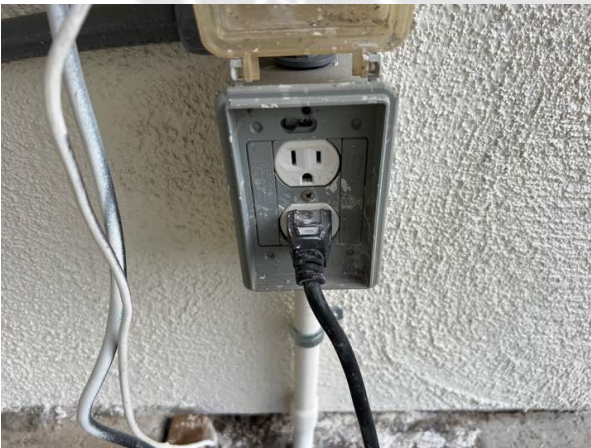
40: The receptacle was GFCI protected from another location.

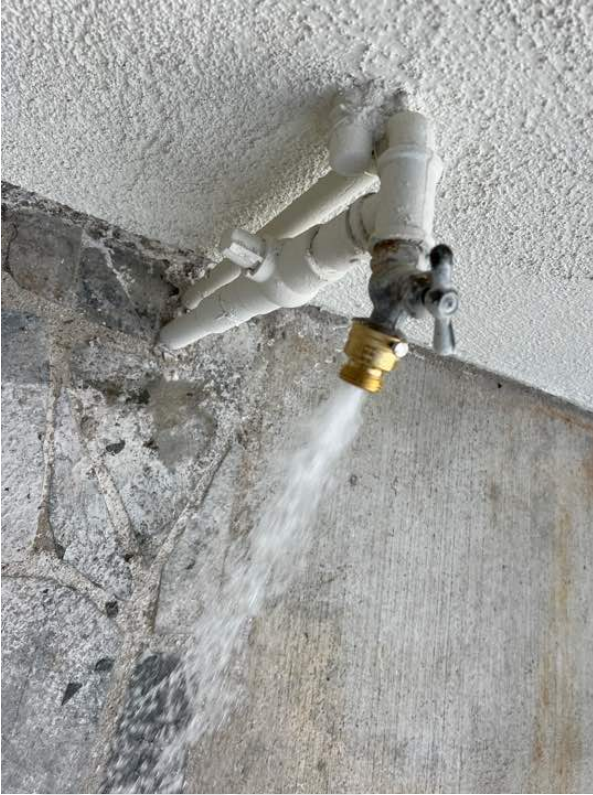
REAR OF HOME HOSE BIB CONDITION

41: Hose bibs were in satisfactory condition.

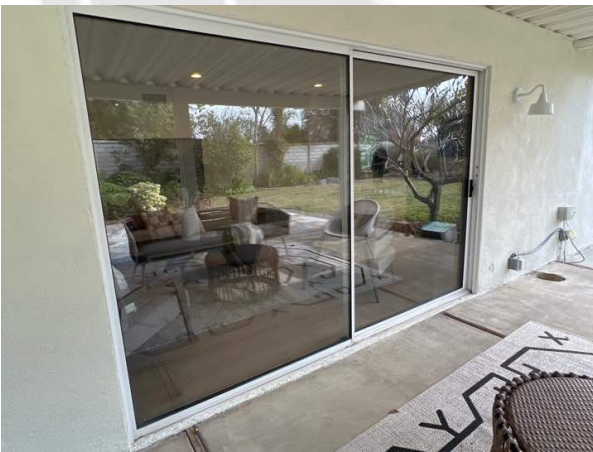
REAR OF HOME PATIO DOOR

42: Patio doors were tested and found to be functional on the day of inspection. Doors show signs of normal wear and tear.

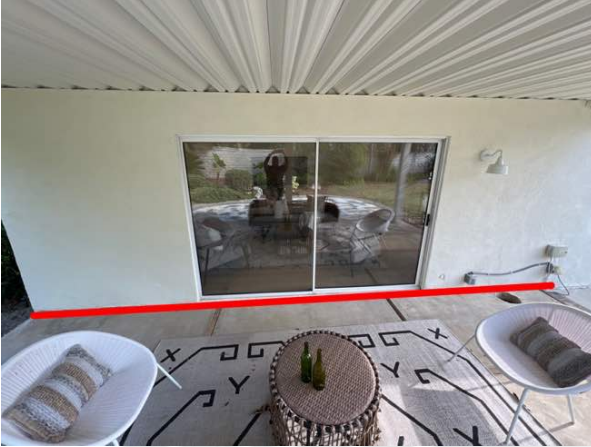
REAR OF HOME PATIO CONDITIONS

REP 43: Concrete around the rear of the home has been installed at an elevation that is higher than recommended. A 2" clearance is recommended below the weep screed to the finish grade. This will help prevent water intrusion and also help to prevent easy access for wood destroying insects or organisms from entering the structure

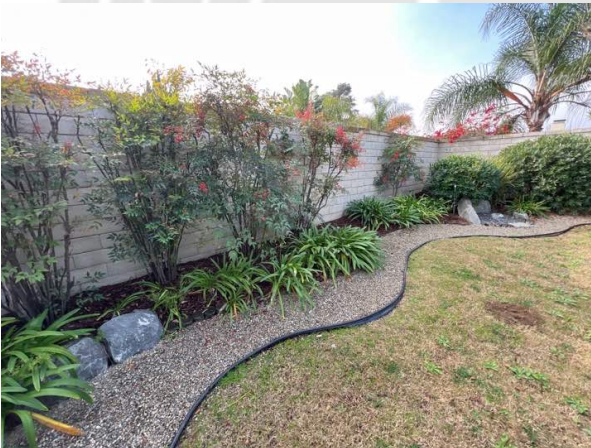
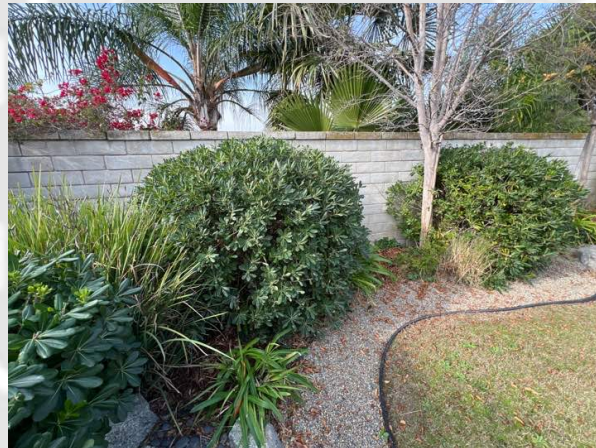
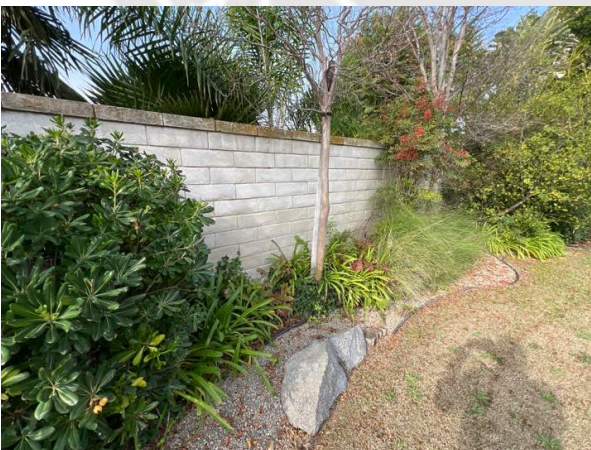
REAR OF HOME PROPERTY WALL CONDITIONS

44: The block wall was in good condition. No significant signs of settling or step cracks were noted.

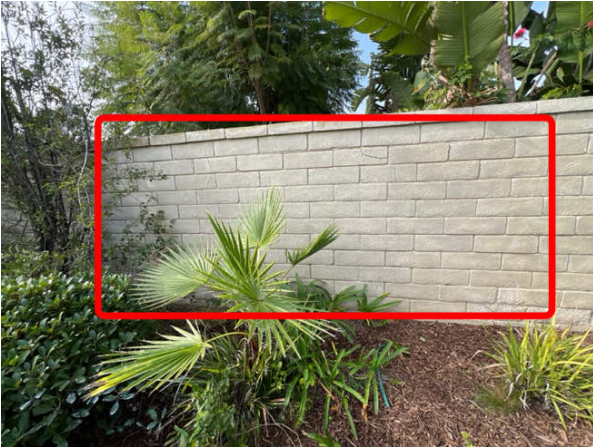
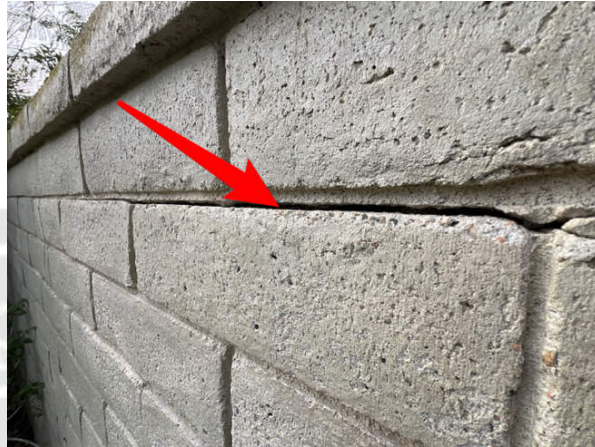
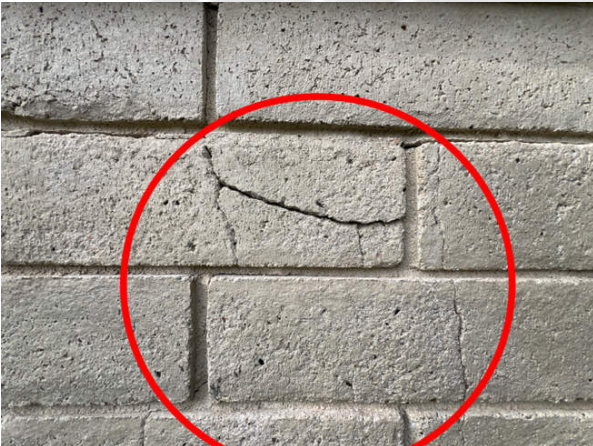
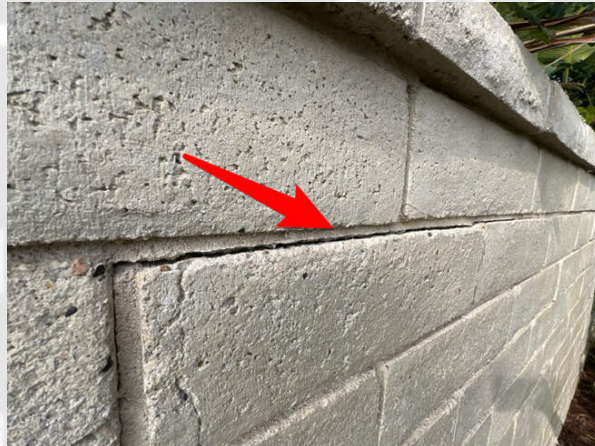
SAF s-45: Significant cracks were observed at the property wall. Repair recommend. Consult a mason for repairs.

SAF 45: Significant cracks were observed at the property wall. Repair recommend. Consult a mason for repairs.

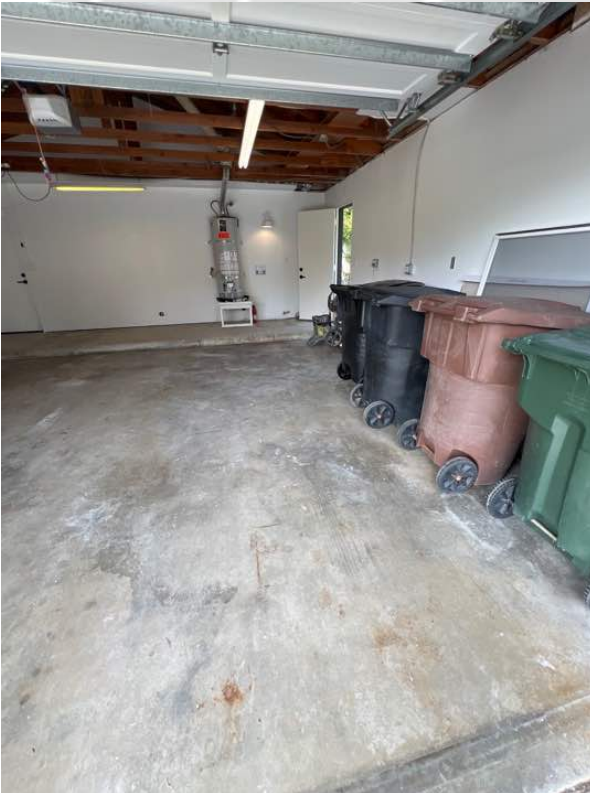
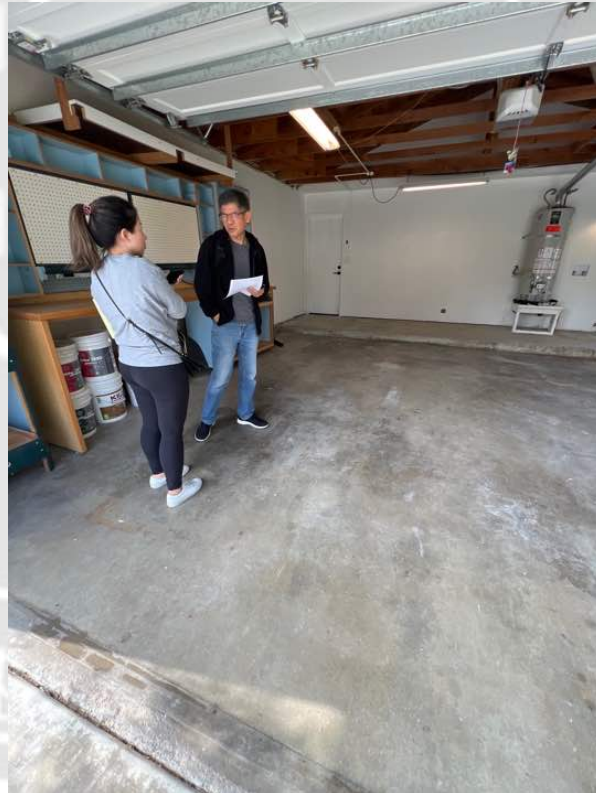
GARAGE NUMBER OF SPACES

46: Two-car attached garage.

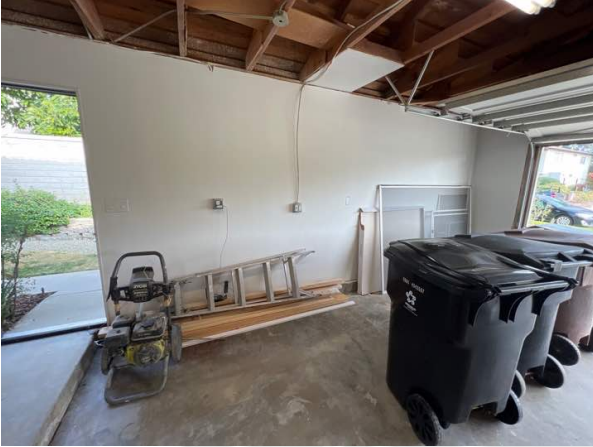
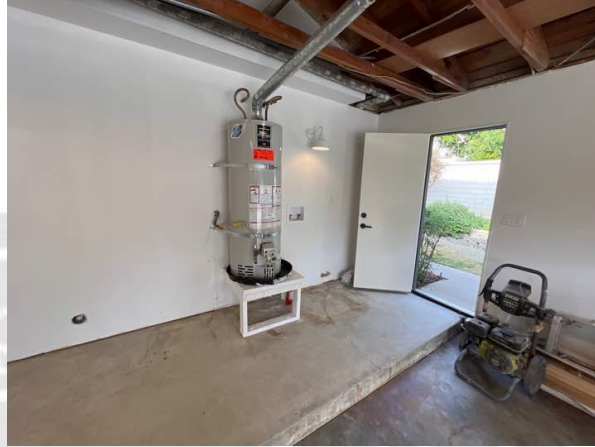
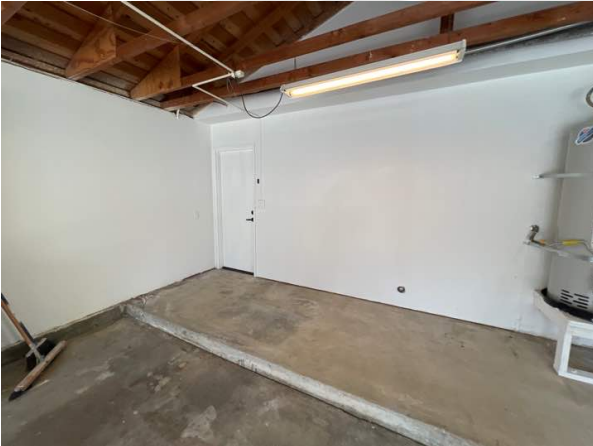
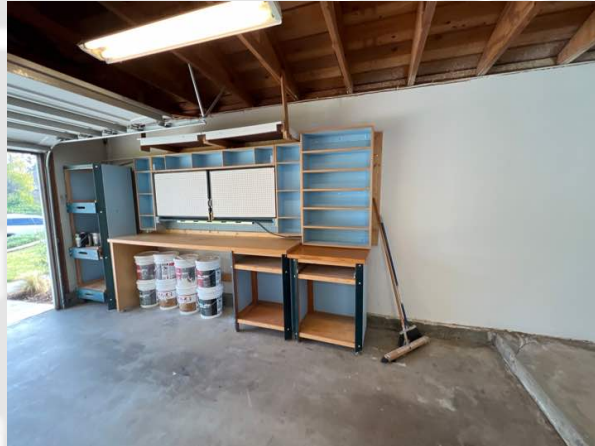
GARAGE SATISFACTORY WALLS AND CEILINGS

47: The garage walls and ceilings were in satisfactory condition overall. No significant deficiencies to report.

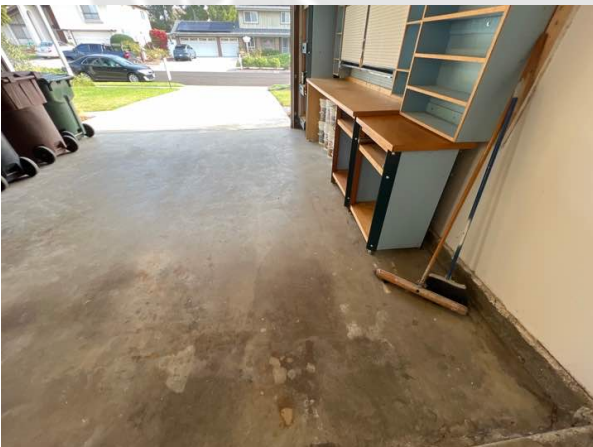
GARAGE SLAB

48: The visible portions of the garage slab was in satisfactory condition. Small hairline cracks were noted but are considered normal.

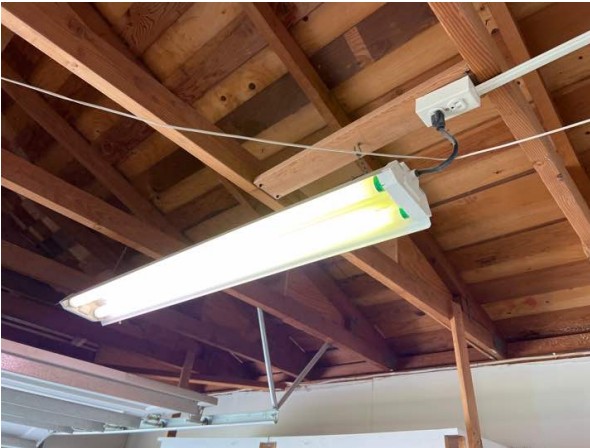
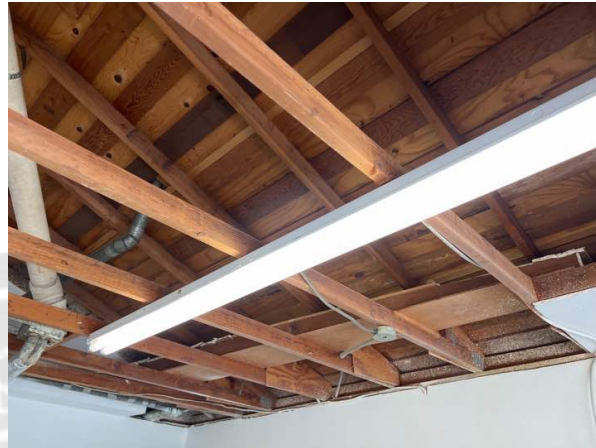
GARAGE LIGHTING

49: Garage lighting was satisfactory.

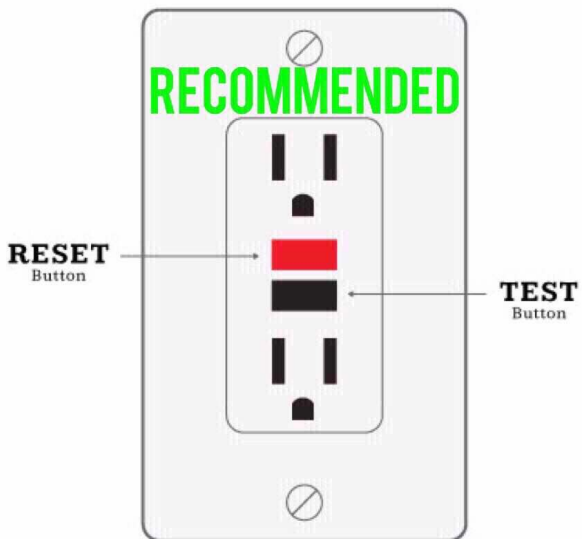
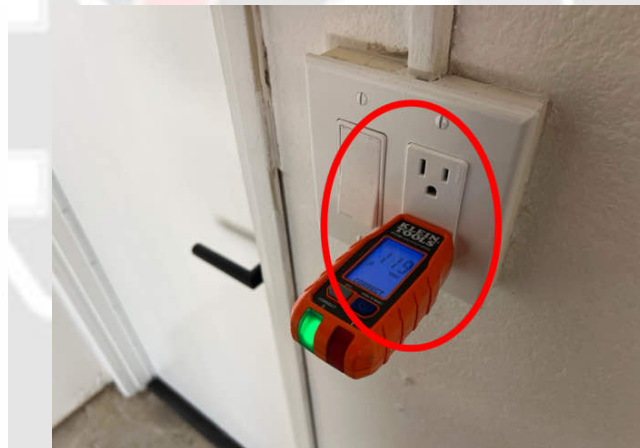
GARAGE ELECTRICAL

SAF s-50: All garage receptacles must be GFCI protected for occupant safety. Consult with a licensed electrician for installation.

SAF 50: All garage receptacles must be GFCI protected for occupant safety. Consult with a licensed electrician for installation.

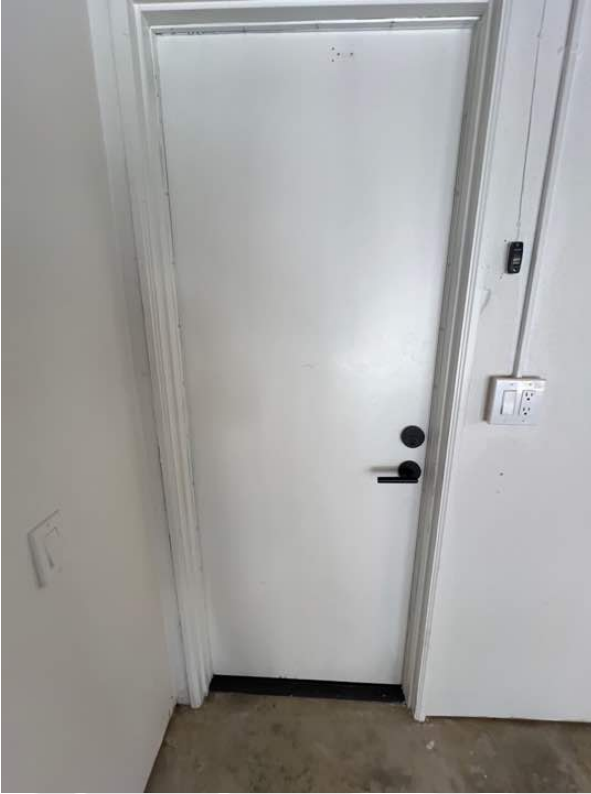
GARAGE FIRE DOOR

SAF 51: A self-closing fire and smoke rated door is needed between the garage and habitable living space. Life safety concern. Consult a general contractor for installation.

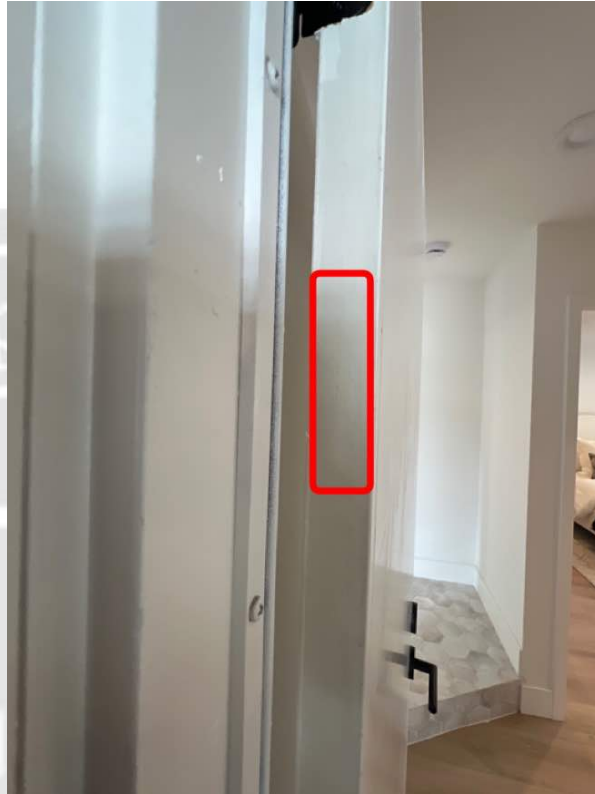
SAF 52: The door between the garage and the habitable living space was missing a proper fire label. Thus the doors fire rating could not be determined.

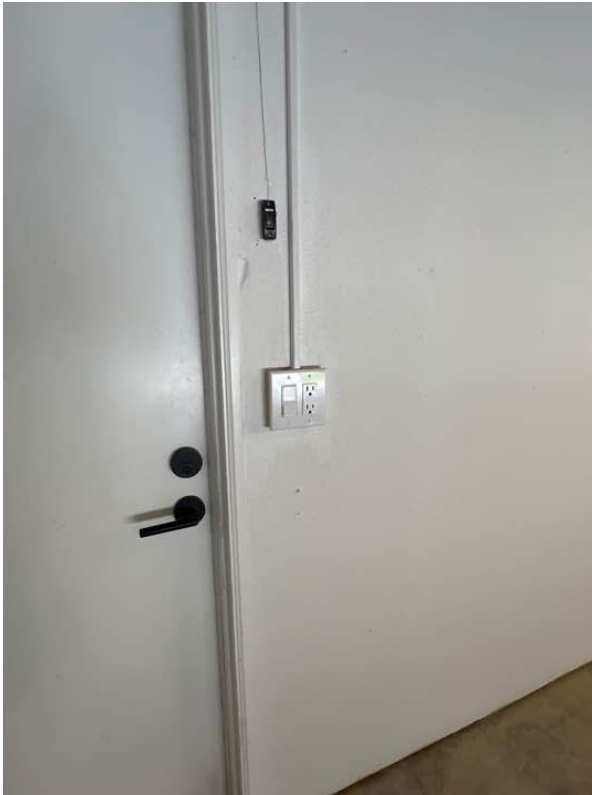
GARAGE OPERATOR BUTTON

53: The operator button was in satisfactory condition and responded normally to testing.

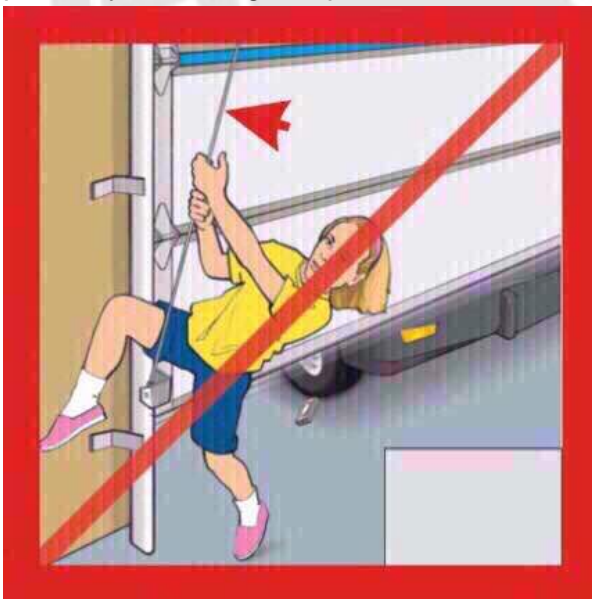
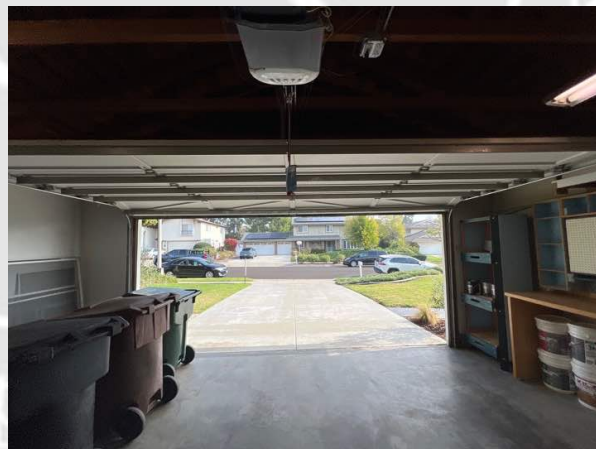
GARAGE GARAGE DOOR CONDITION

WARN 54: Sectional rollup doors have a unique set of safety concerns. Pinch points and operable cables can cause severe injury. The door should not be operated while individuals or objects are in close proximity to moving components.

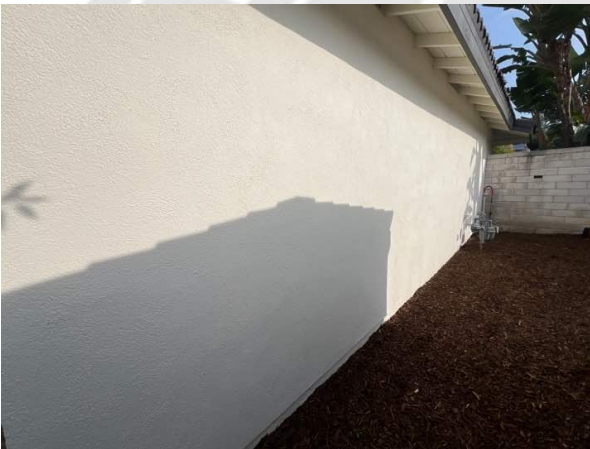
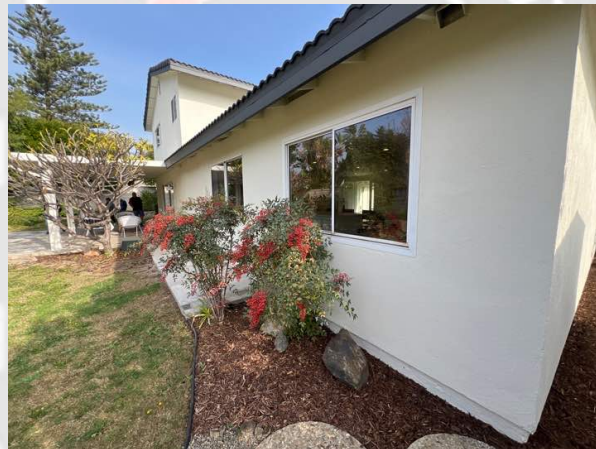
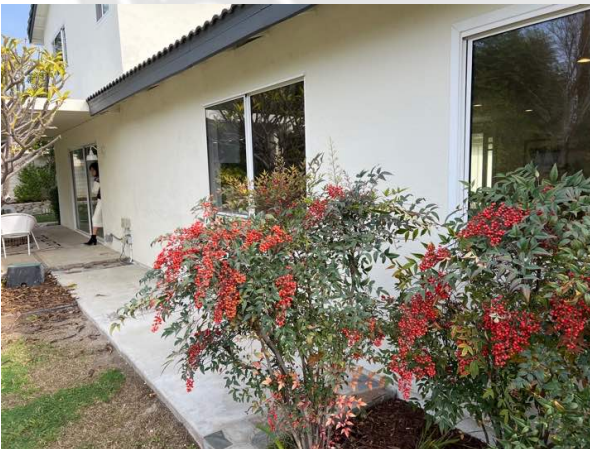
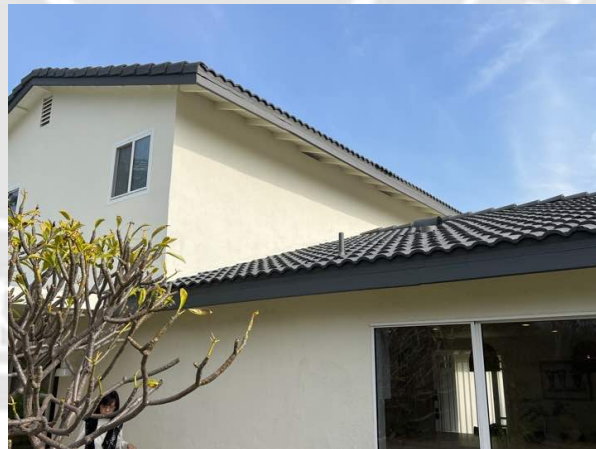
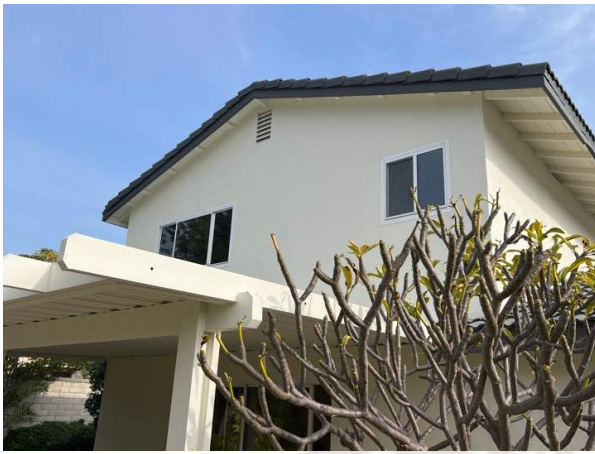
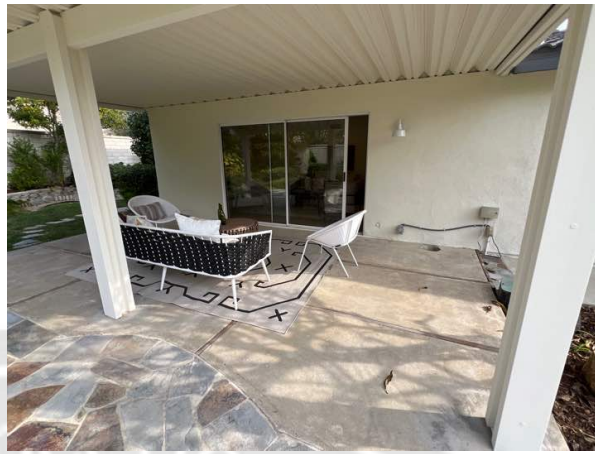
EXTERIOR WALLS EXTERIOR WALL CONDITIONS

58: The stucco was in satisfactory condition. Minor hairline cracks were noted. But are considered a normal part of the curing and settling.

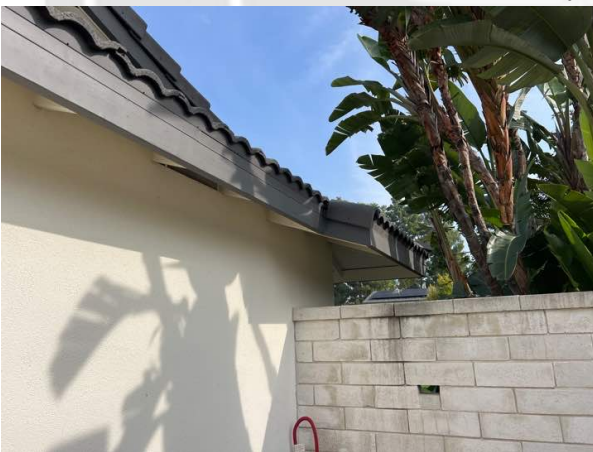
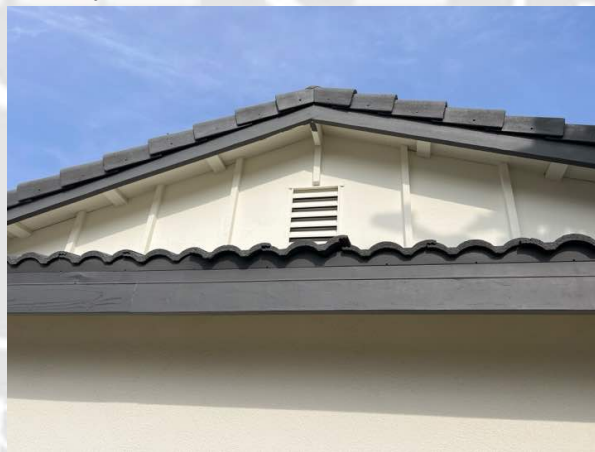
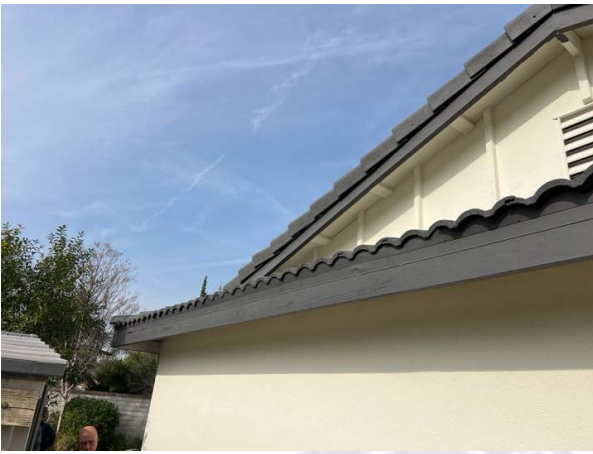
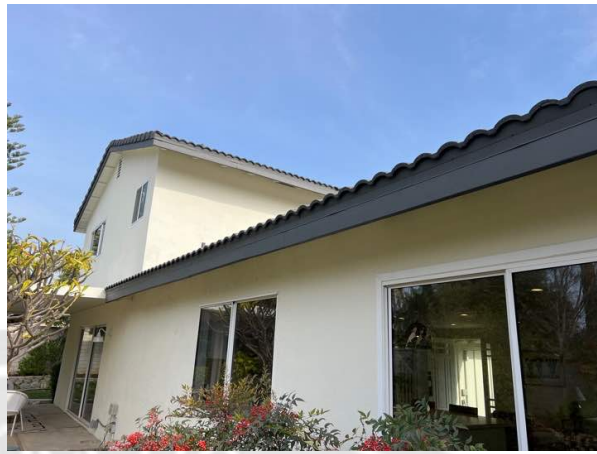
WOOD TRIM WOOD TRIM CONDITIONS

59: The fascia, soffits and trim are in mostly satisfactory condition.

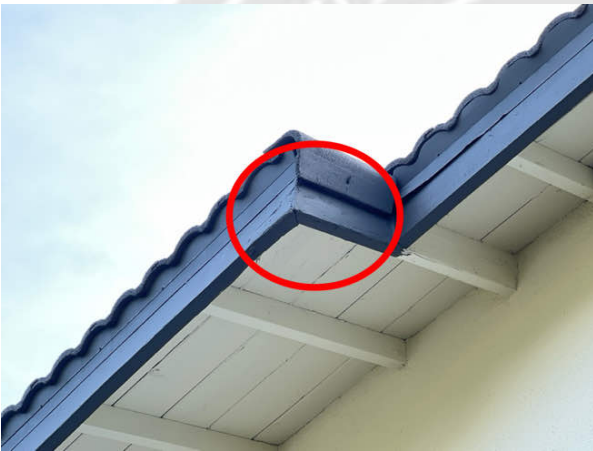
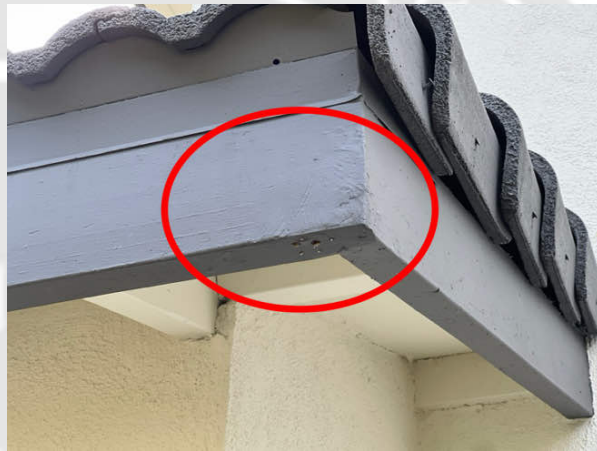
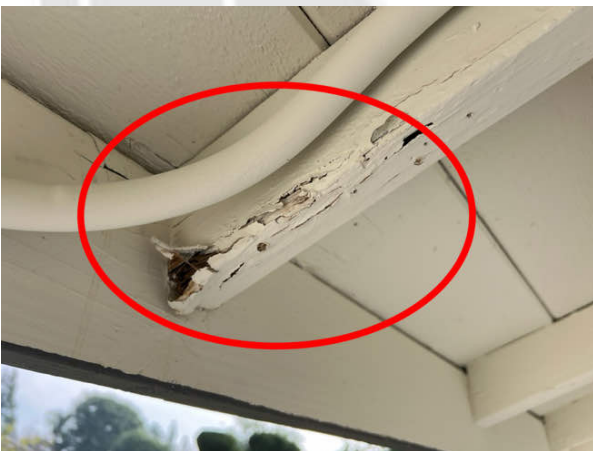
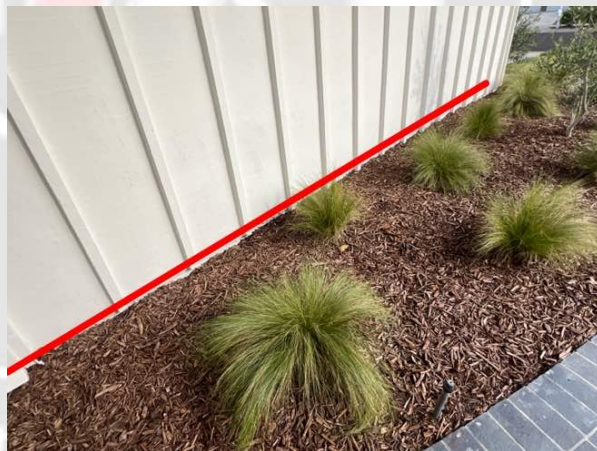
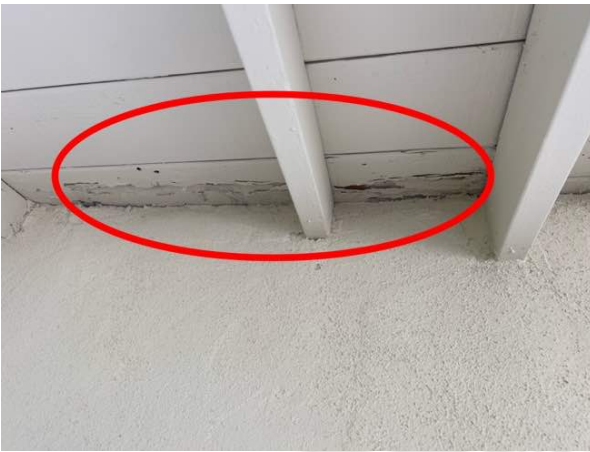
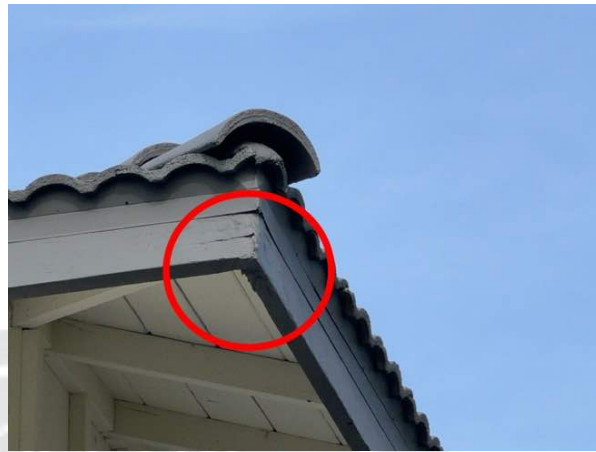
REP 60: Evidence of wood destroying insects and or organisms were observed. Client is encouraged to speak with a licensed pest control expert for further evaluation and resolution.

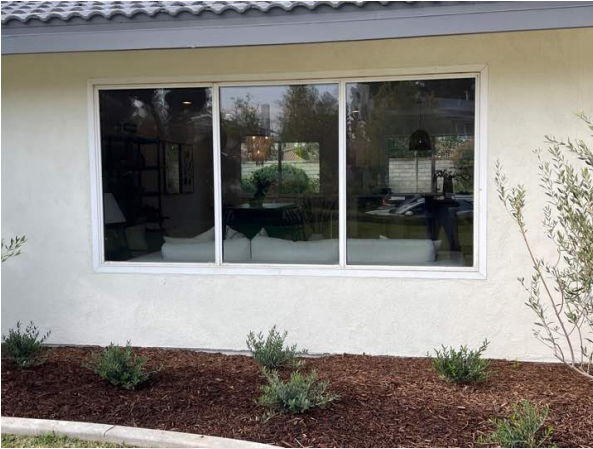
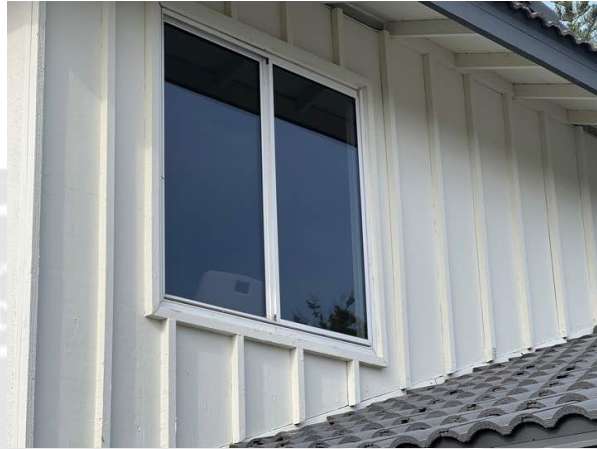
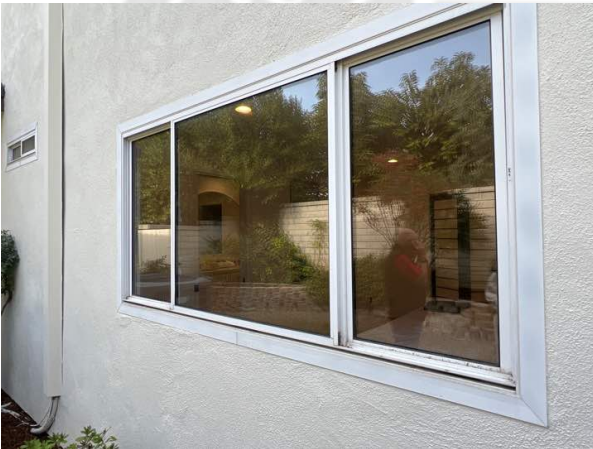
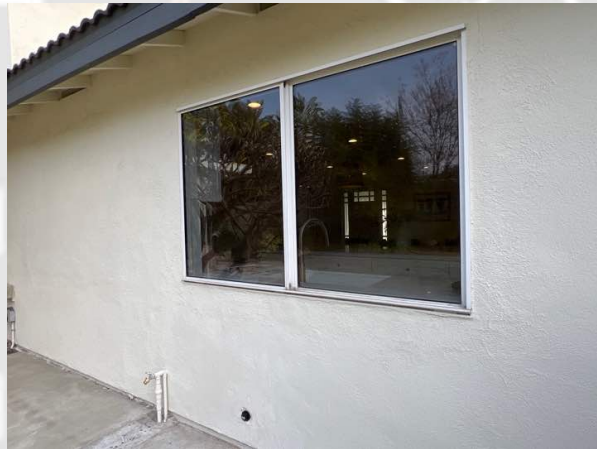
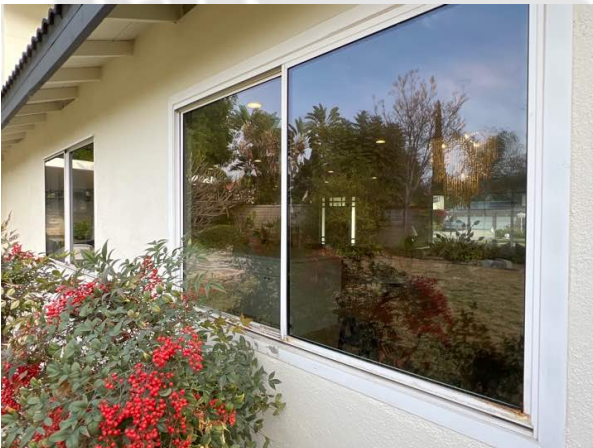
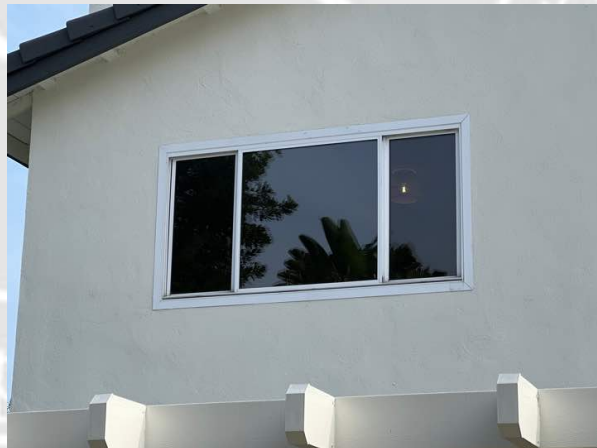
REP 62: Aluminum frame windows were in satisfactory condition overall. Signs of normal wear and tear were present. Cleaning of the lower track and caulking of the corner assemblies is needed to prevent water intrusion.

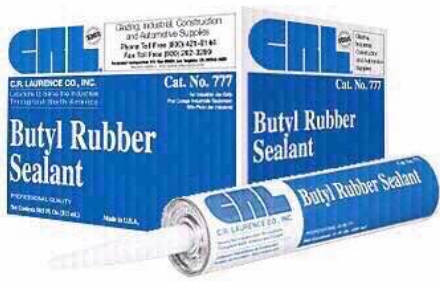
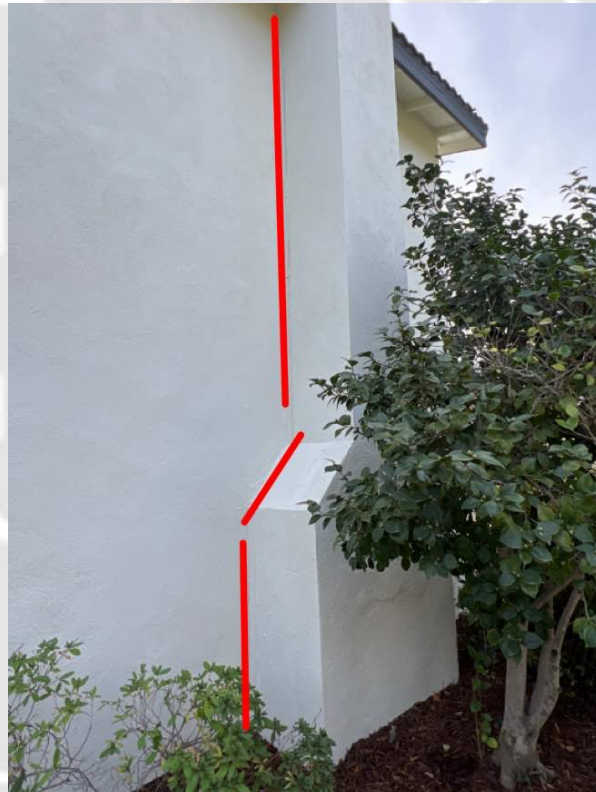
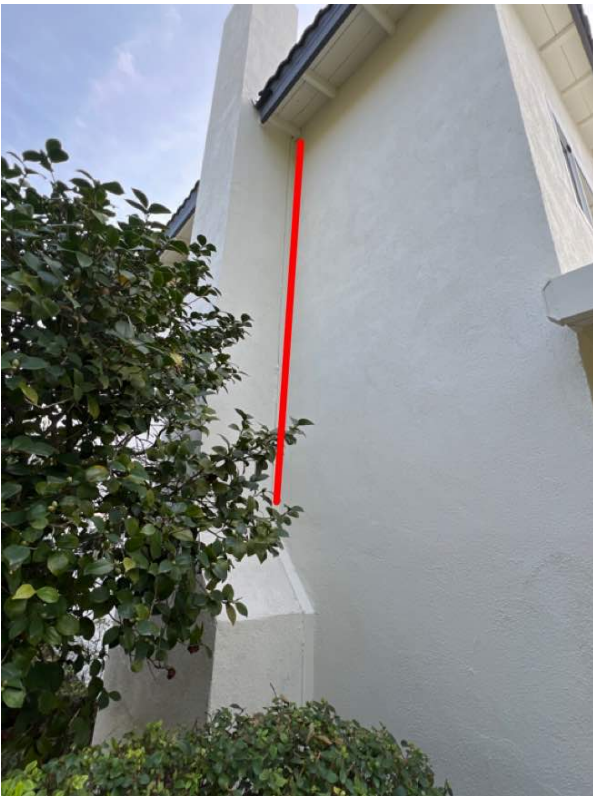
REP 63: The chimney wall flashing is showing signs of deferred maintenance. The sealant was dry and brittle. This can lead to water intrusion. Consult a general contractor for replacement.

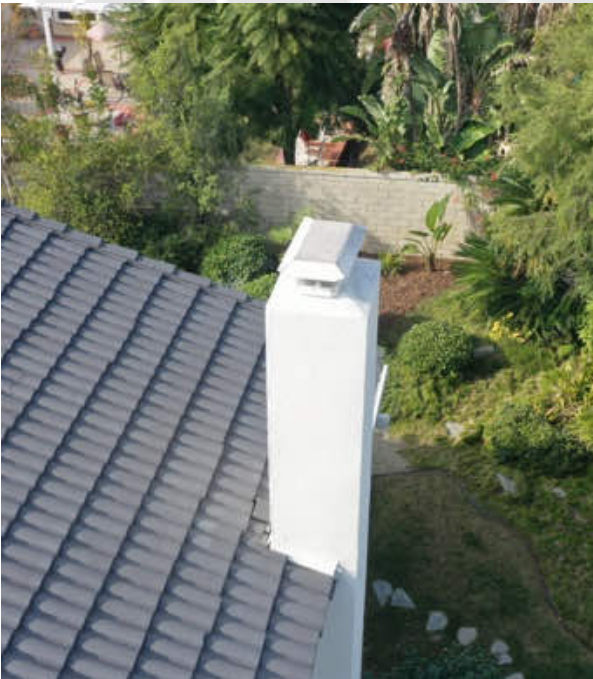
CHIMNEY STORM CAP & SPARK ARRESTOR
64: Storm cap and spark arrestor were present.

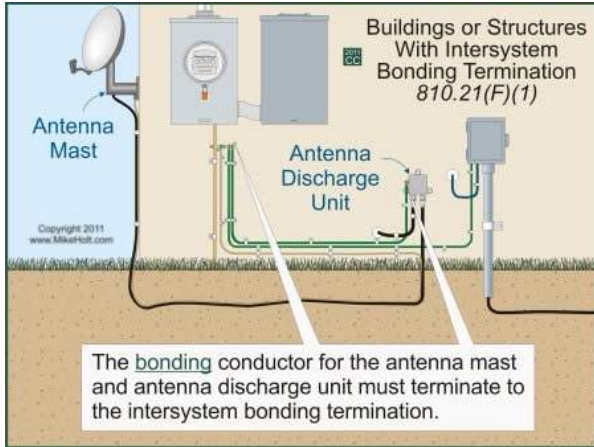
SAF 66: Missing intersystem bonding termination device. (IBT) Bonding of communication systems. A bonding termination device must be provided for communication systems in accordance with article 250.94 A and B of the national electrical code. It is suggested that a "Licensed Electrical Contractor" be contacted for further evaluation and installation.
