Inspection Report

Lynridge Dr
Yorba Linda, California
92886

Inspected By
David Salvato
California Inspection Authority INC.
(949) 981-8320
CIAHomeInspection@gmail.com
Inspecting The Finest Homes In California
www.CIAHomeInspection.com

Wednesday
December 27, 2023

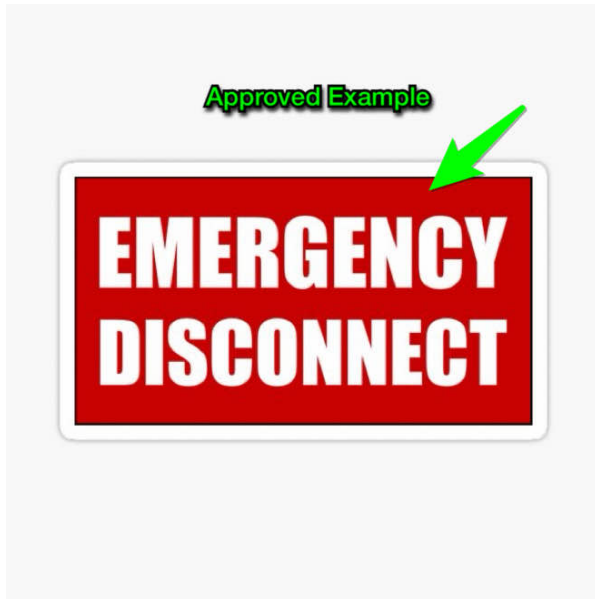
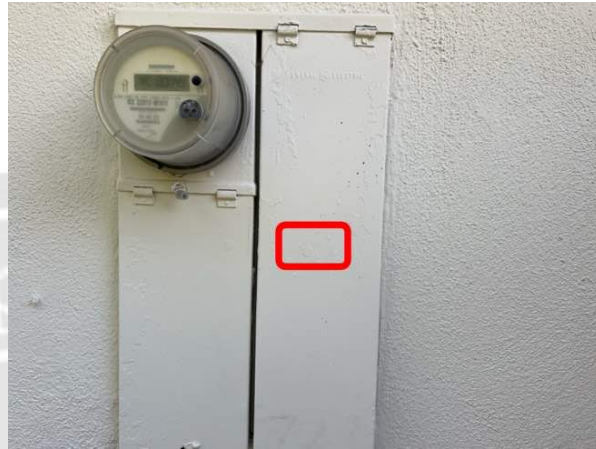
SAF 68: All main electrical panels should have appropriate labeling so emergency responders can locate the emergency service disconnect. NEC 230.85 Service disconnects marked as follows: EMERGENCY DISCONNECT, SERVICE DISCONNECT

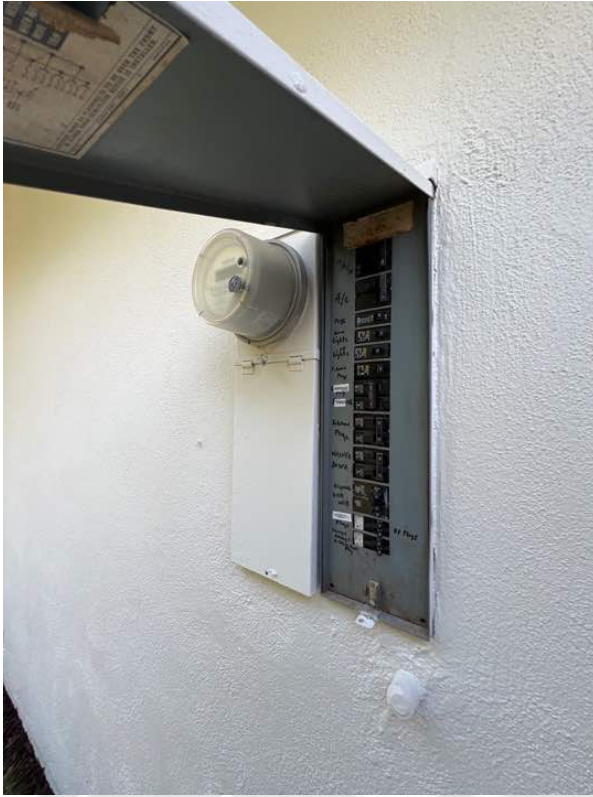
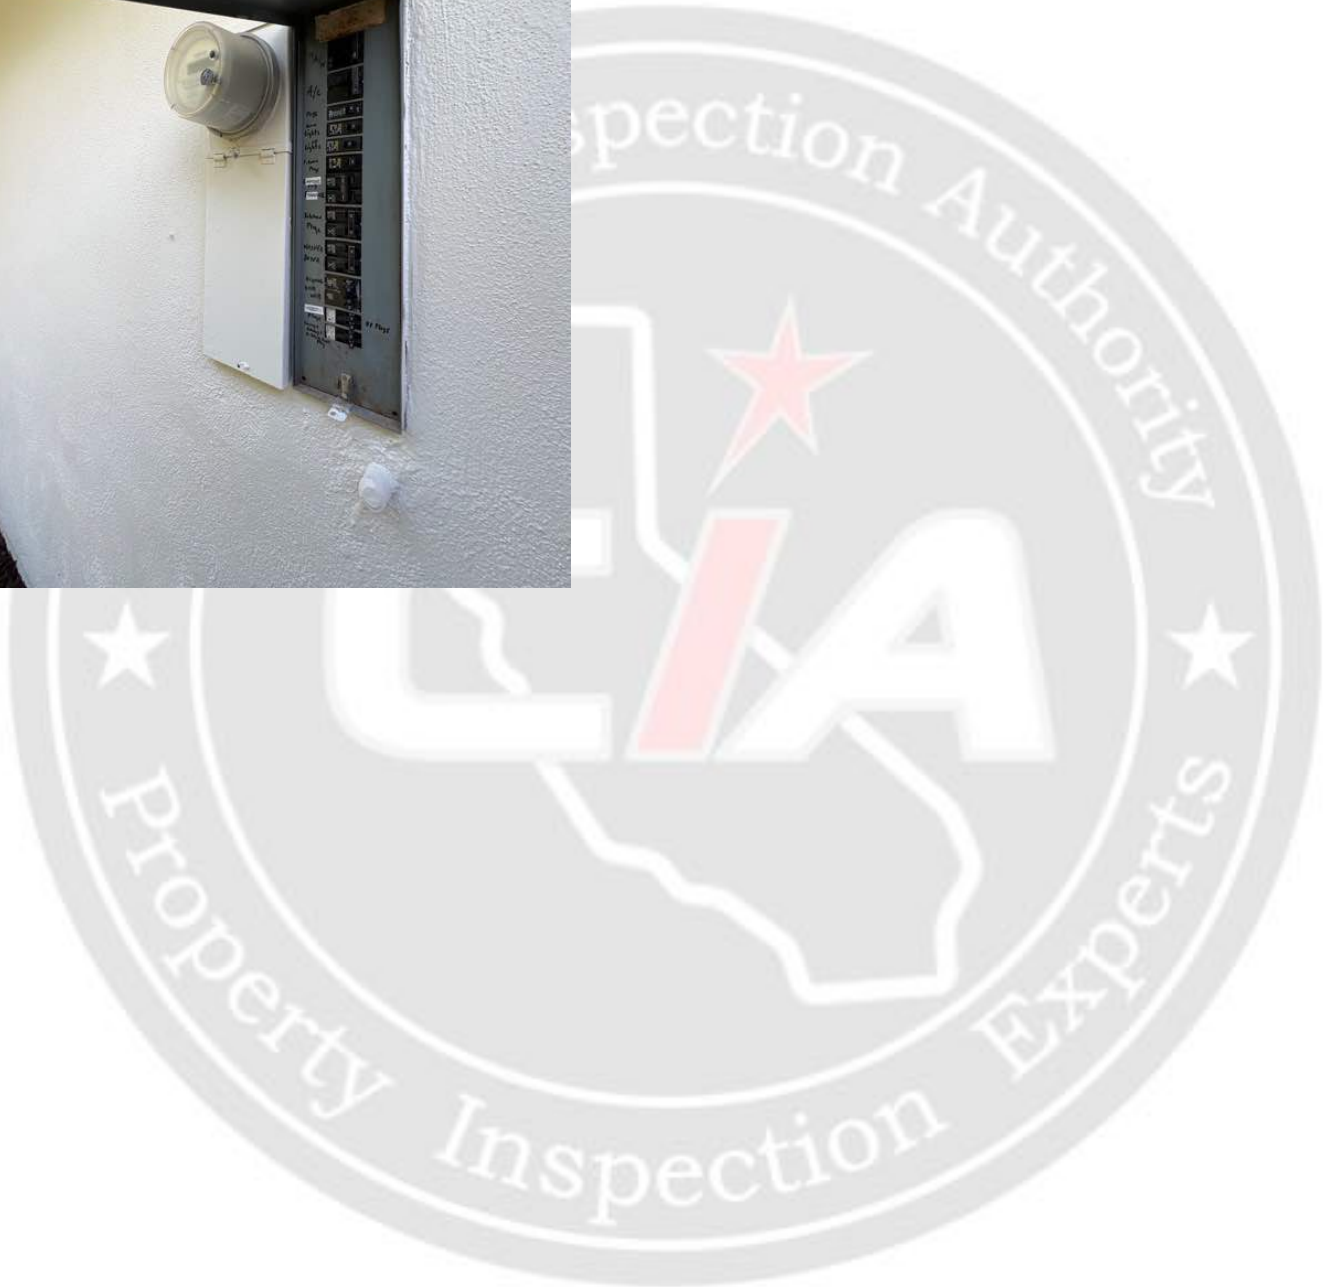
70: The main electrical panel is manufactured by General Electric and is rated for 125/250 Volts. The panel is in good condition. Voltage was tested and well within guidelines.

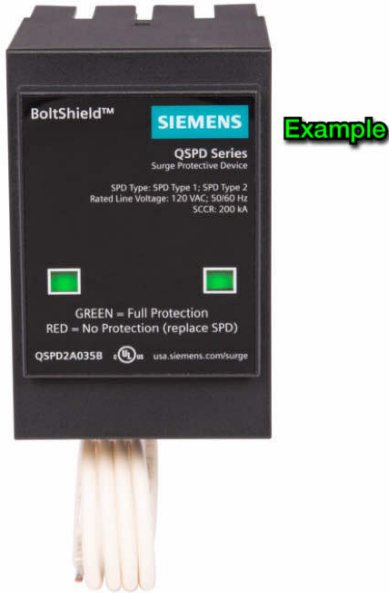
SAF 72: There was no surge protection provided. Article 230.67 of the 2020 National Electrical Code® (NEC) now requires all services supplying dwelling units to be provided with a surge protective device (SPD), as an integral part of equipment or located immediately adjacent. The SPD must be a Type 1 or Type 2 SPD.

It is suggested that a "Licensed Electrical Contractor" be contacted for further evaluation and installation.

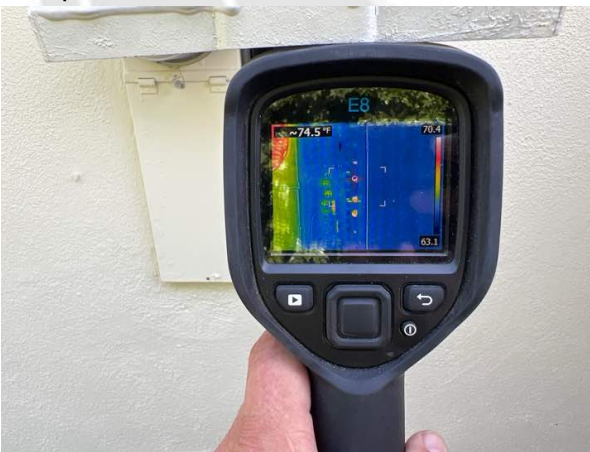
73: FLIR scan of main panel. All temperatures were well within guidelines. There were no deficiencies to report.

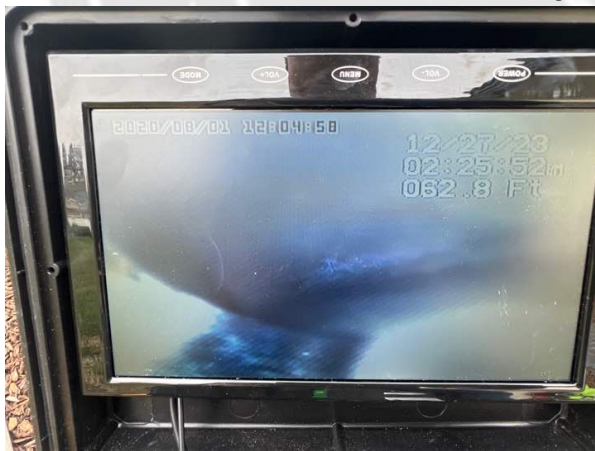
79: The sewer lateral was evaluated using a high-definition sewer line camera.

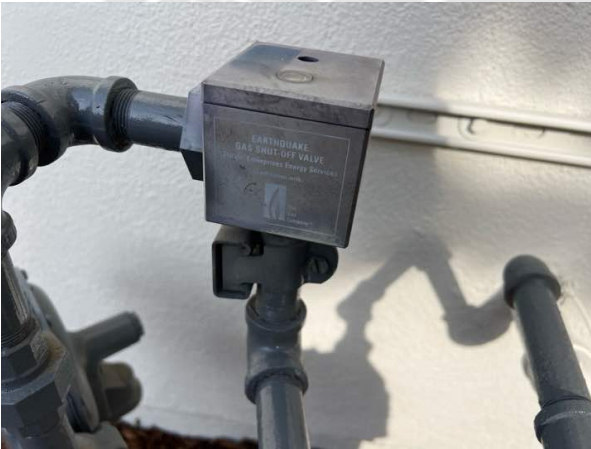
WARN 81: Seismic shut off valve has been installed. This valve may need to be reset in the event of an earthquake. This will restore gas once the system has been inspected.

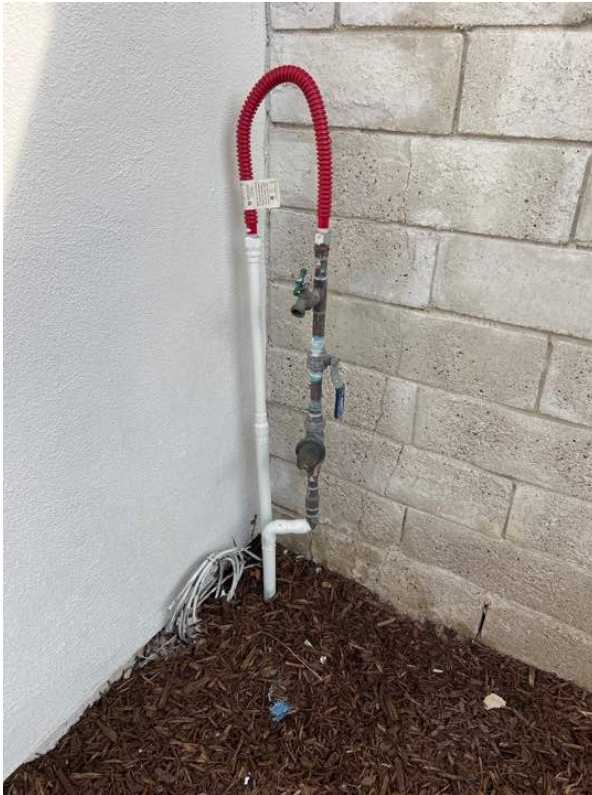
83: Copper was observed exiting the soil line. Materials used underground are unknown.

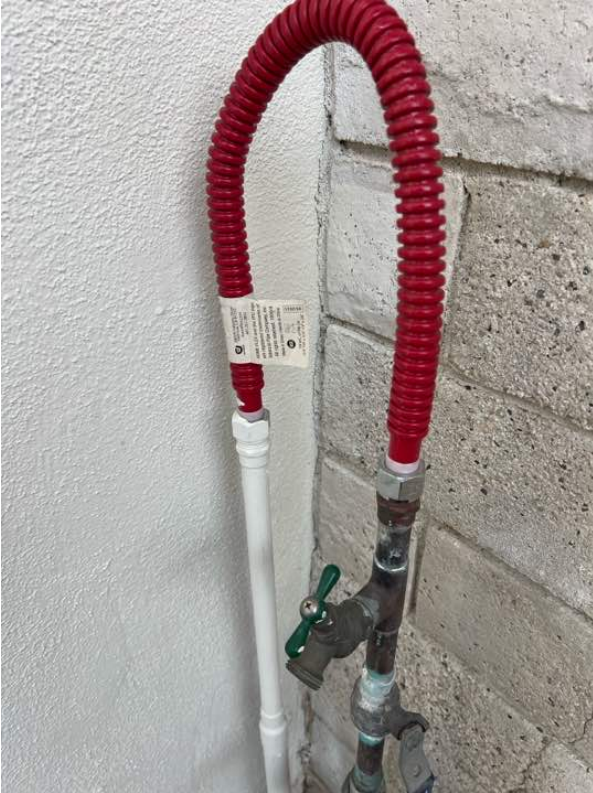
REP 84: It should be noted that a hot water heater flex line is utilized to connect the Watermain to the homes main water supply. It is suggested that a plumber be consulted to properly plumb the fittings, in lieu of the flex line. Flex lines of the nature are subject to failures. Upgrades recommended.

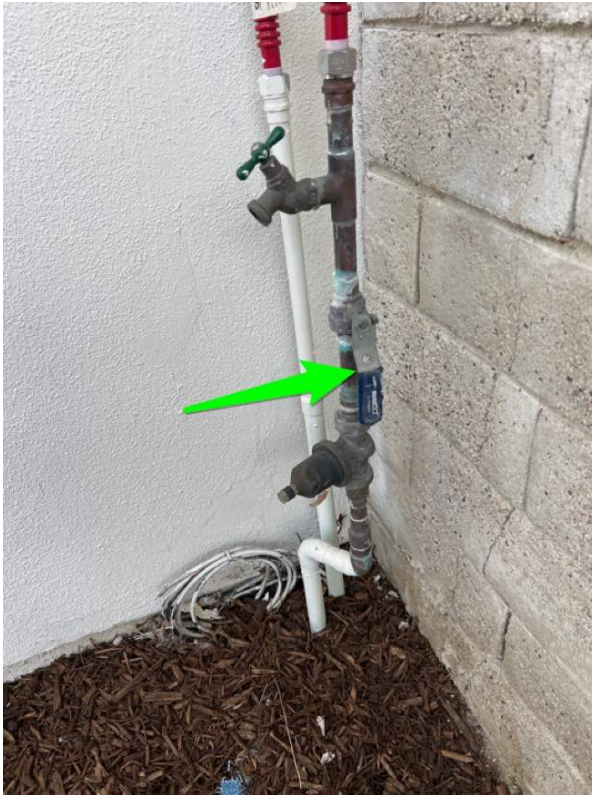
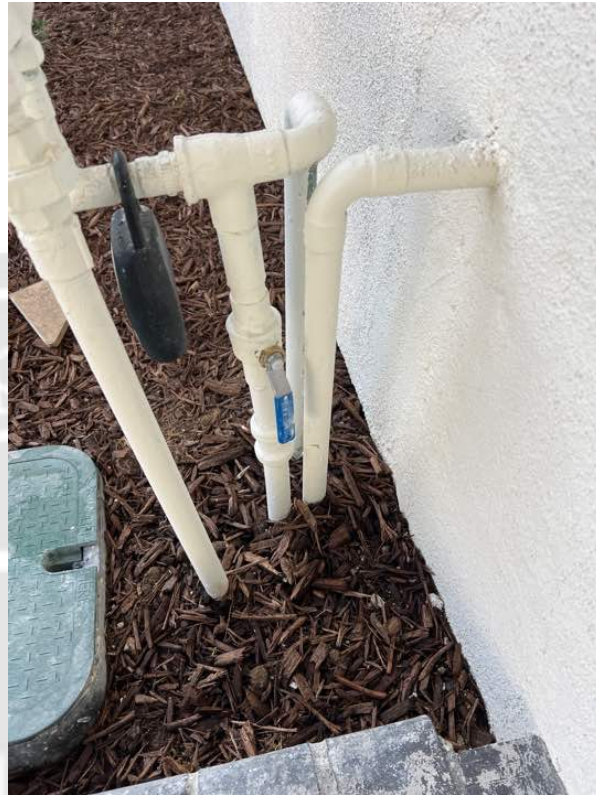
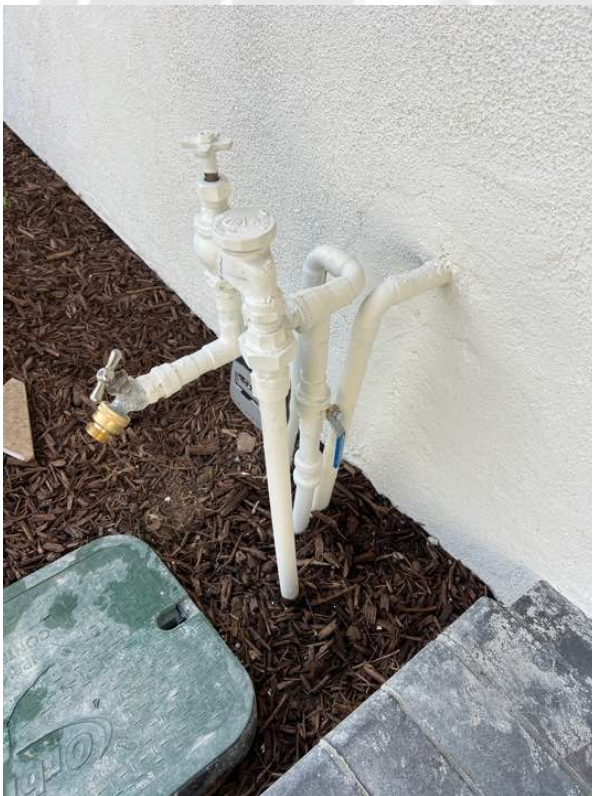
WATER SERVICE MAIN SHUTOFF LOCATION

85: The main shutoff valve is located at the side of the home.

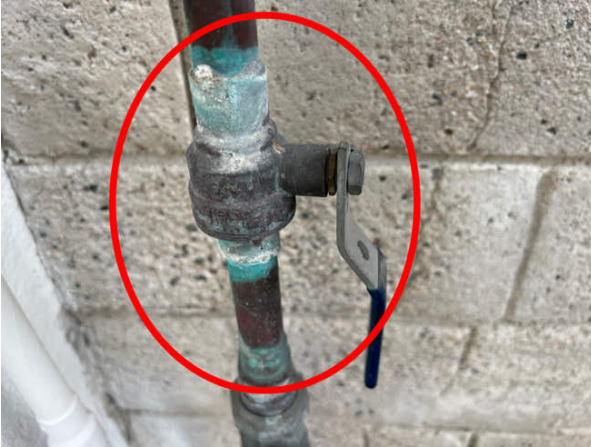
WATER SERVICE MAIN SHUTOFF VALVE CONDITION

REP 86: Calcium deposits noted at shut off valve. These types of calcium deposits are subject to water leaks. And failures. Replacement recommended.

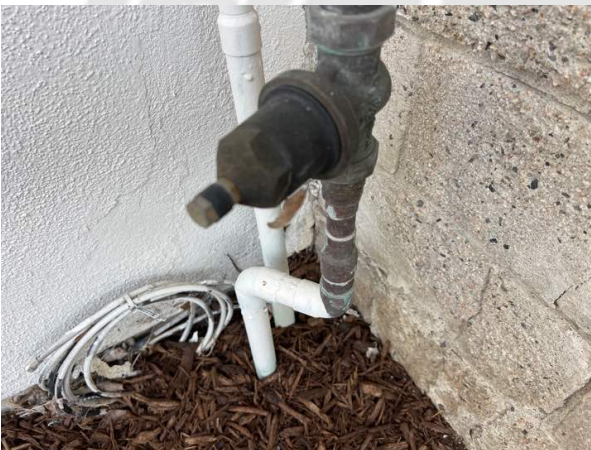
WATER SERVICE WATER PRESSURE REGULATOR

87: The water pressure regulator was tested and found to be in satisfactory condition.

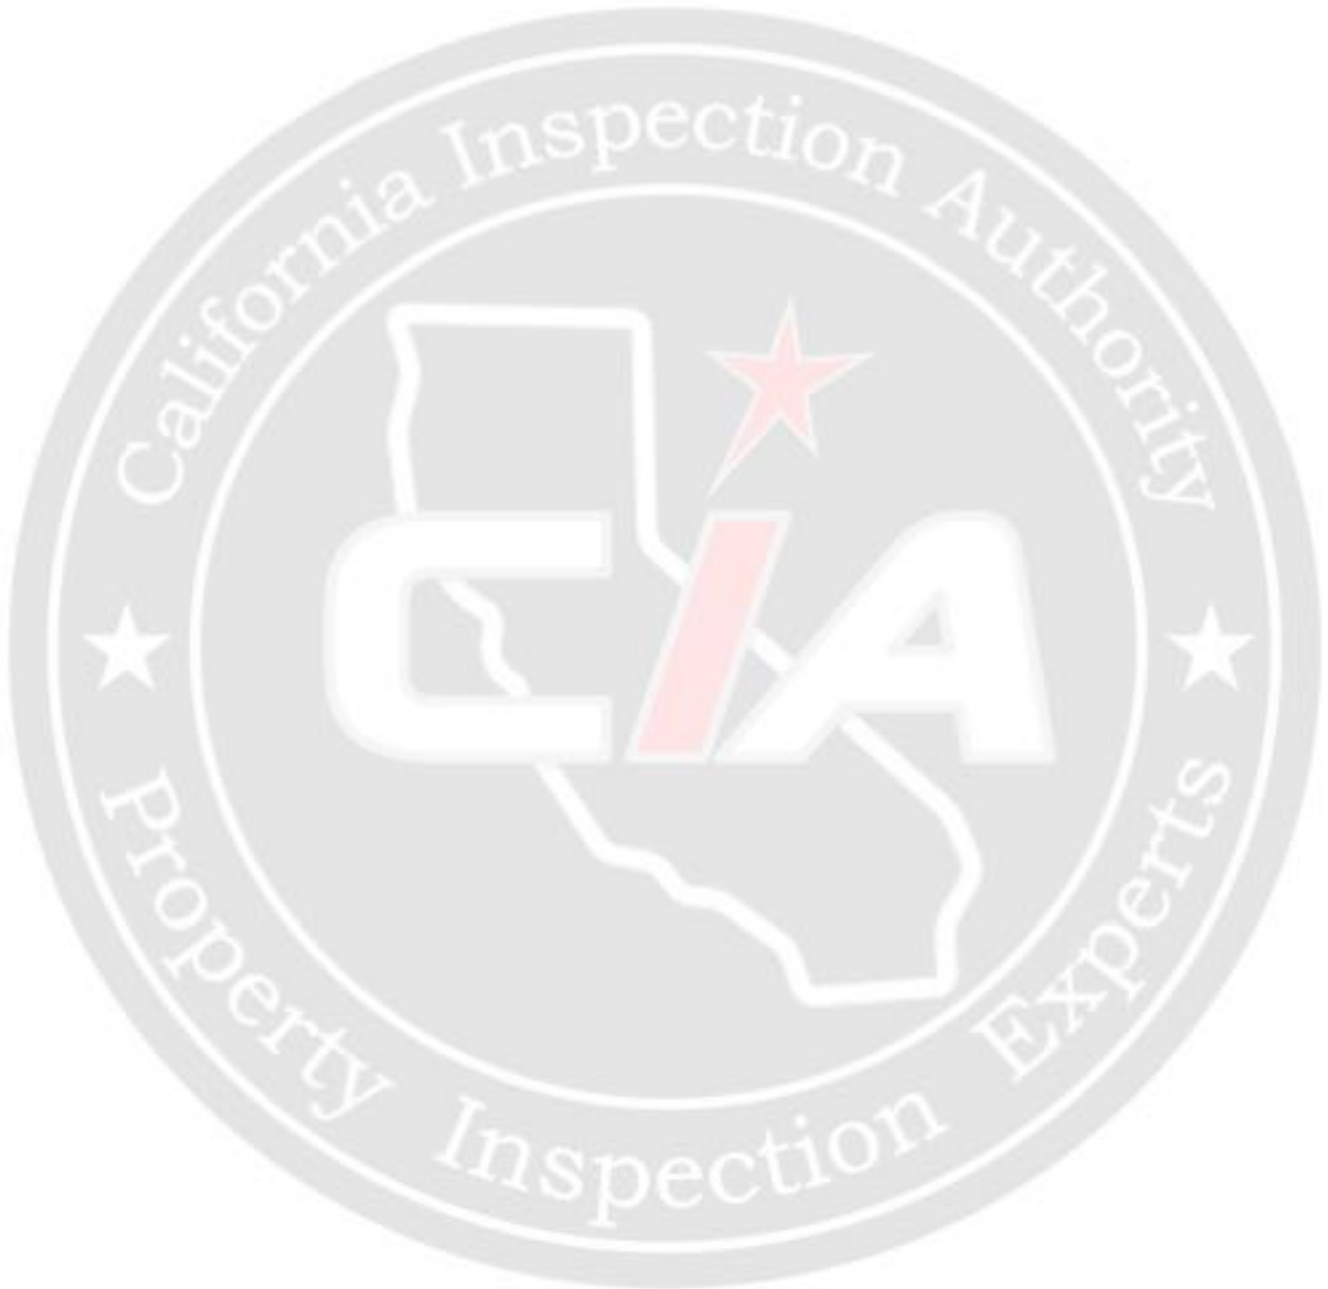
FIRE SPRINKLERS FIRE SPRINKLER CONDITIONS

WARN 91: Your home is equipped with a fire suppression system. Also referred to as fire sprinklers. These systems are excluded from the home inspection process and are excluded from the home inspection industry standards of which your home was inspected. If the home inspector makes comments regarding the fire sprinkler system it is done as a courtesy only. Any comments should be followed up with a licensed professional in your area certified to inspect and or repair fire sprinkler systems.

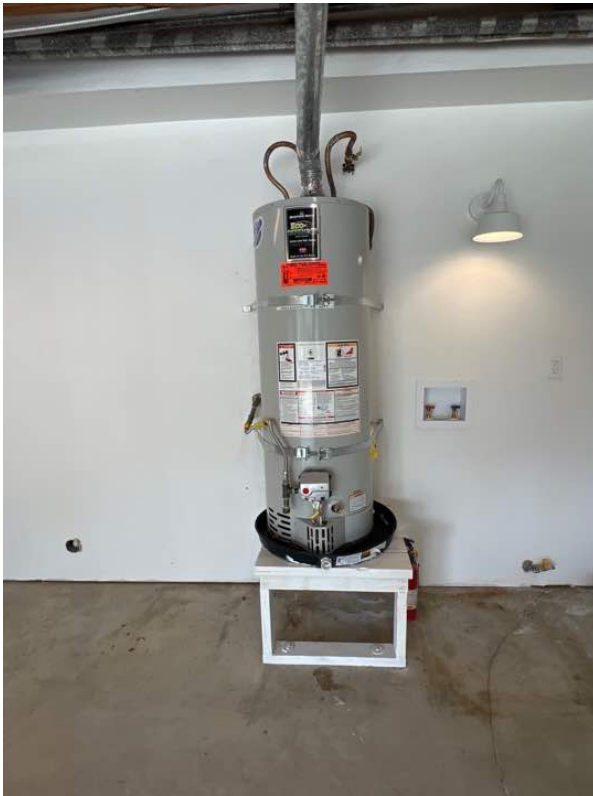
WATER HEATER(S) LOCATION

92: The hot water heater was located in the garage. Burner is located approximately 18 inches or more above the finish floor.

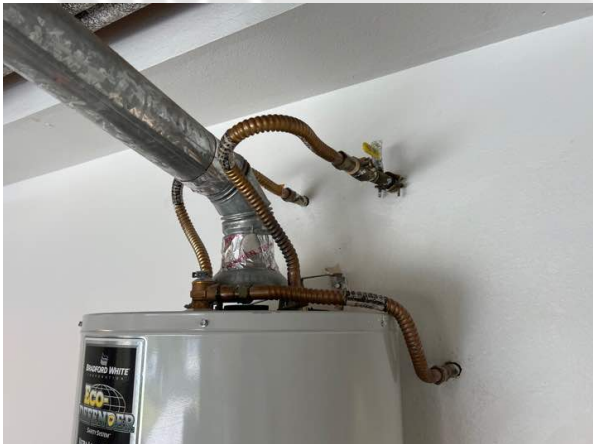
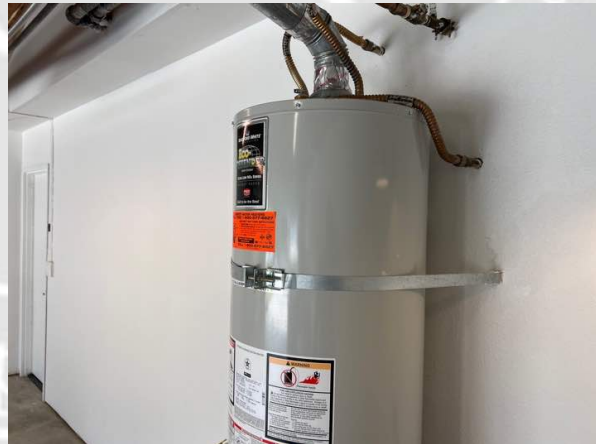
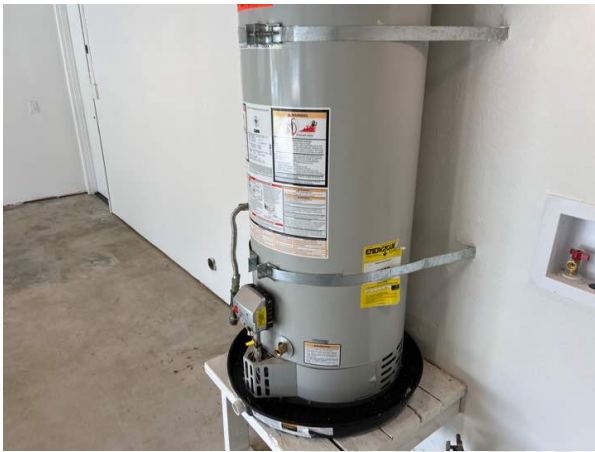
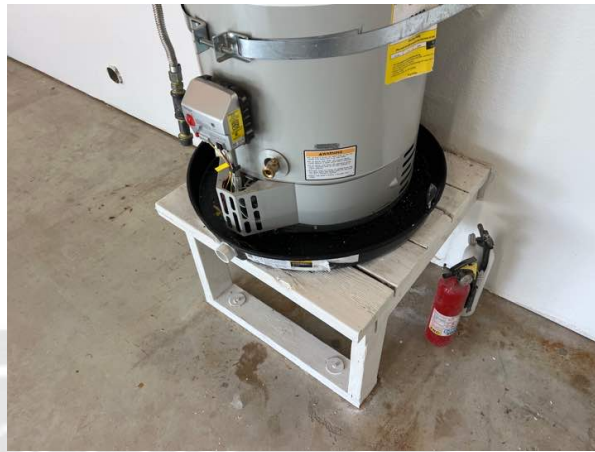
WATER HEATER(S) TYPE

93: Natural gas fired hot water storage tank.

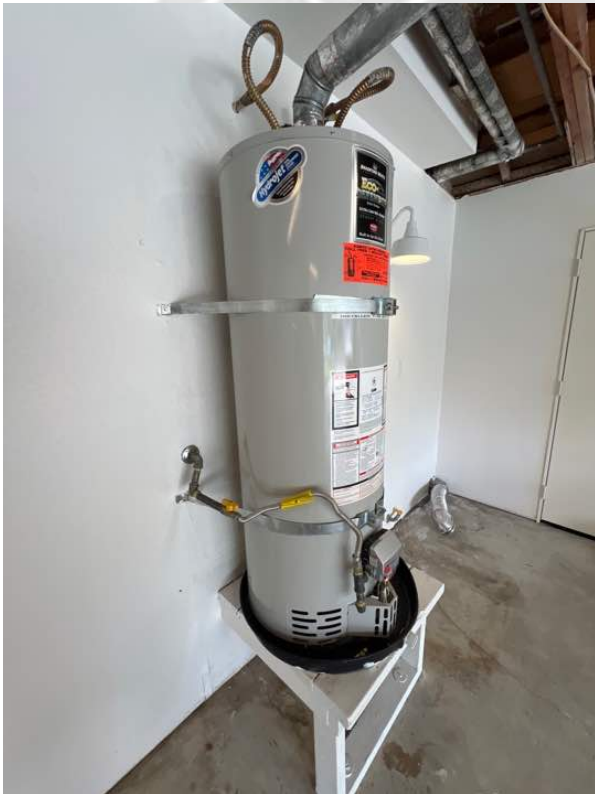
WATER HEATER(S) GENERAL CONDITION

94: Hot water heater was in satisfactory condition.

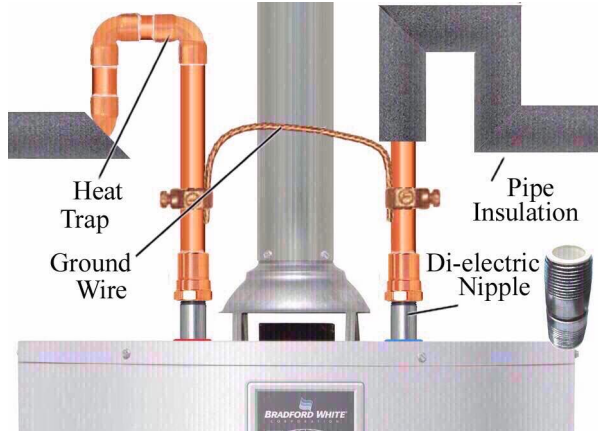
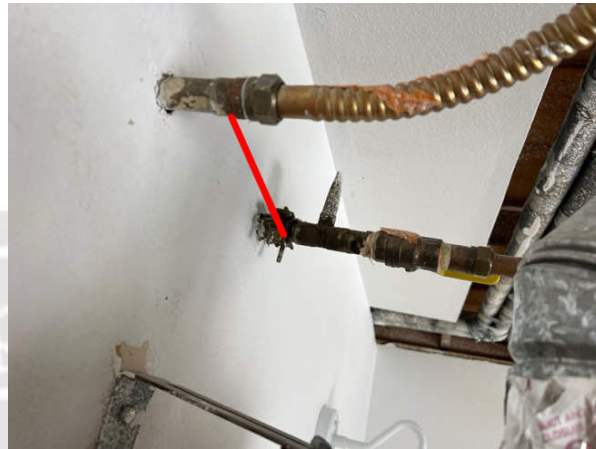
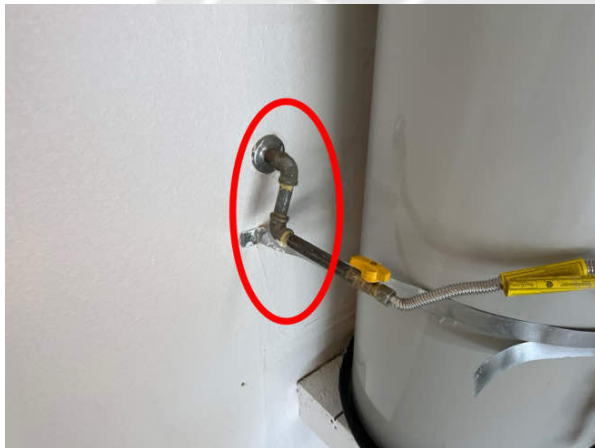
REP 95: It is recommended that a bonding jumper be installed at the hot water heater lines as seen in the diagram. This will help ensure grounding continuity through the plumbing system.

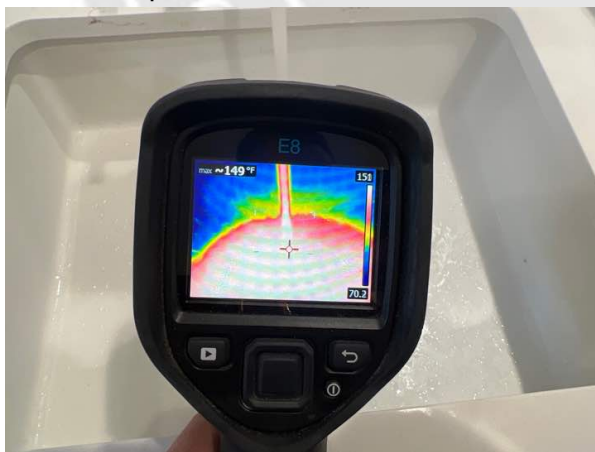
SAF 96: The hot water heater temperature exceeded 120°. While this temperature may be tolerable to most individuals. Anything over 120° could be considered scolding. We recommend the hot water heater temperature be lowered to a nominal safe level.

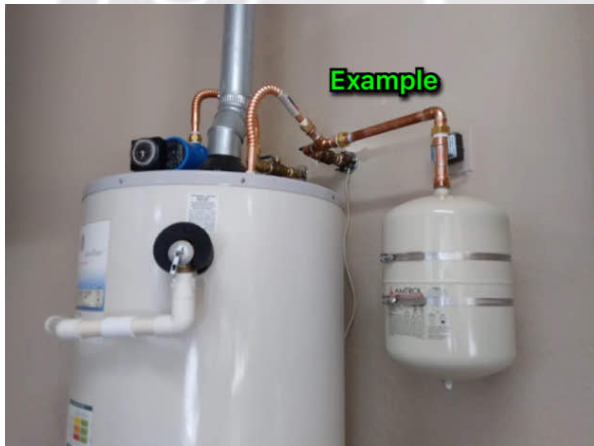
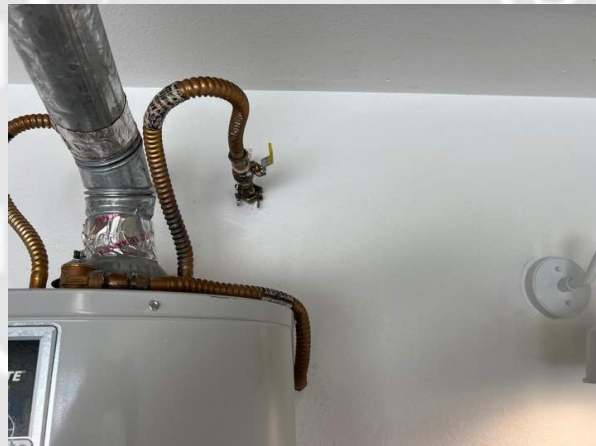
WATER HEATER(S) EXPANSION TANK

REP 98: There was no expansion tank present. Expansion tanks help to balance water pressures that can cause damage to the plumbing system. Consult with a licensed plumbing contractor for cost of installation.

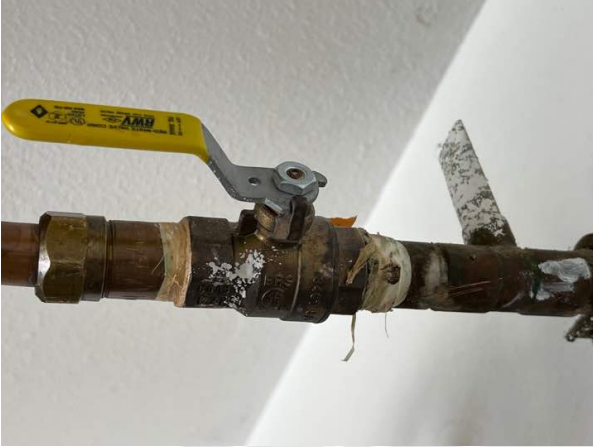
WATER HEATER(S) SHUT OFF VALVE

99: The hot water heater shut off valve was in satisfactory condition. There were no signs of leaks rust or corrosion.

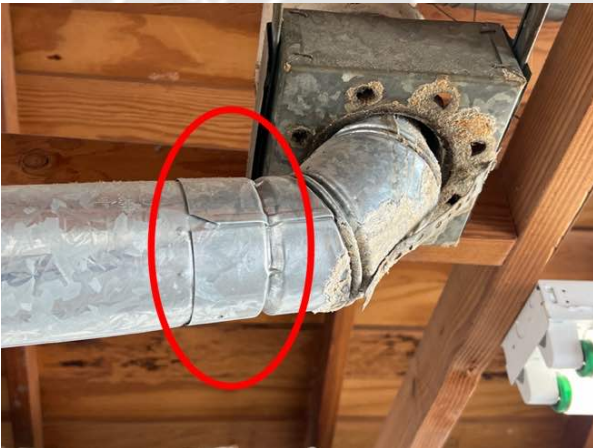
WATER HEATER(S) VENT PIPE

REP 100: All single-wall vent pipe should have three screws per joint. This will help prevent misalignment during seismic activity. Carbon monoxide hazard.

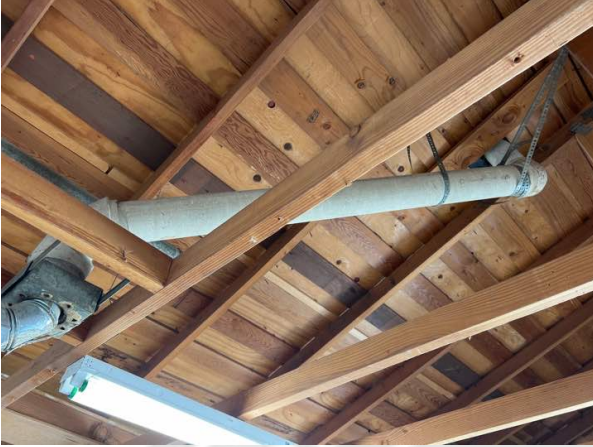
WARN 101: Transite pipe was utilized to vent the hot water heater. Transite pipe is comprised of cement-like materials and is known to contain asbestos fibers. This material is not harmful unless damaged, deteriorating or disturbed. Recommend removal to satisfy any health and safety concerns.

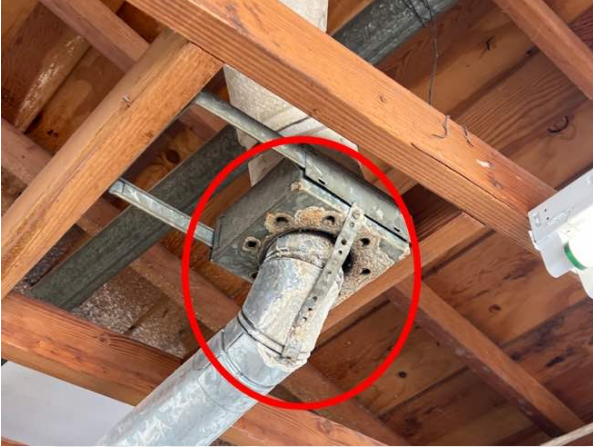
102: Signs of water, intrusion, rust and corrosion at type B transition vent to Transite thimble.

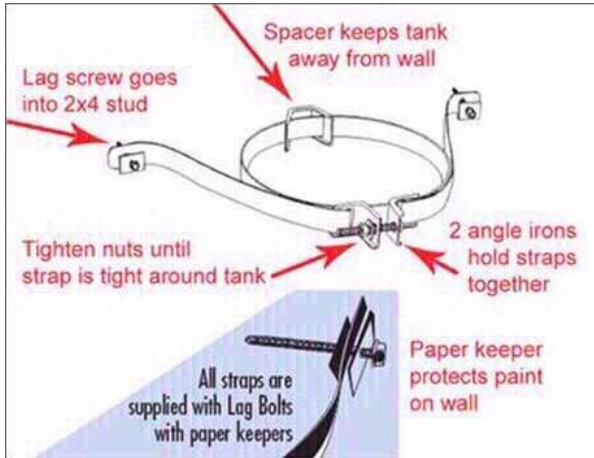
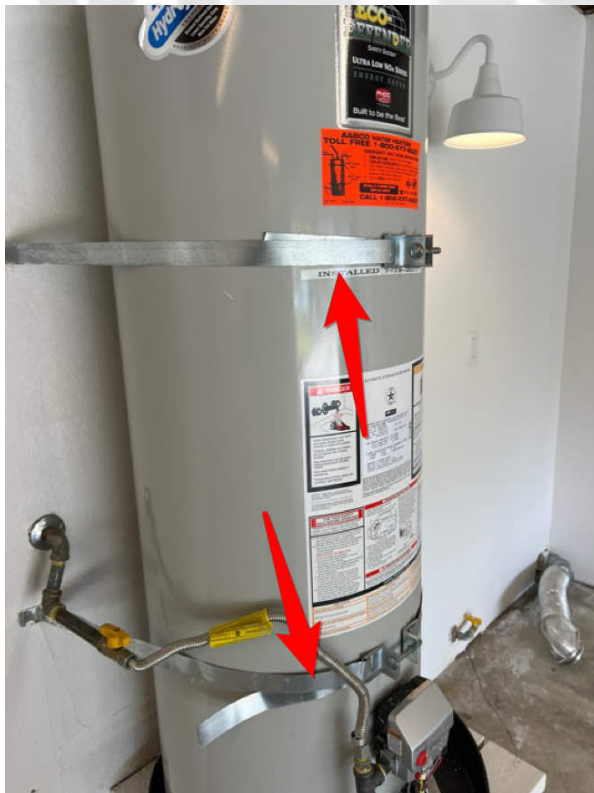
WATER HEATER(S) SEISMIC STRAPS

SAF 103: Hot water heater seismic straps were not installed according to manufacturers guidelines. The hot water heater moves about freely. Consult with a plumbing contractor for proper blocking and bracing.

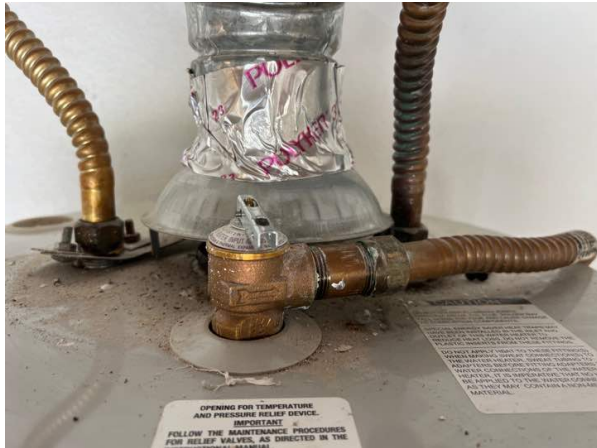
WATER HEATER(S) TPR VALVE

104: The TPR valve was in satisfactory condition. There were no signs of leaks, rust or corrosion.

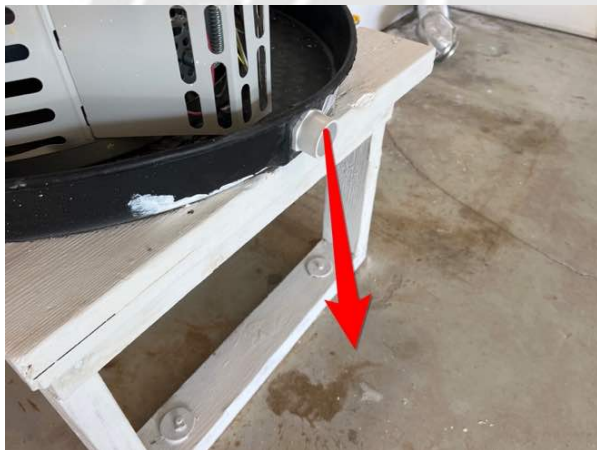
WATER HEATER(S) DRIP PAN

REP 105: Drain pan was missing discharge tube. Discharge tube should be connected to the drip pan and terminate within 3 inches of the slab to prevent water damage to the platform.

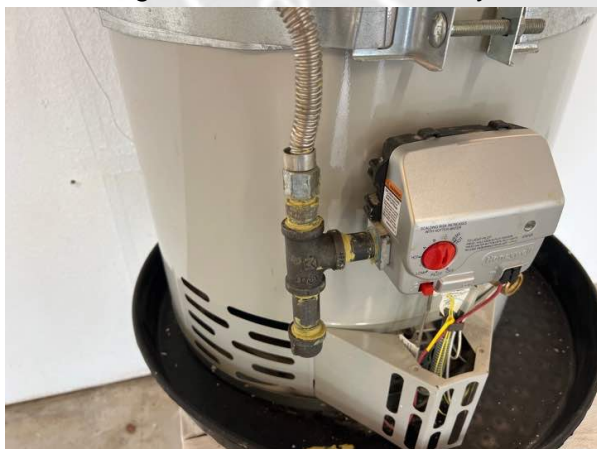
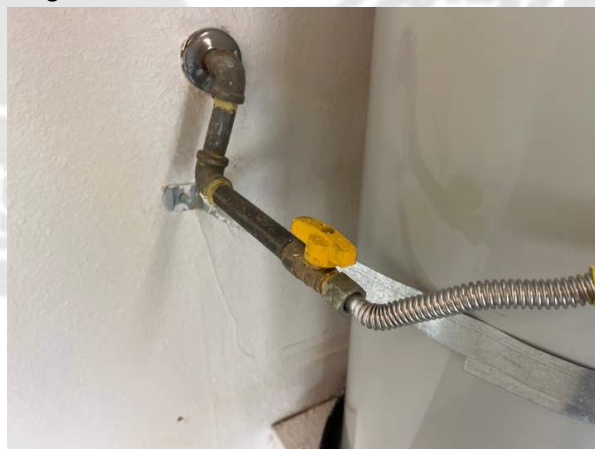
WATER HEATER(S) GAS LINE

106: The gas line was in satisfactory condition. No gas leaks were detected.

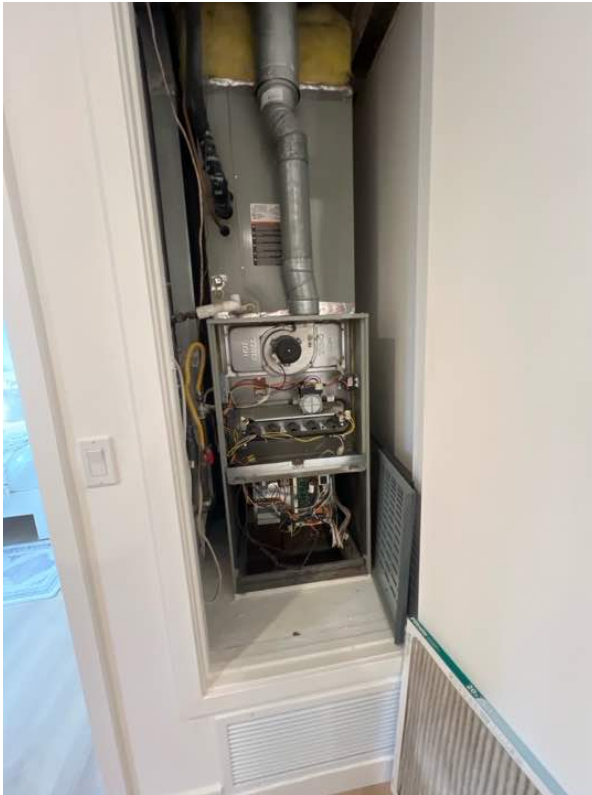
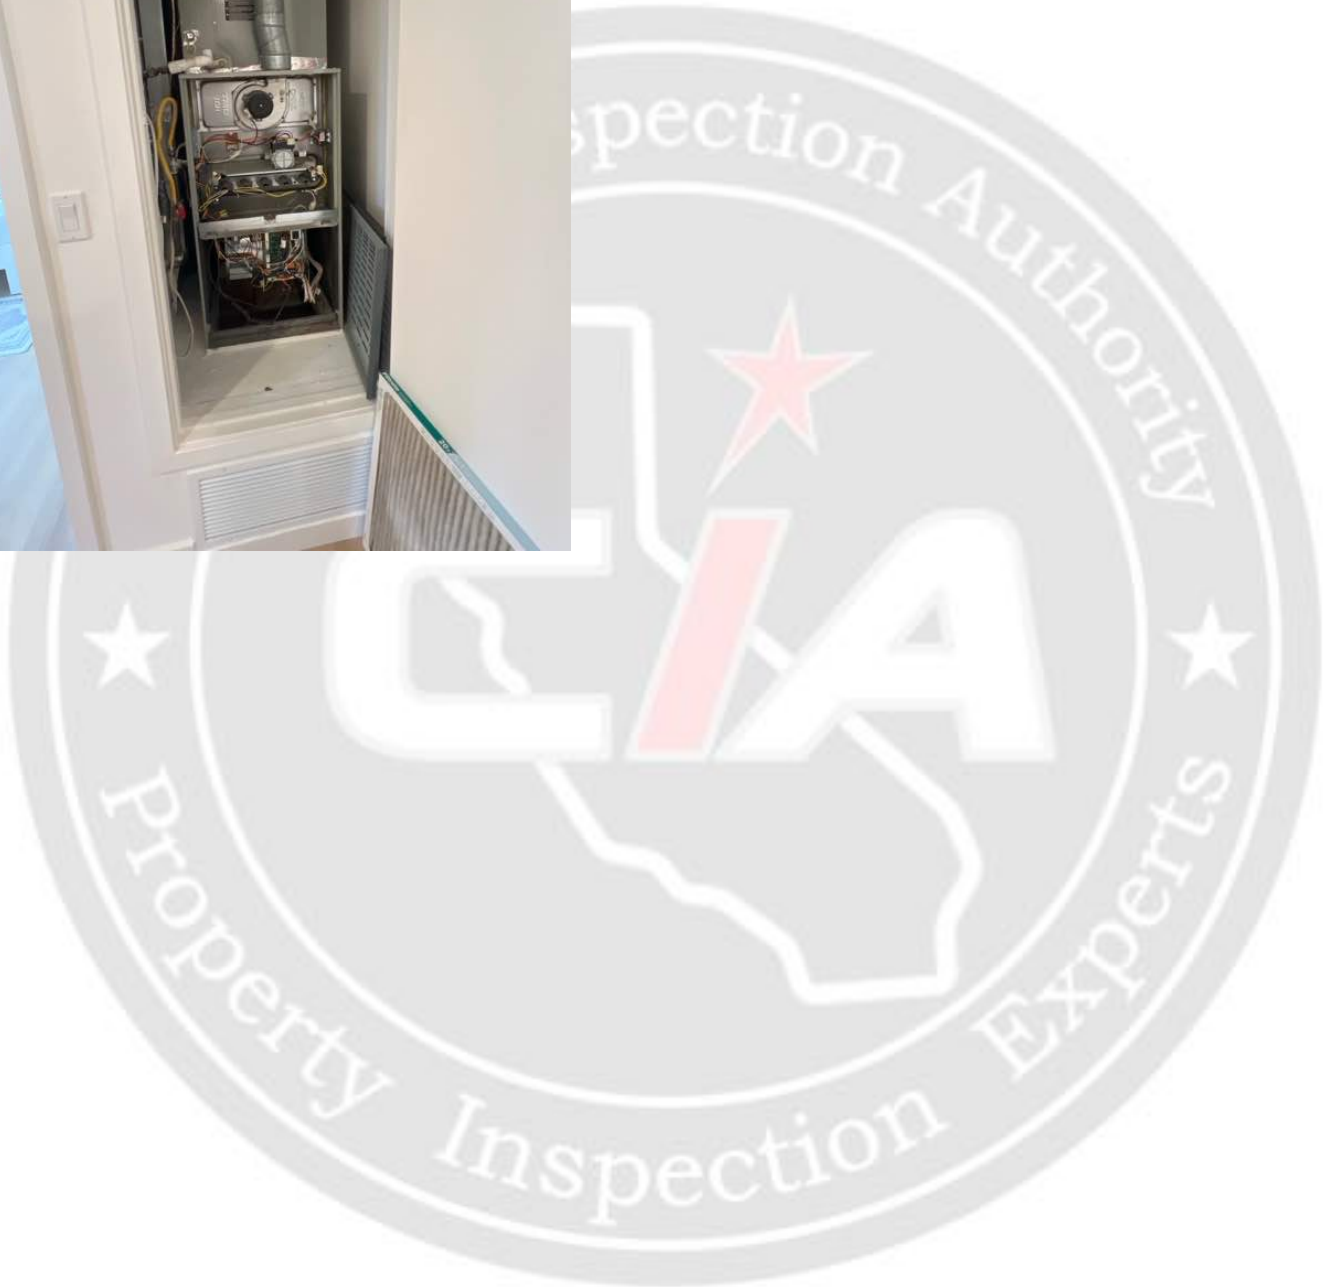
HEATING SYSTEM FUEL TYPE

107: Natural gas fired.

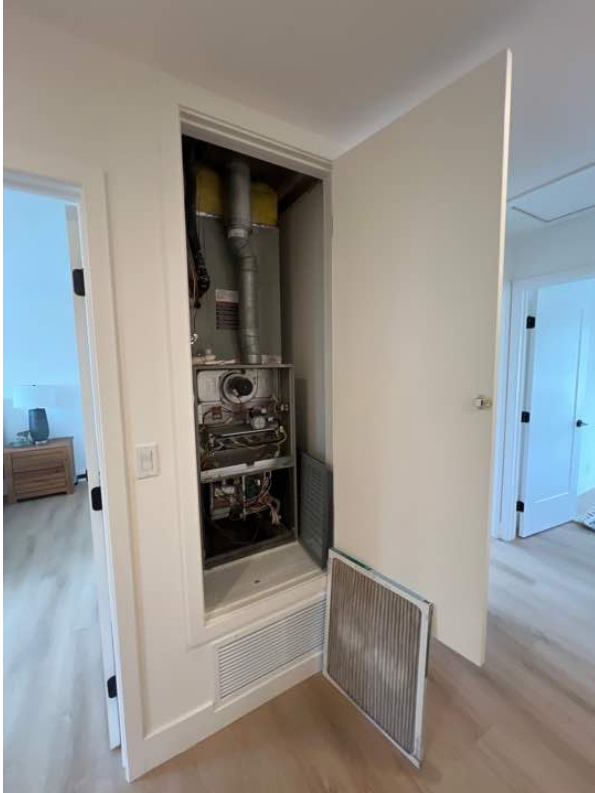
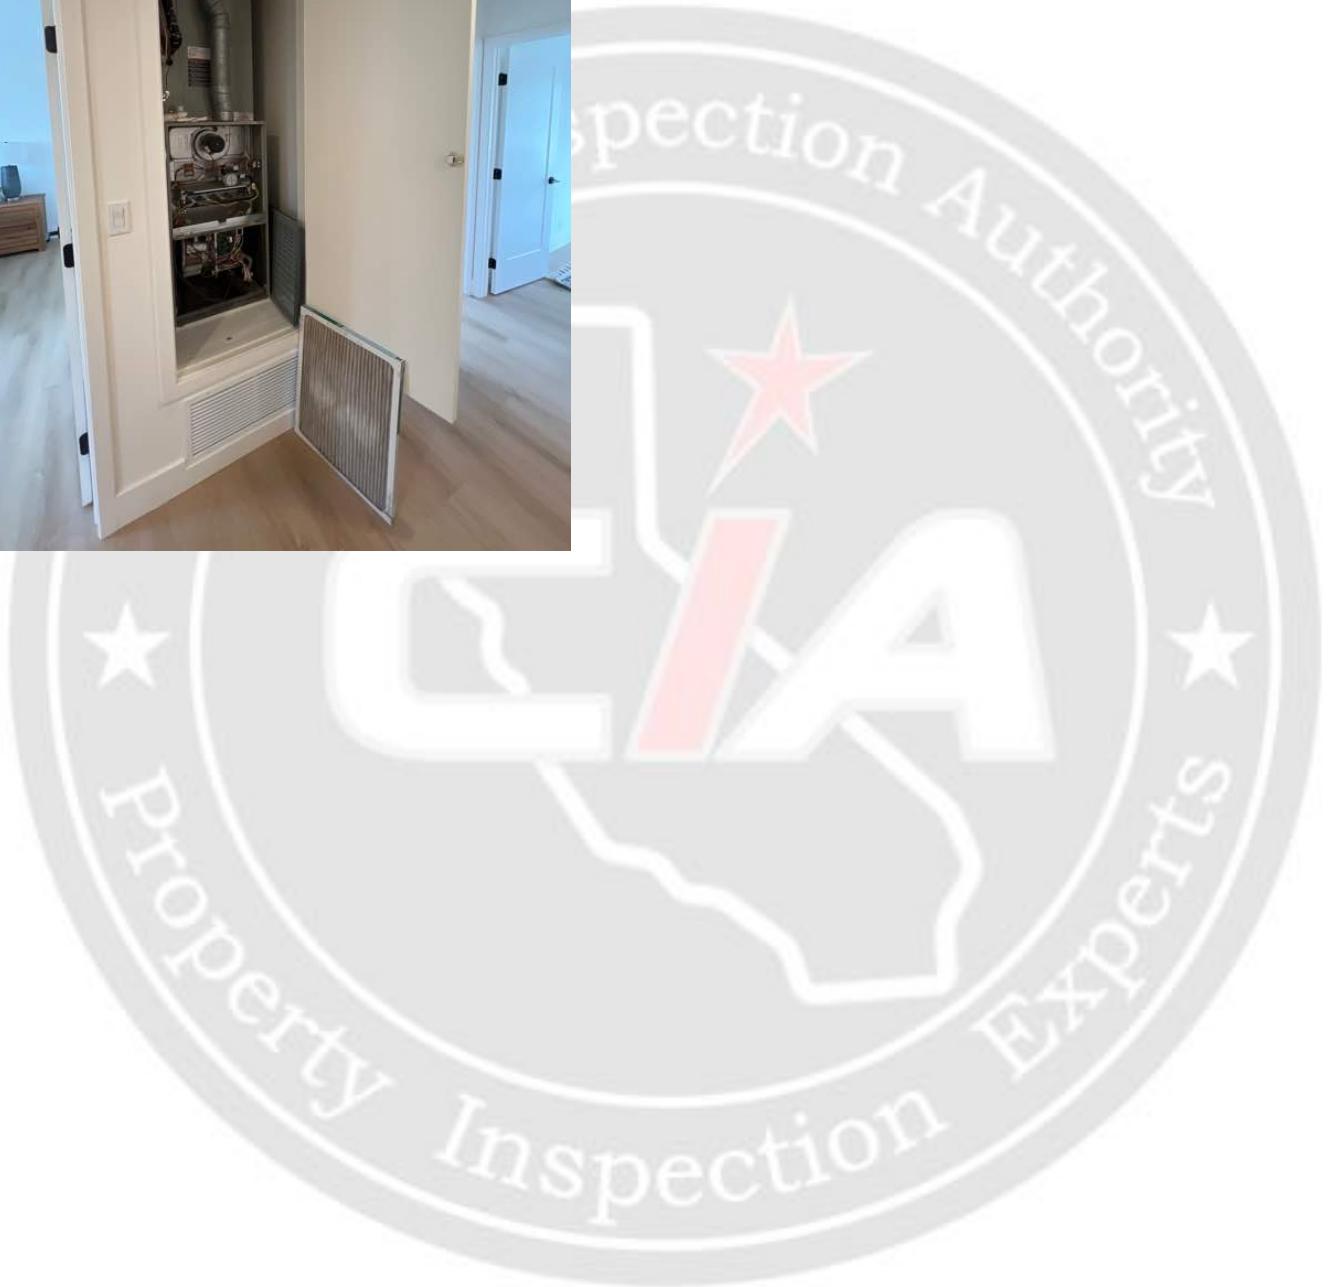
HEATING SYSTEM SYSTEM LOCATION

108: The gas furnaces located on the second-floor the home.

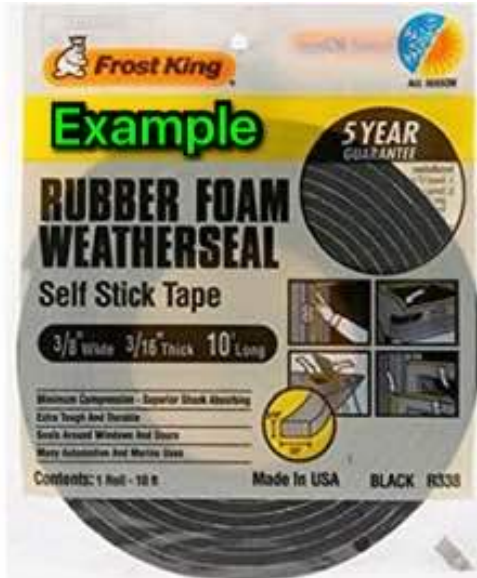
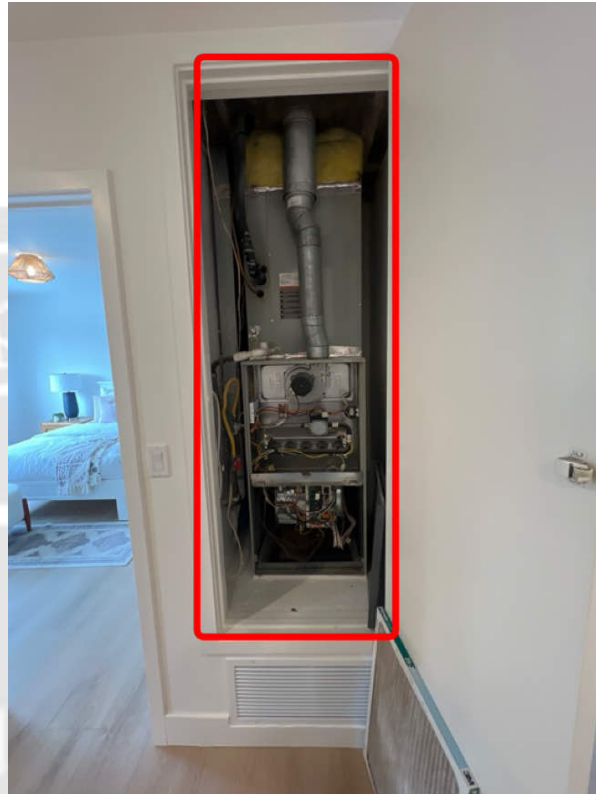
HEATING SYSTEM HEATING SYSTEM CONDITION

SAF 109: Because of the close proximity to the return air register. It is strongly recommended that the door to the heating system be properly sealed. This will prevent air scavenging from the furnace closet.

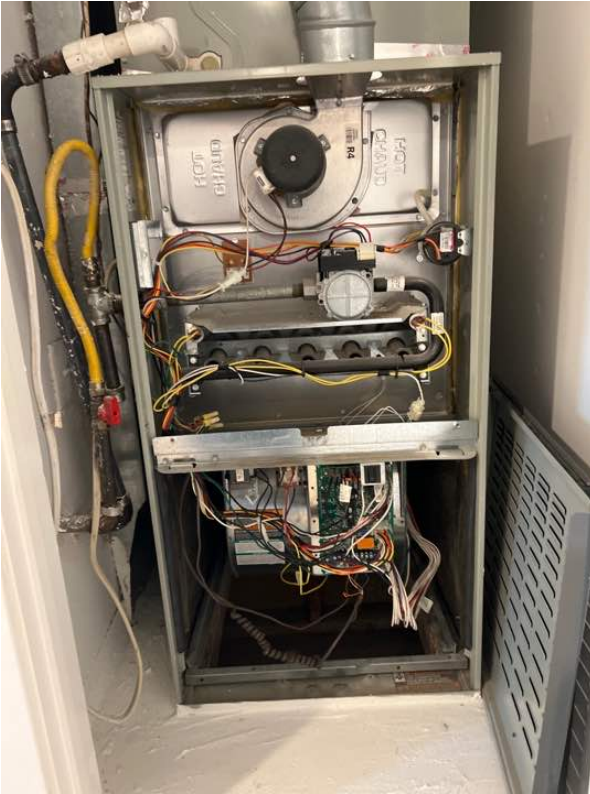
REP 110: The furnace system was nonresponsive on the day of the inspection. Consult with a licensed HVAC contractor for complete evaluation prior to the close of escrow.
