Inspection Report

Lynridge Dr
Yorba Linda, California
92886

Inspected By
David Salvato
California Inspection Authority INC.
(949) 981-8320
CIAHomeInspection@gmail.com
Inspecting The Finest Homes In California
www.CIAHomeInspection.com

Wednesday
December 27, 2023

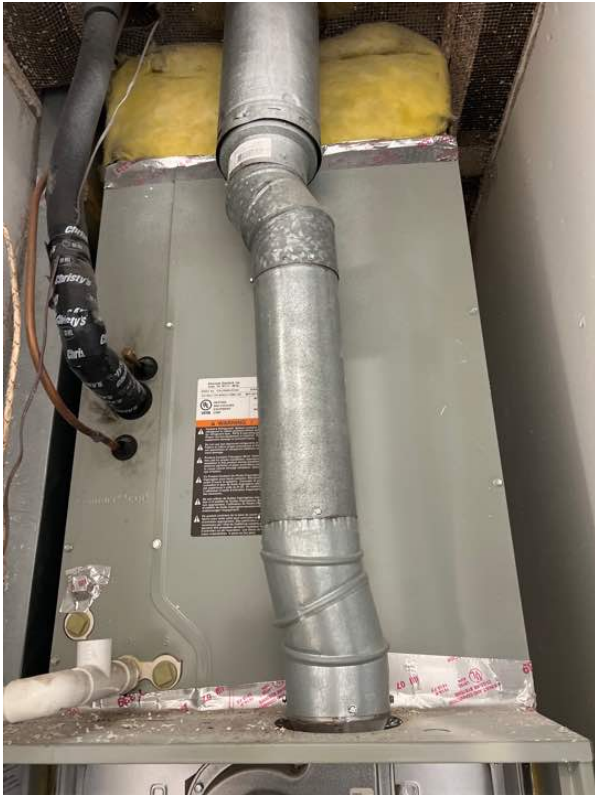
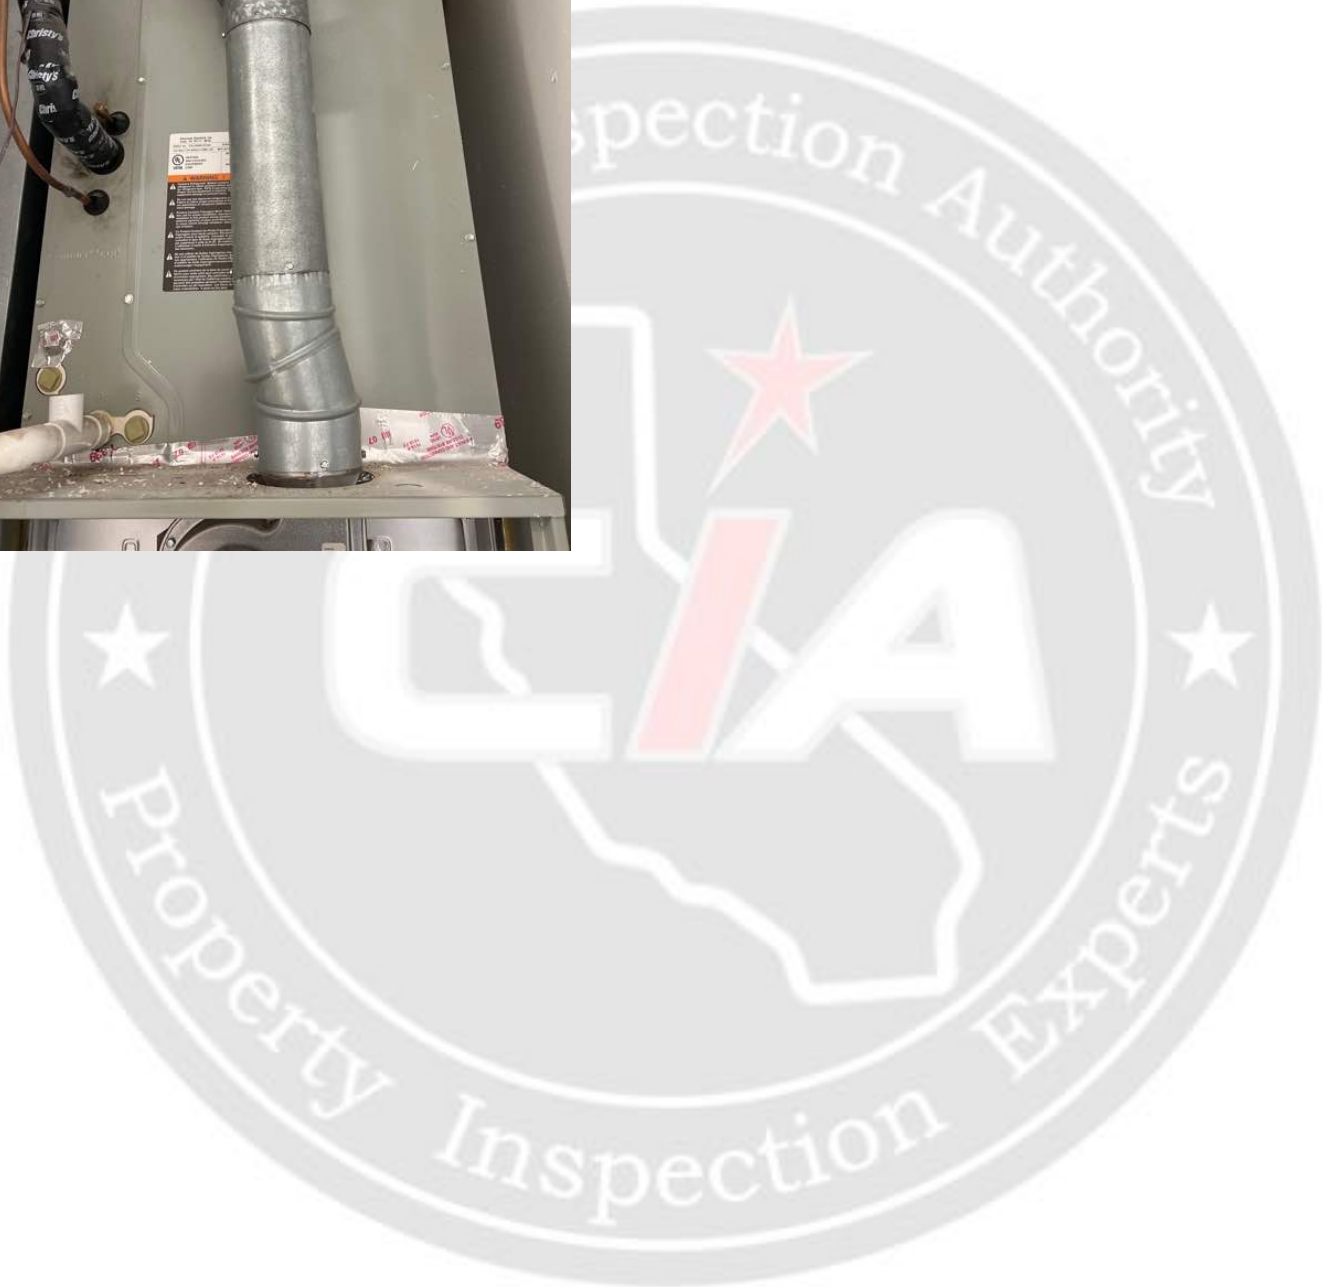
HEATING SYSTEM VENTING

111: Heater vent was in satisfactory condition and directly vented through the roof.

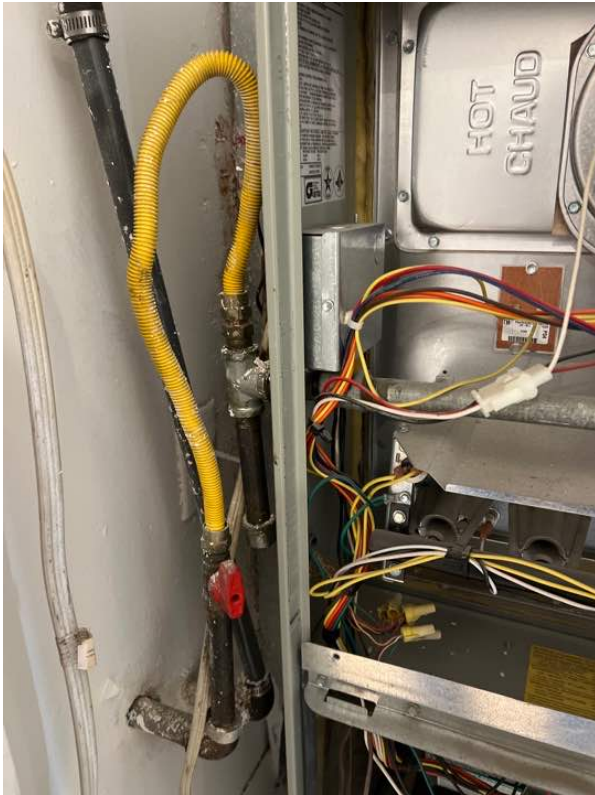
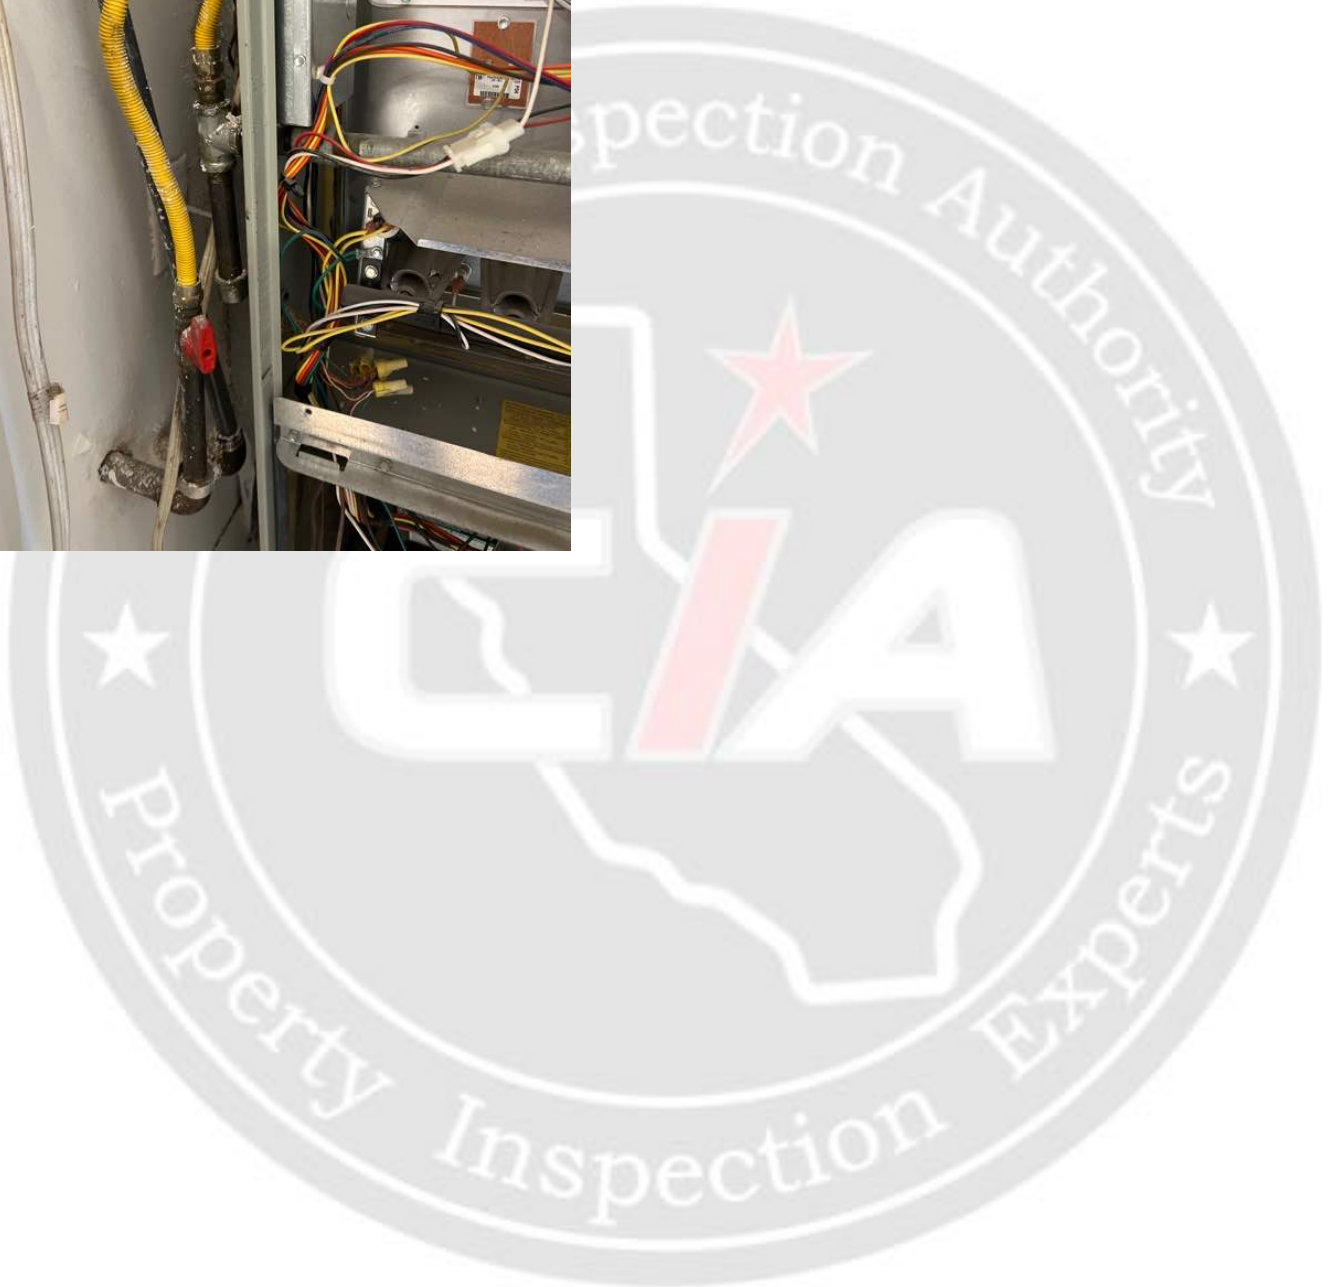
112: The gas line was in good condition. There were no gas leaks detected.

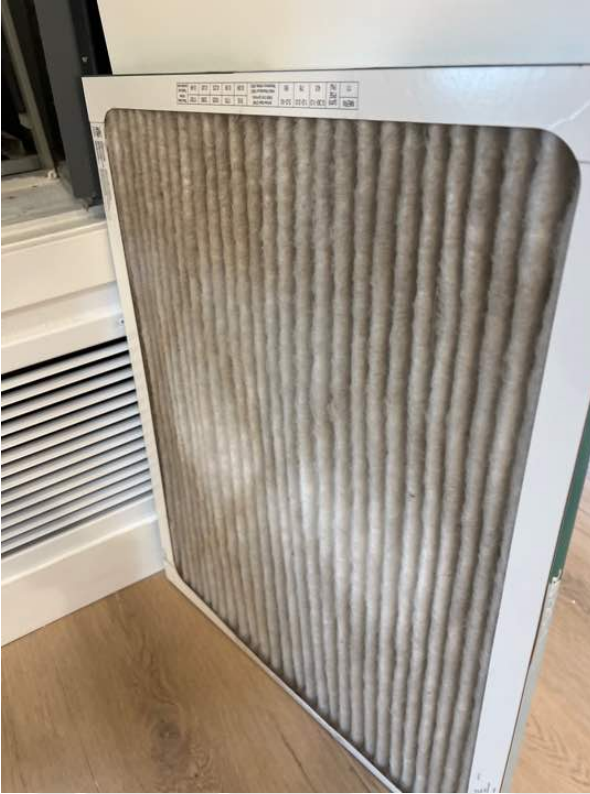
REP 113: The filter was dirty. Replacement needed. Filter should be replaced every 3 to 6 months as part of regular home maintenance.

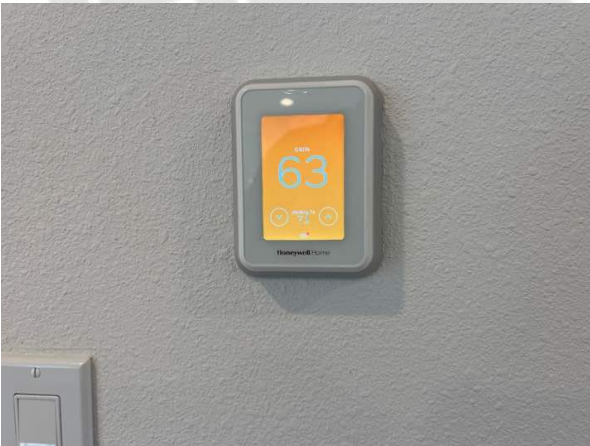
114: The thermostat was located in the hallway. The thermostat appears to be properly installed and the unit responded to the basic controls. This is a programmable device with many options for setback settings, timed events, etc. No attempt was made to test all functions of the thermostat. To do so would be time consuming and outside of the scope of a general home inspection.

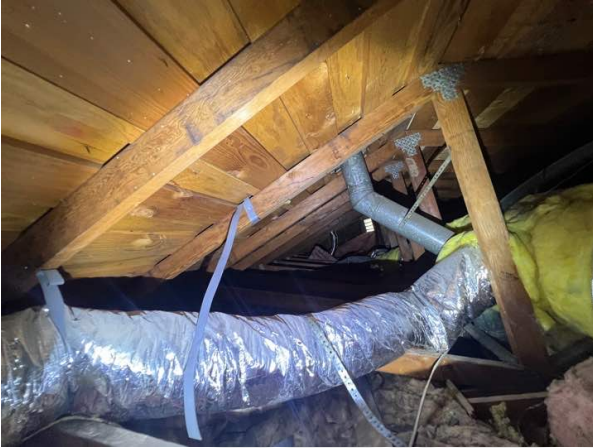
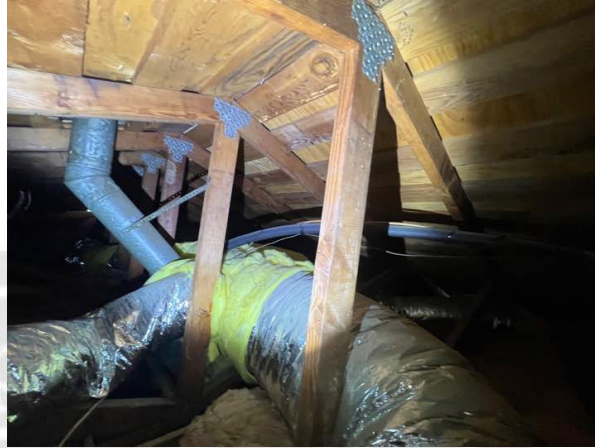
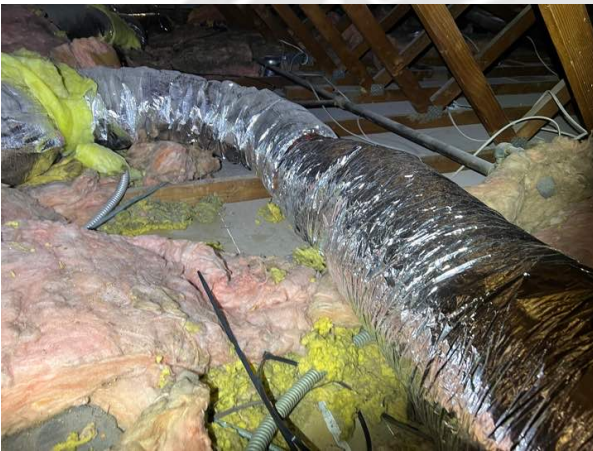
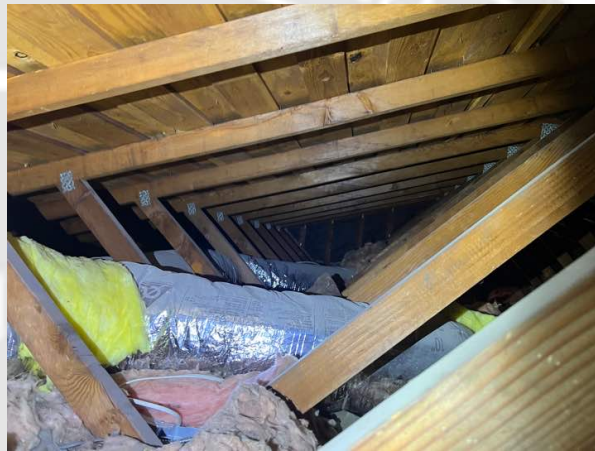
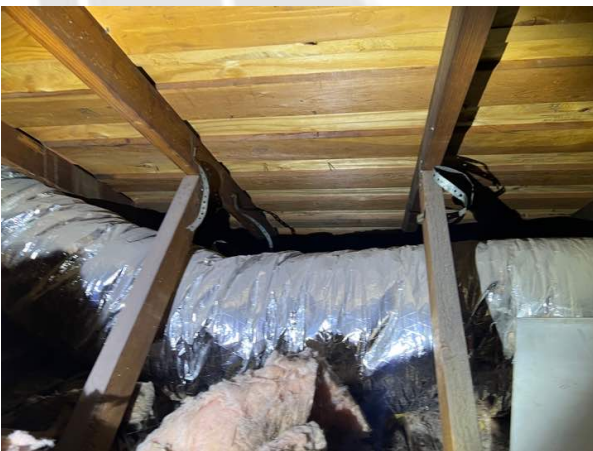
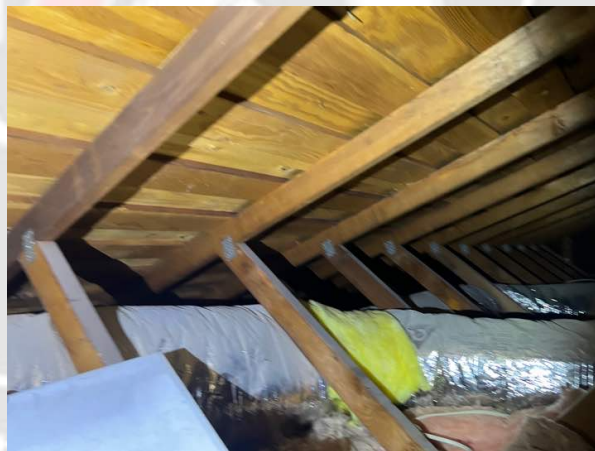
115: Flexible insulated duct work was utilized. The duct work was in satisfactory condition where visible.

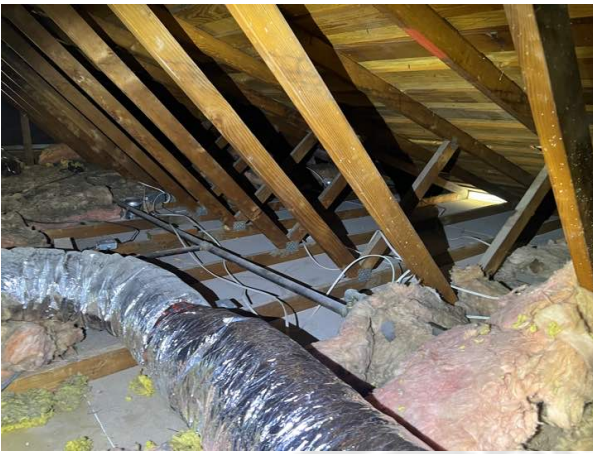
SAF 116: Asbestos like materials were noted at register heads. These materials were commonly used during the time of construction. It is highly recommended that the air distribution lines be tested for asbestos content prior to the close of escrow. Client should consider the cost of upgrades. Consult with a licensed HVAC contractor for full evaluation and cost of encapsulation or other resolution.

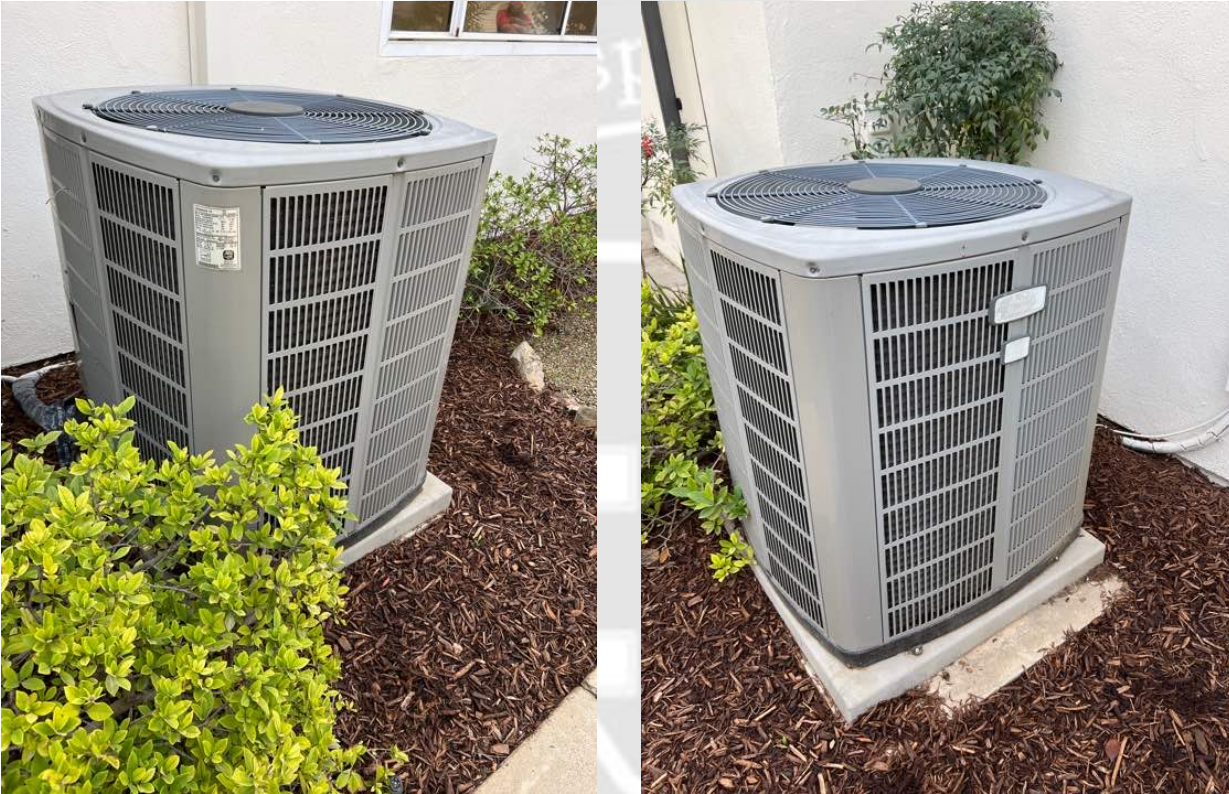
REP 118: The air conditioning system did not respond to thermostat controls properly for testing. This may be the result of cold ambient temperatures on the day of inspection. Air-conditioning system is nearing the end of its life expectancy. Client should consult with a licensed HVAC contractor for cost of upgrades.

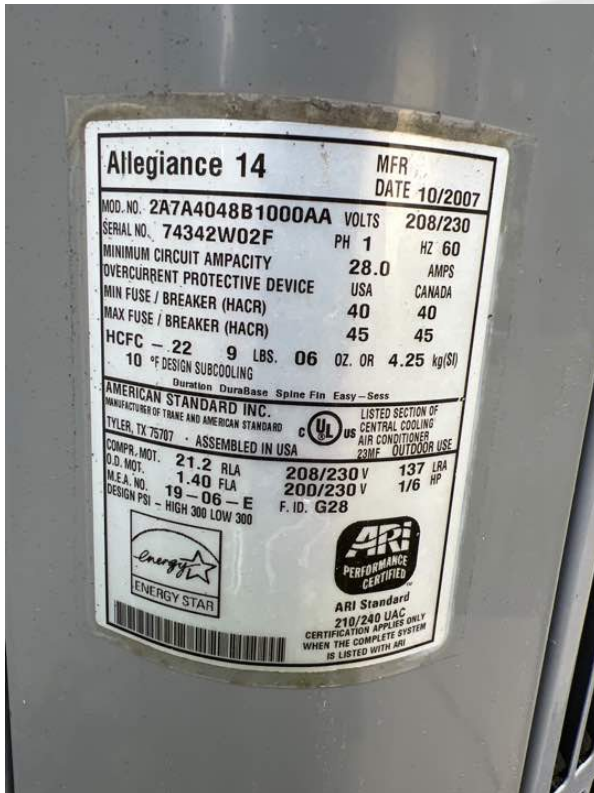
REP 119: The EPA has mandated that all refrigerant manufactures cease in the distribution of R-22 refrigerant. This refrigerant has been connected with O-Zone deterioration and will no longer be manufactured. While stockpiles of R-22 refrigerant may still be available for a few years following its discontinuation. It should be noted that repairing and servicing R-22 equipment will skyrocket. And may become cost prohibitive making said equipment obsolete. If the inspector has marked your equipment as a potential unit for R-22 refrigerant. It is vital that you speak with an HVAC contractor prior to the close of escrow to determine if your equipment is suitable for upgrade or replacement. Any air conditioner manufactured up until 2015 may have been charged or supplied with R-22 refrigerant.

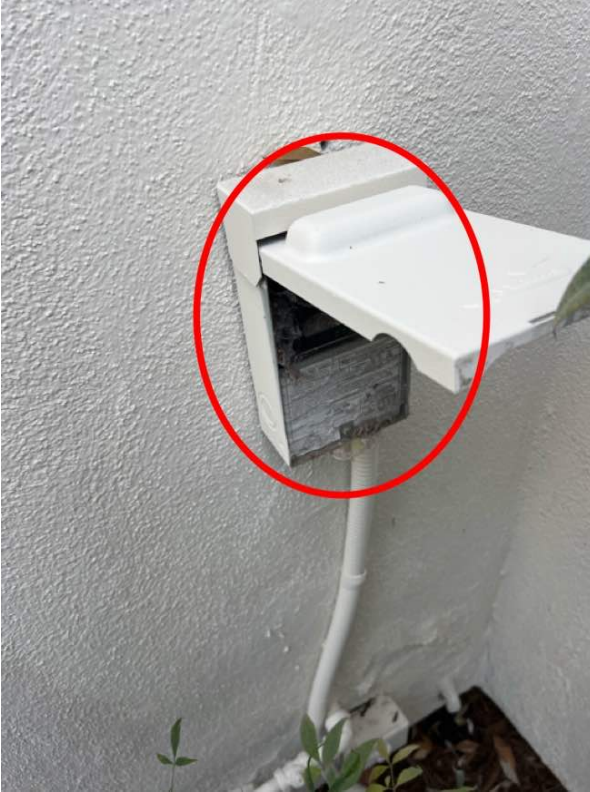
REP 120: The service disconnect should be properly sealed to the structure.

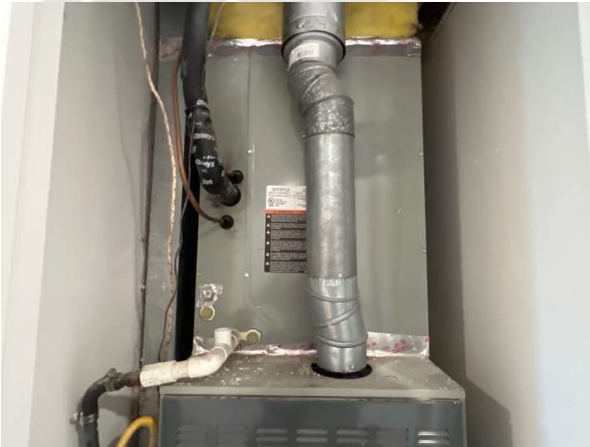
121: The evaporator was in satisfactory condition. There were no apparent signs of leaks on the day of inspection.

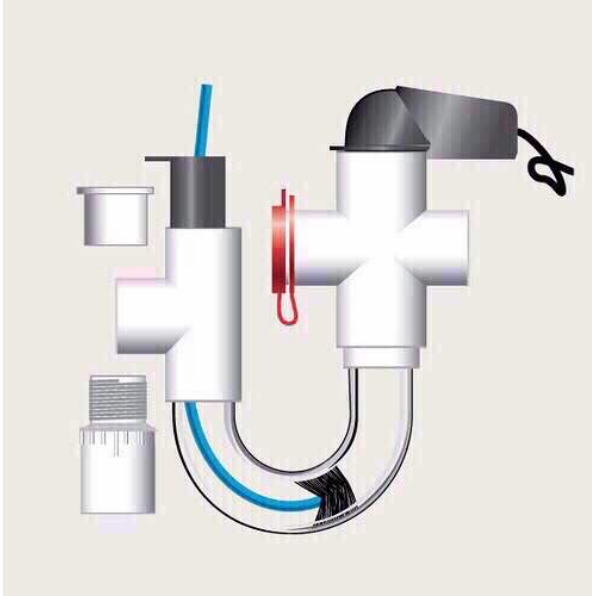
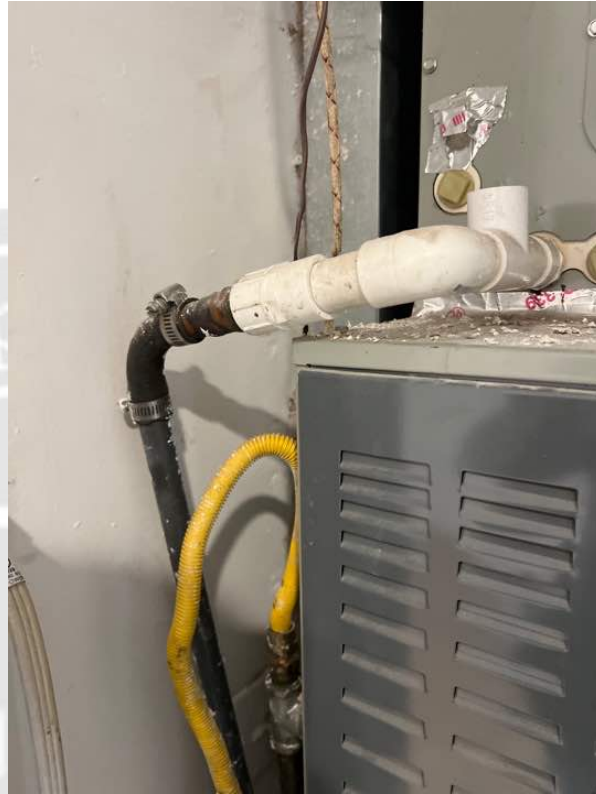
REP 122: We recommend a suitable trap and cut off switch be installed at the evaporator. Consult with an HVAC contractor for installation.

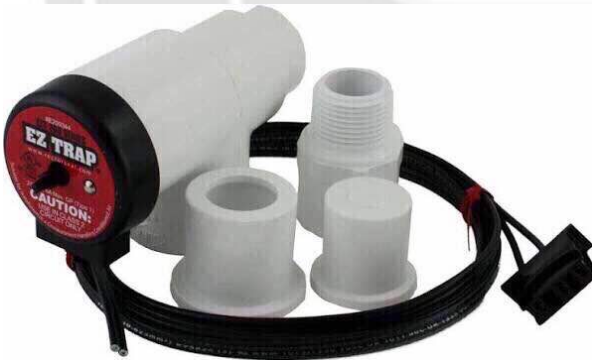
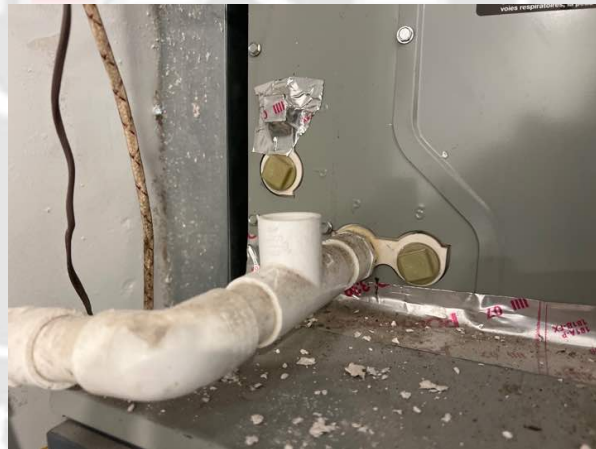
WARN 123: No condensation cut off switch present. Condensation cut off switches are a modern safety device to help prevent water damage in the event of a clog in the condensation lines. Client is encouraged to speak with a licensed HVAC contractor for installation.

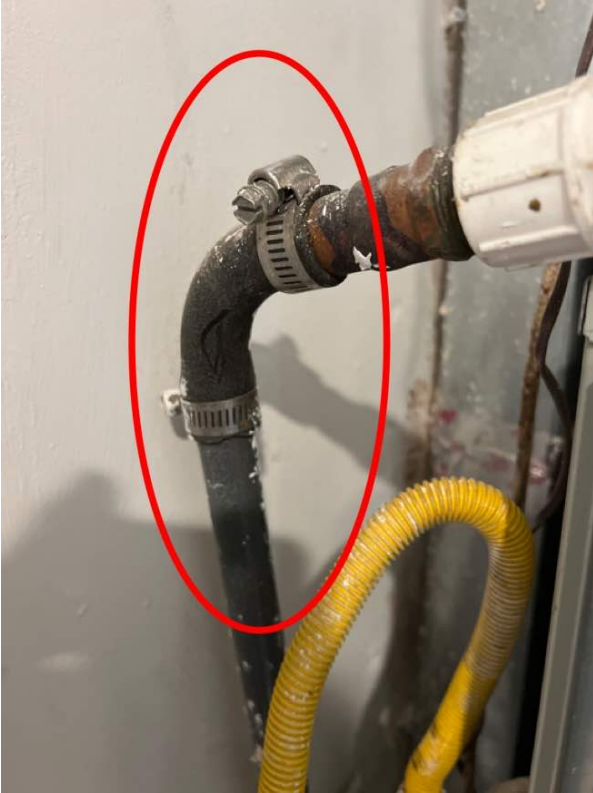
REP 124: Condensation drain line materials are inconsistent with common construction methods used for condensation drain lines. This can lead to future clogs and leaks. Consult with an HVAC contractor for further evaluation and repair.

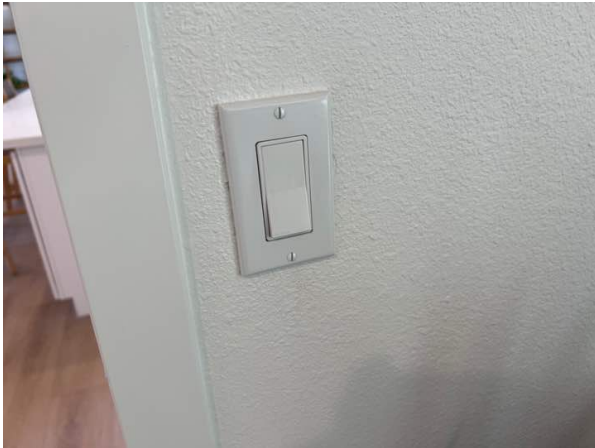
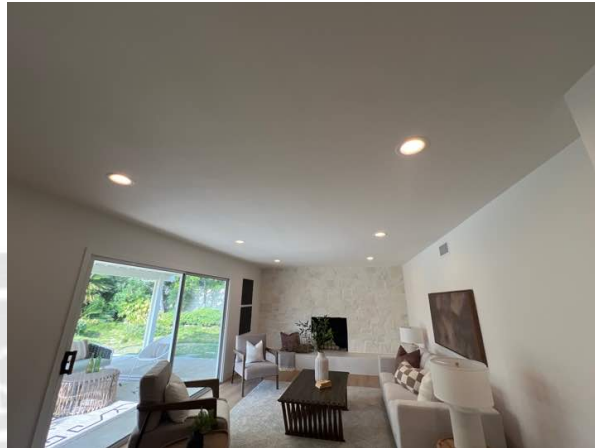
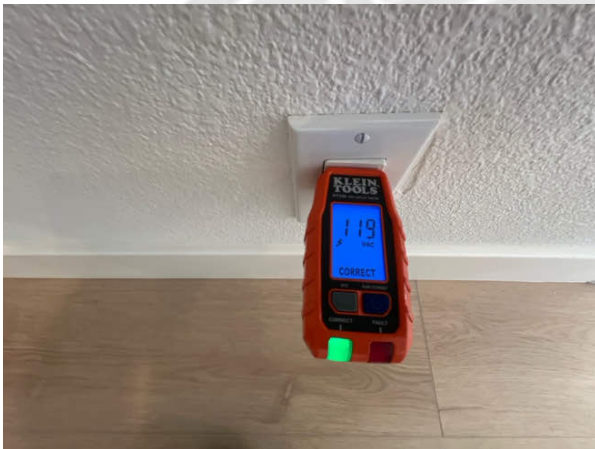
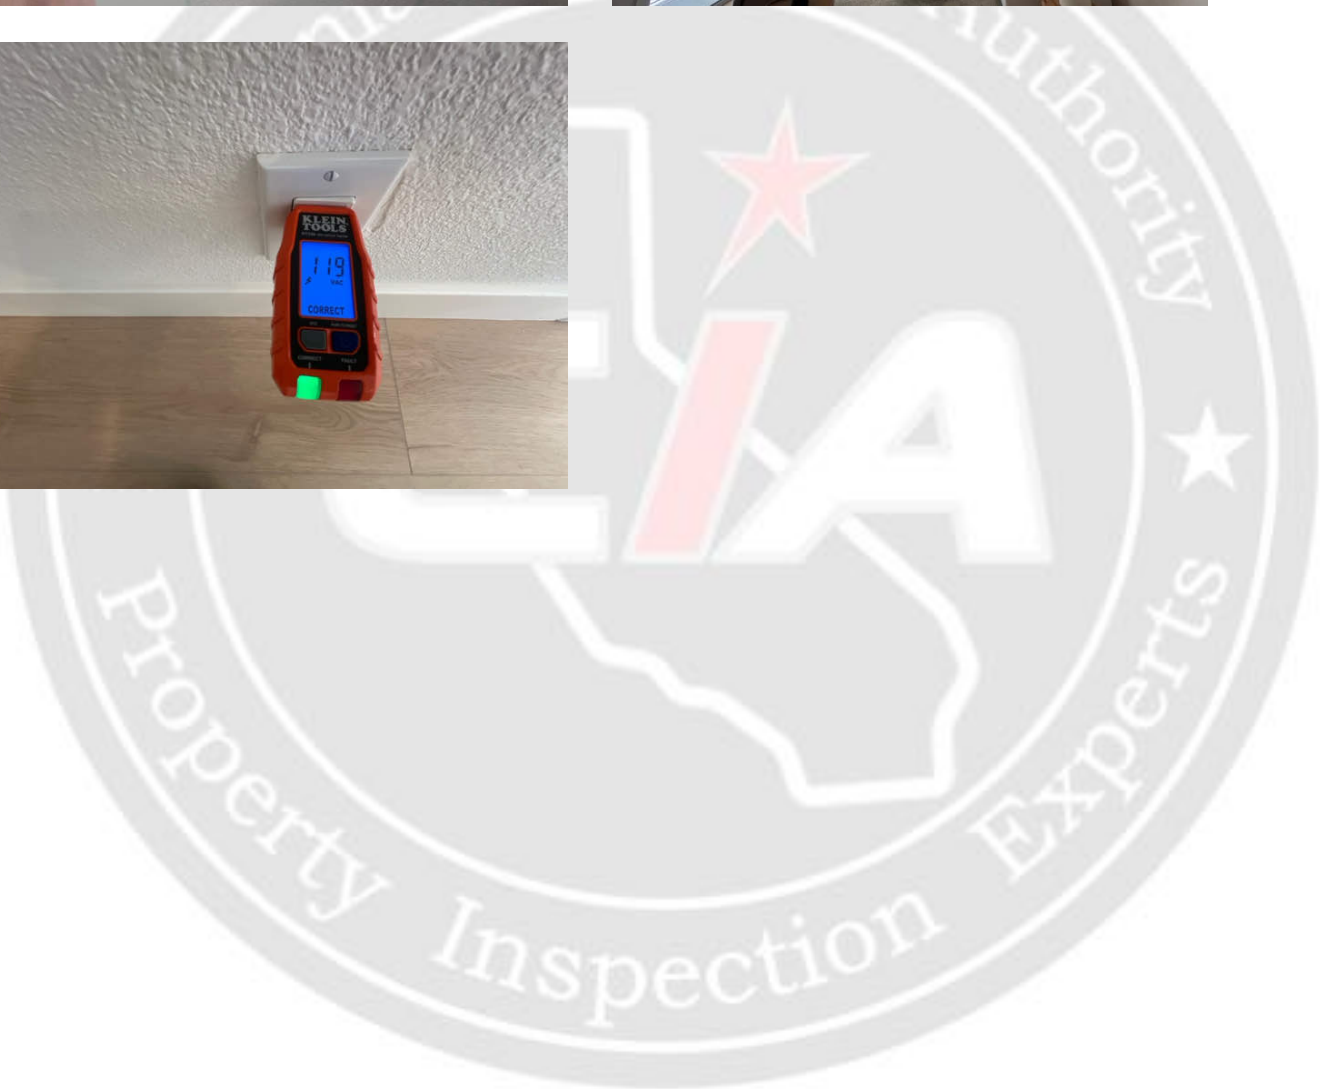
FAMILY ROOM OUTLETS LIGHTS AND SWITCHES

133: Plugs lights and switches were satisfactory throughout.

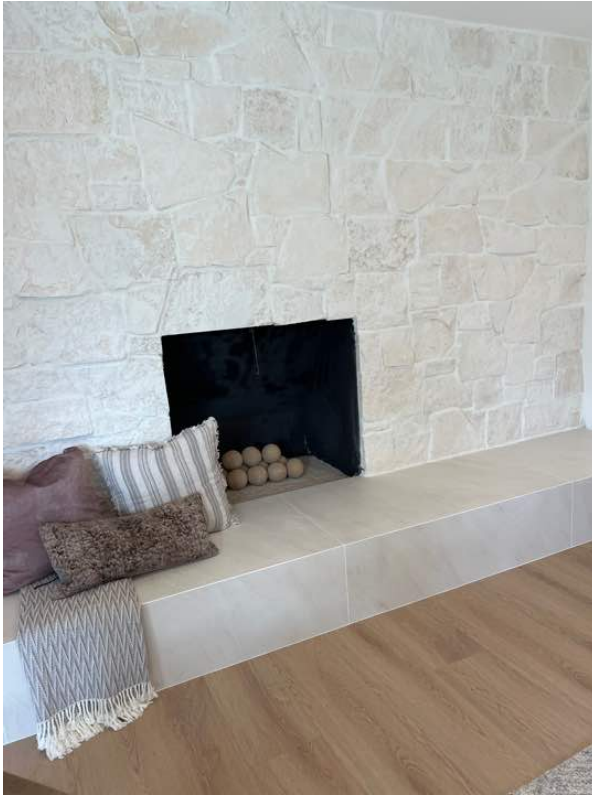
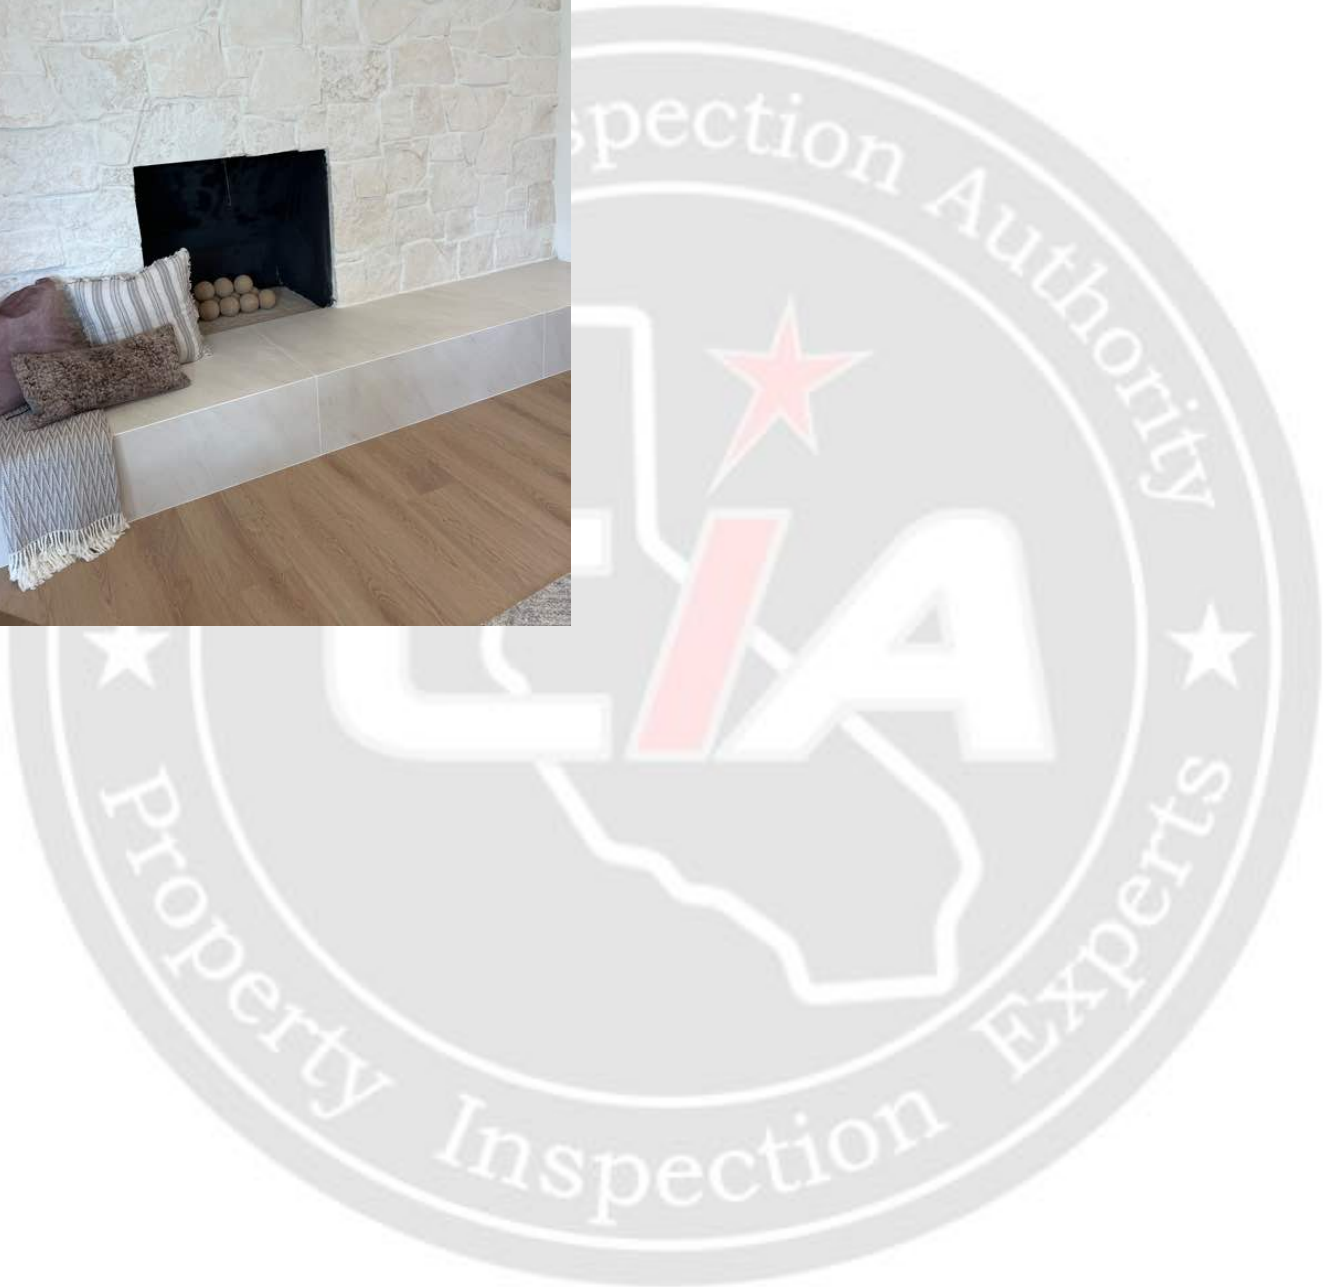
FIREPLACE FIREPLACE LOCATION

134: Family room.

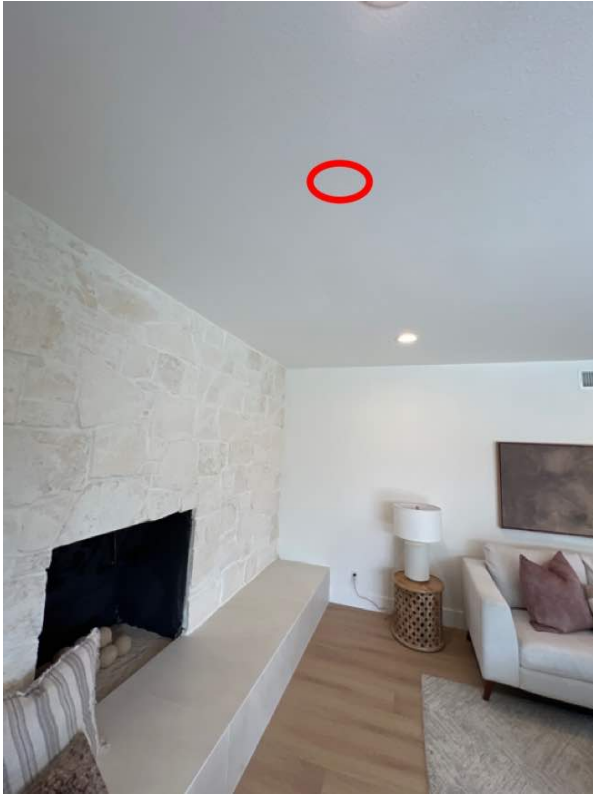
FIREPLACE DETECTORS

SAF 135: Combination/smoke and carbon monoxide detectors are recommended in rooms that have installed fireplaces. Detectors will function as an early warning device in the event of a fireplace with drafting issues.

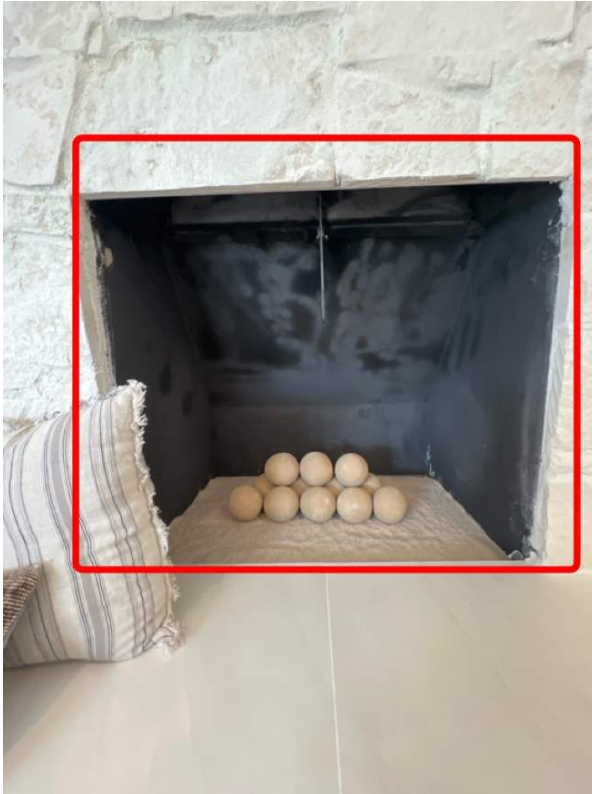
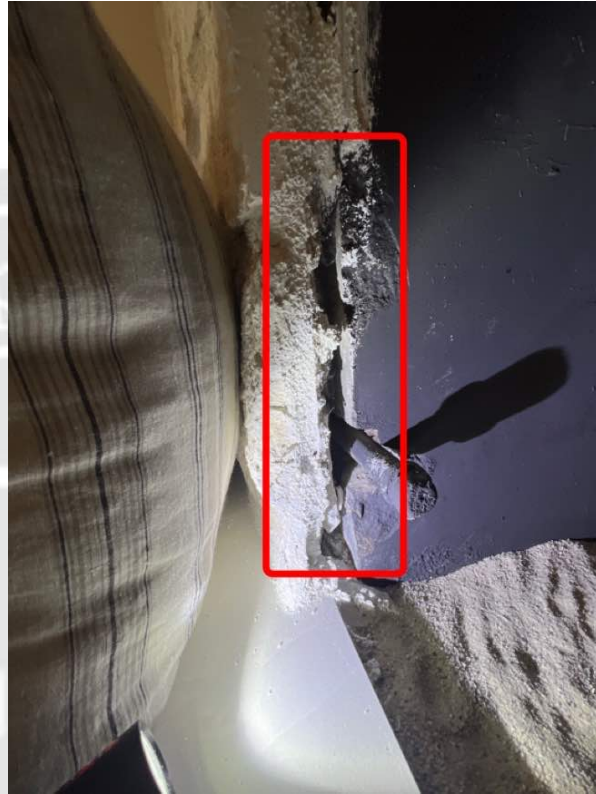
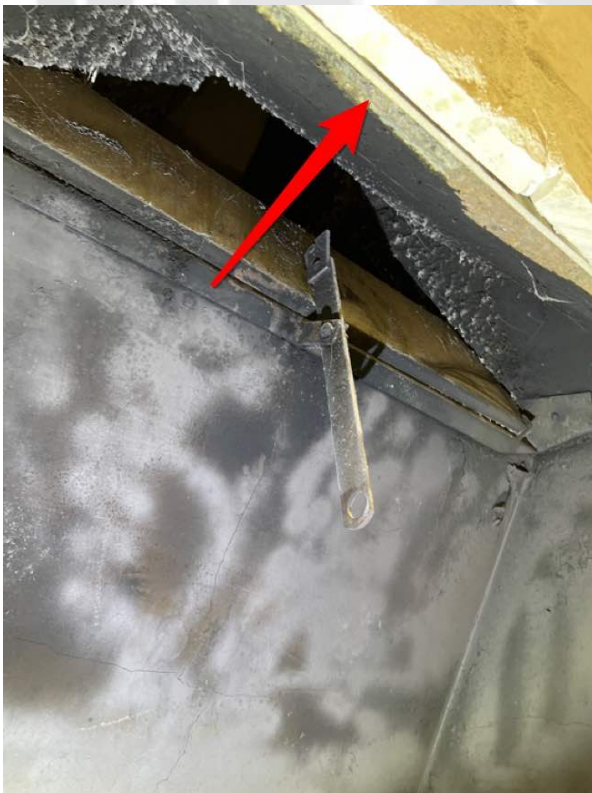
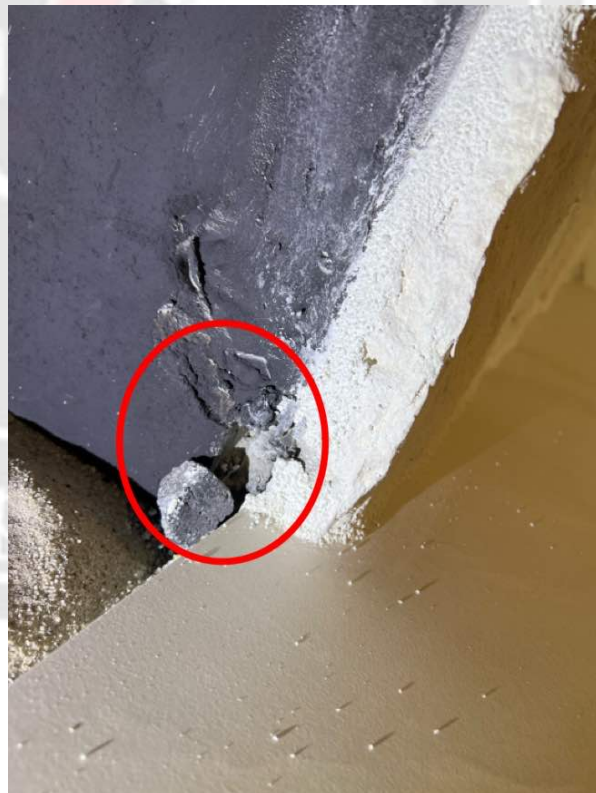
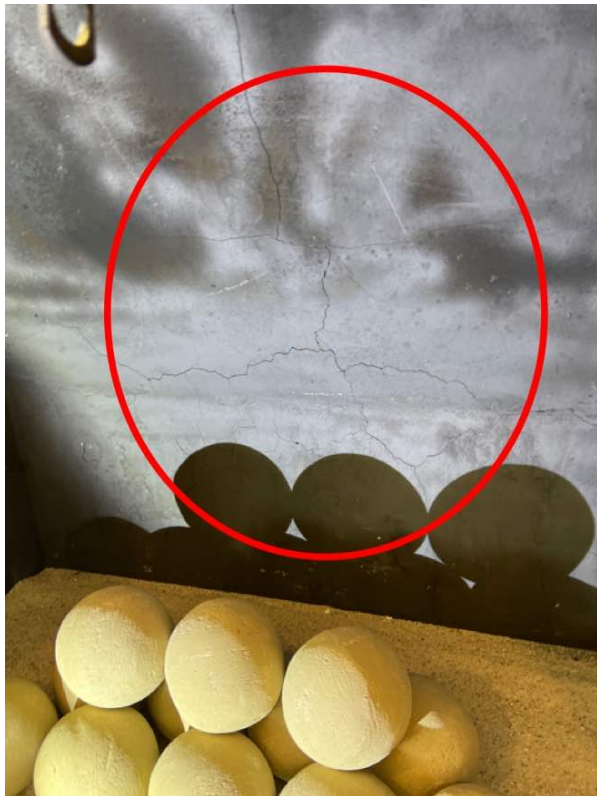
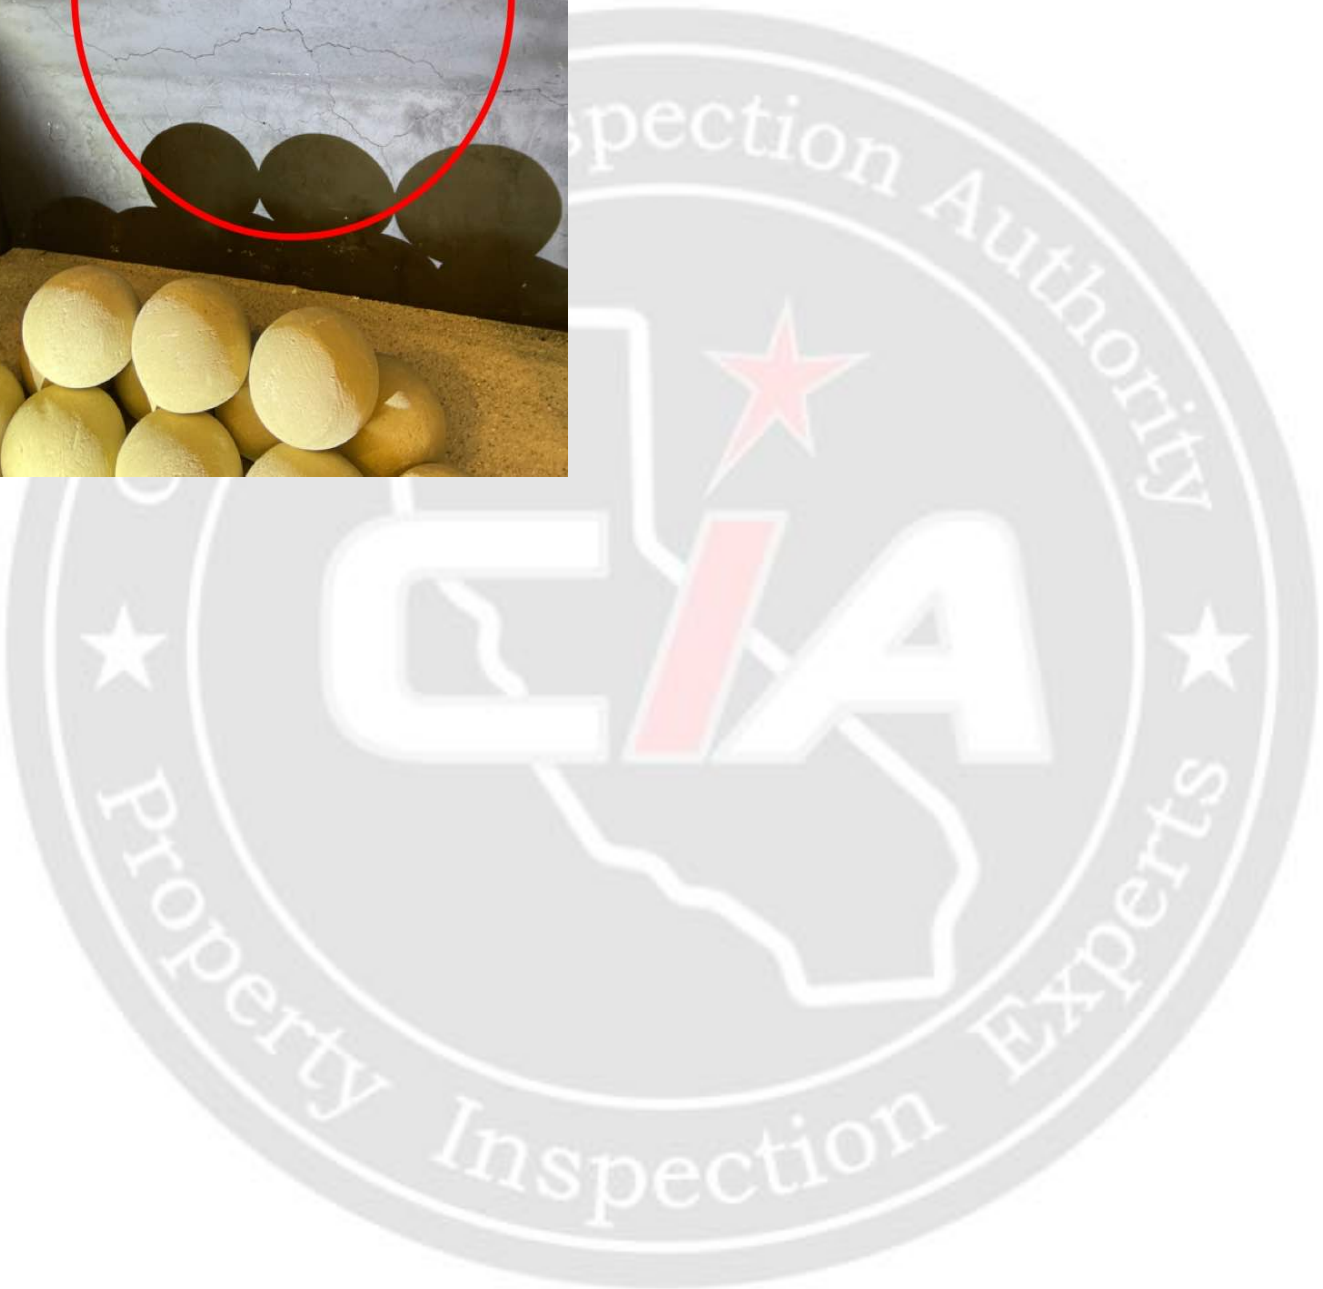
FIREPLACE GENERAL CONDITIONS

SAF 136: Signs of alterations were made at the fireplace opening. The fireplace should not be used until a level two evaluation of the firebox has been made. Numerous hairline cracks were noted in the firebox. Fire and light safety concern.

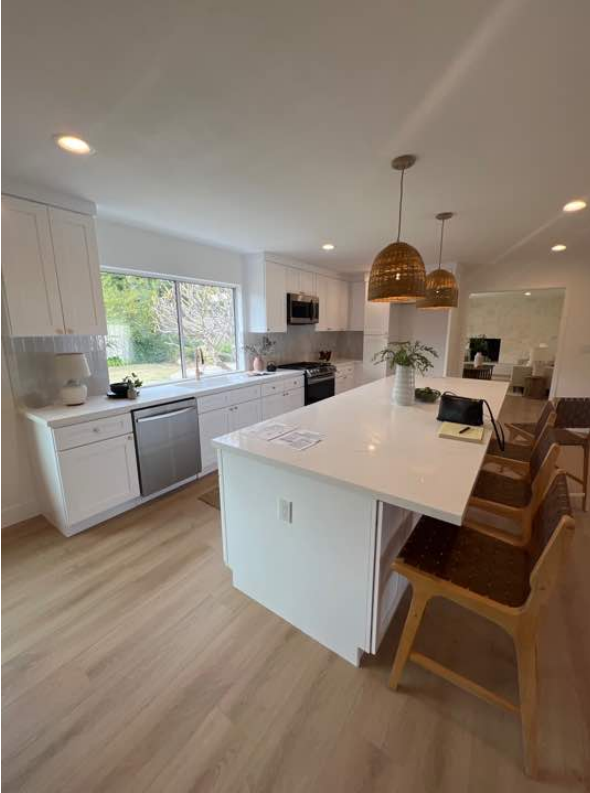
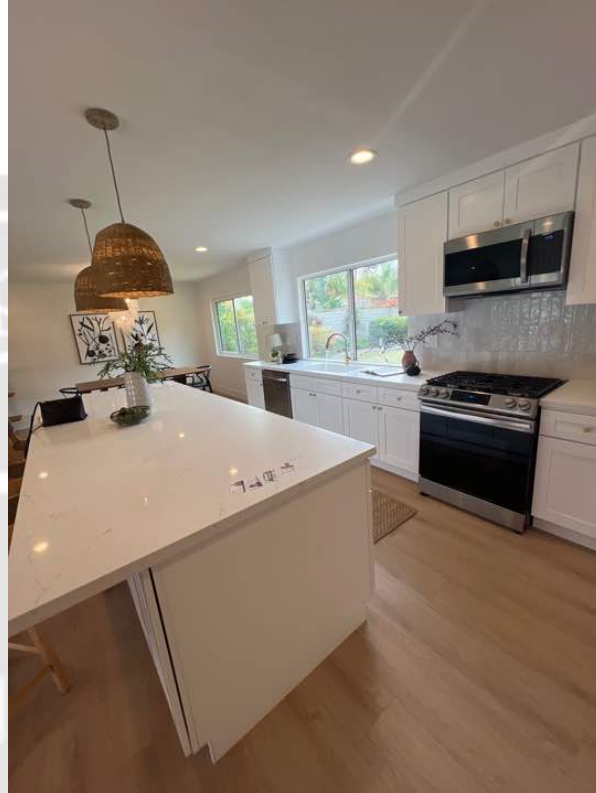
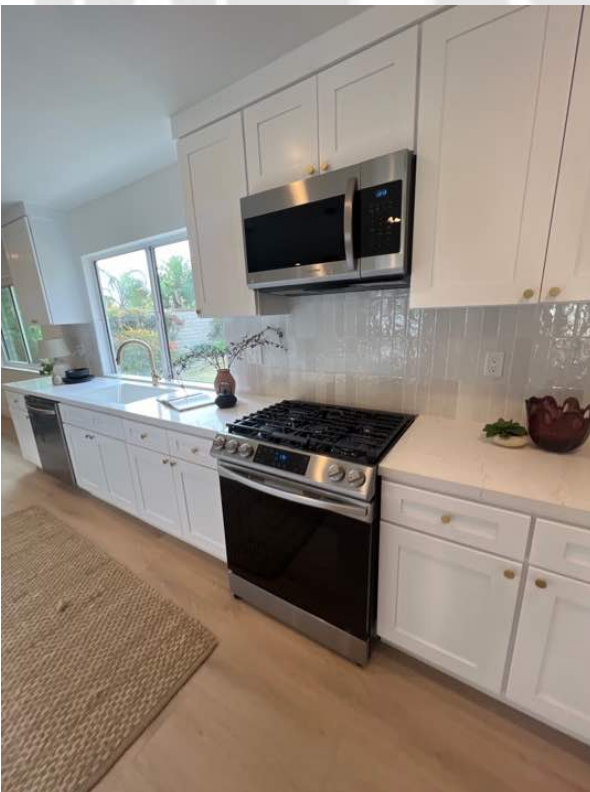
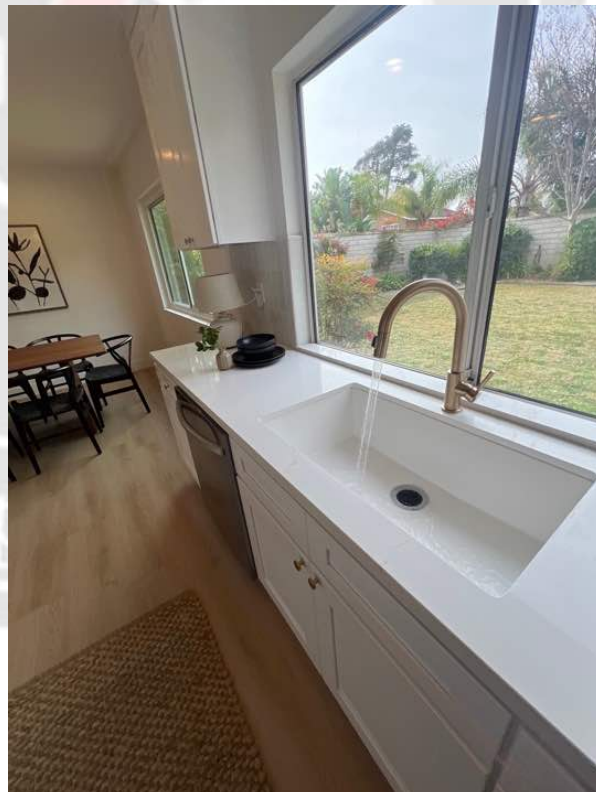
KITCHEN WALLS - CEILING - FLOOR GENERAL CONDITION

137: Floor, walls and ceiling in the kitchen area were in satisfactory condition overall.
