Inspection Report

Lynridge Dr
Yorba Linda, California
92886

Inspected By
David Salvato
California Inspection Authority INC.
(949) 981-8320
CIAHomeInspection@gmail.com
Inspecting The Finest Homes In California
www.CIAHomeInspection.com

Wednesday
December 27, 2023

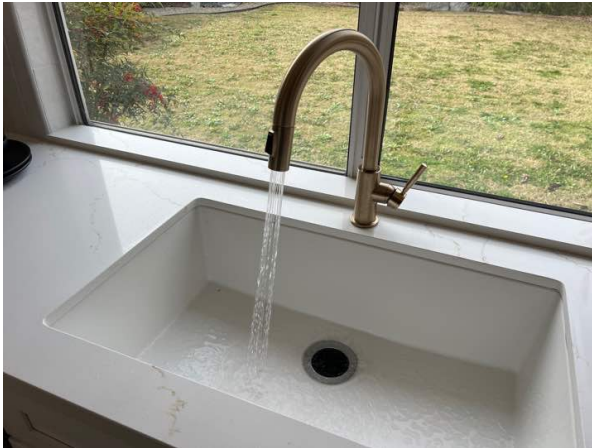
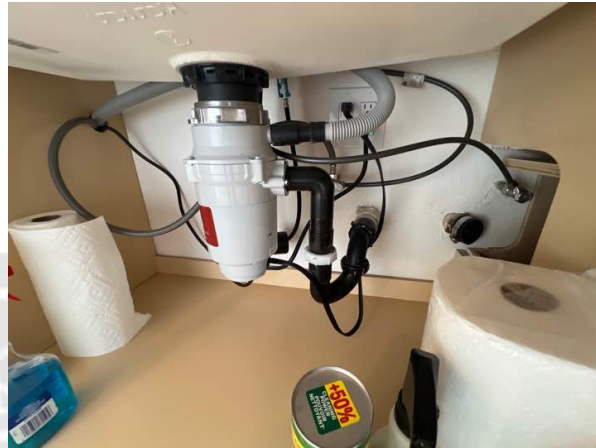
KITCHEN SINK - COUNTER TOPS SINK PLUMBING CONDITIONS

138: The kitchen sink was in satisfactory condition. Faucet was functional.

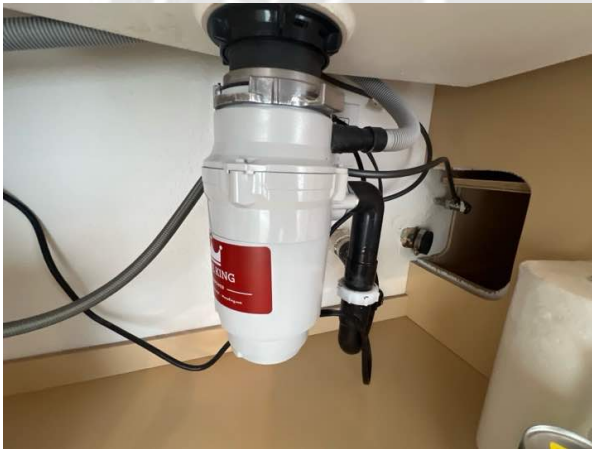
KITCHEN SINK - COUNTER TOPS GARBAGE DISPOSAL

139: The garbage disposal was in satisfactory condition.

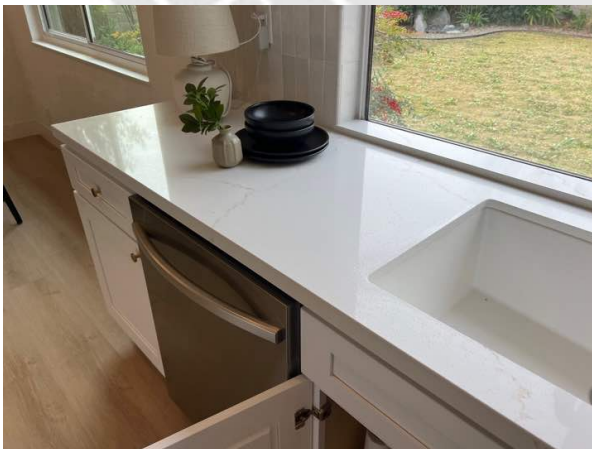
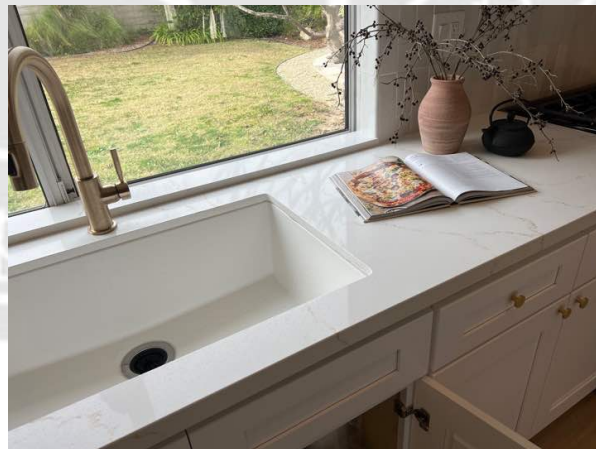
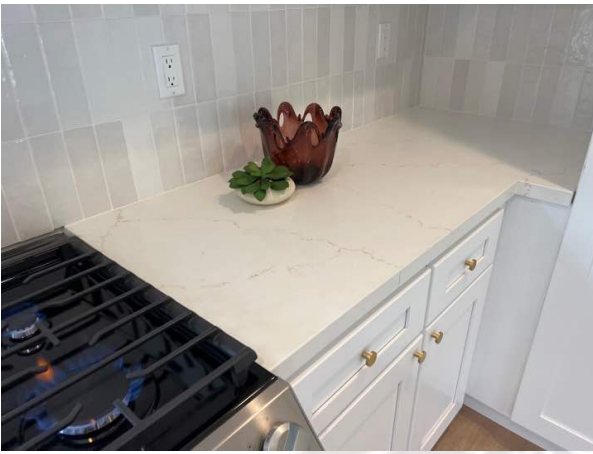
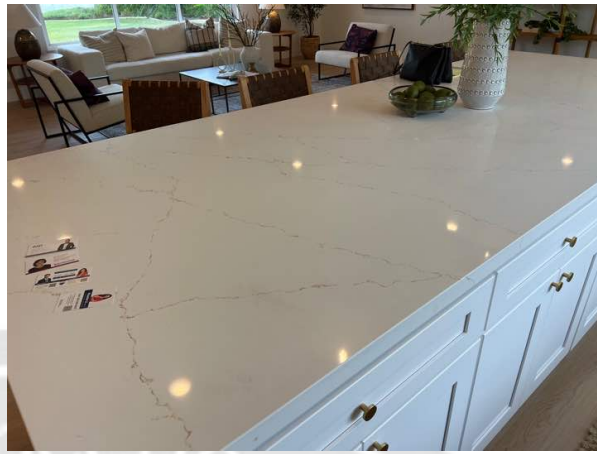
KITCHEN SINK - COUNTER TOPS COUNTER CONDITIONS

140: Quartz countertops were in satisfactory condition and professionally finish the edges and seams.

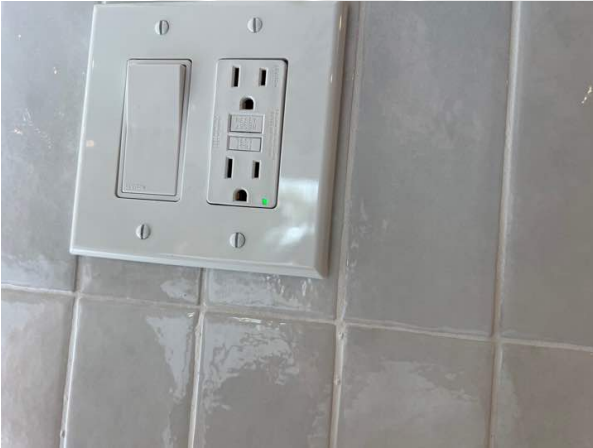
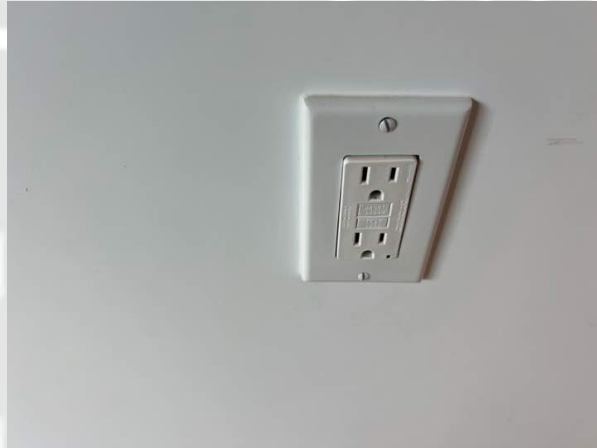
ELECTRICAL CONDITIONS ELECTRICAL CONDITIONS

141: All GFCI receptacles were in satisfactory condition.

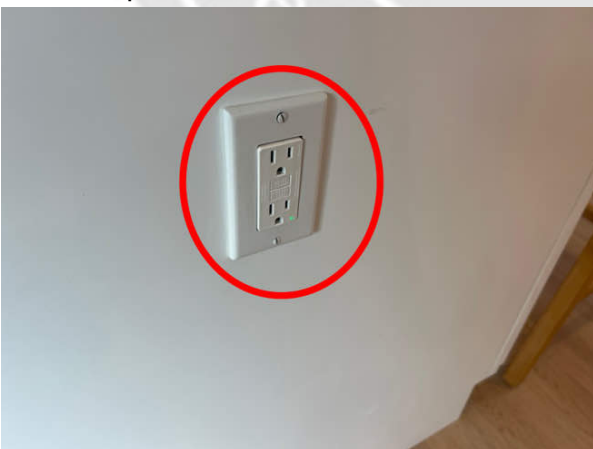
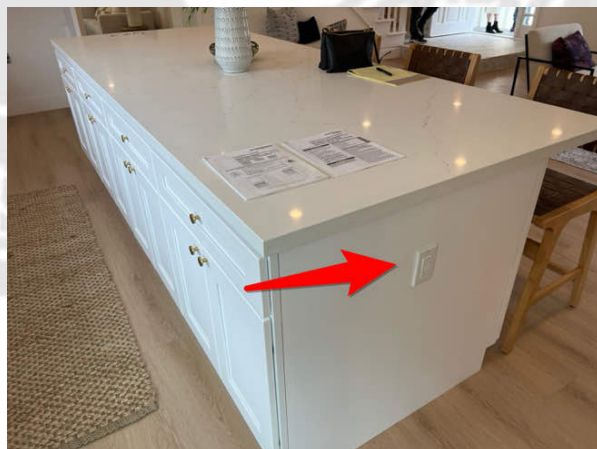
SAF 142: IF" receptacles are installed to serve an island or peninsular countertop or work surface, they must be installed in accordance with the rules in Section 210.52(C)(3) below:

Installed on or above the countertop or work surface, but not higher than 20 inches above the countertop or work surface. Installed in a countertop using receptacle assemblies listed for use in countertops.

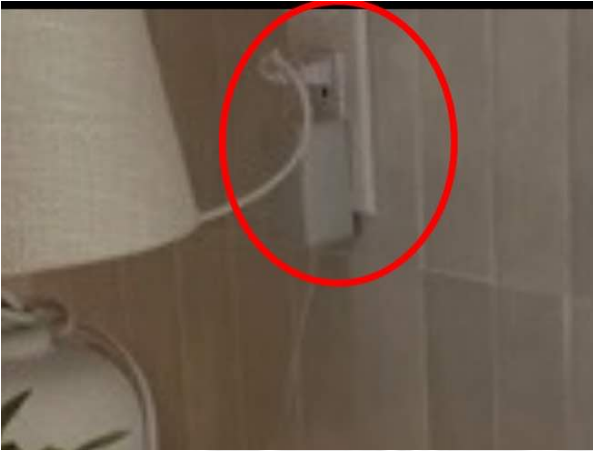
REP 143: Countertop receptacle was loosely installed in the wall. Repair needed.

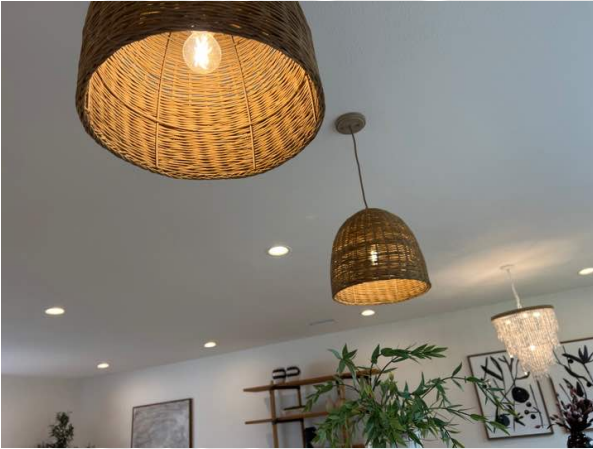
ELECTRICAL CONDITIONS LIGHTING CONDITIONS

144: Kitchen lighting was satisfactory.

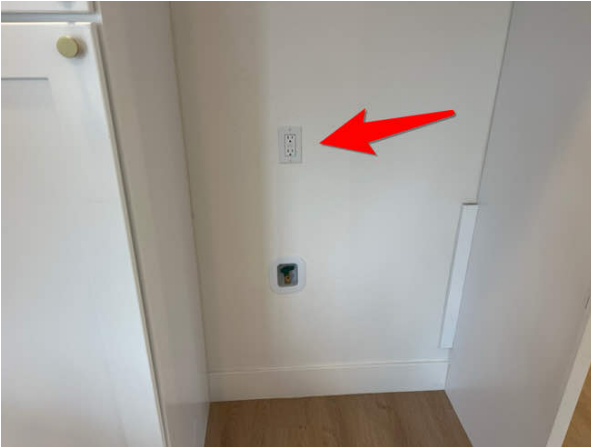
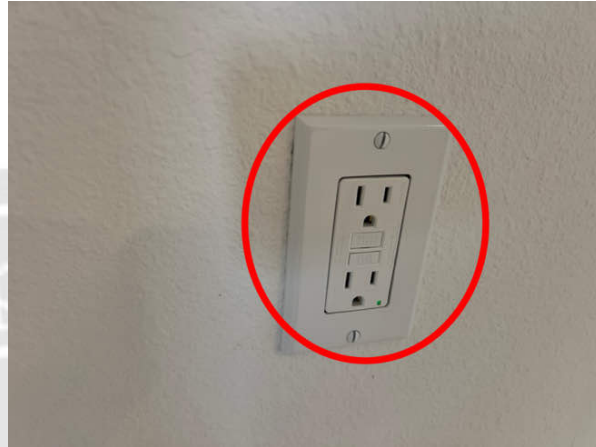
APPLIANCES REFRIGERATOR

REP 145: GFCI receptacle located behind refrigerator. All GFCI receptacles should be installed in a readily accessible location. Having to remove an appliances to reset a GFCI does not make it readily accessible. Consult with a licensed electrician for relocation.

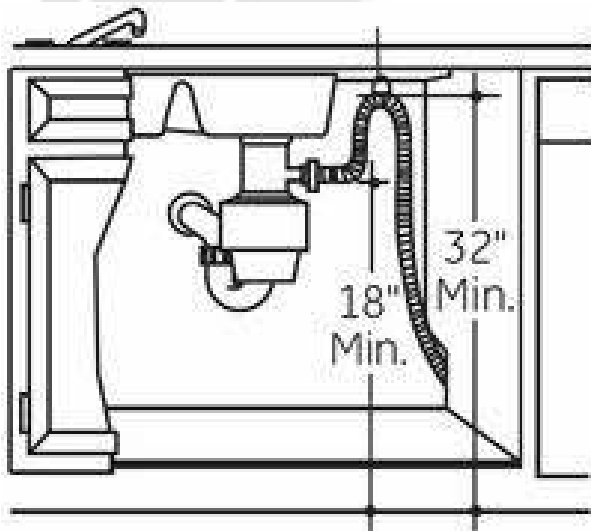
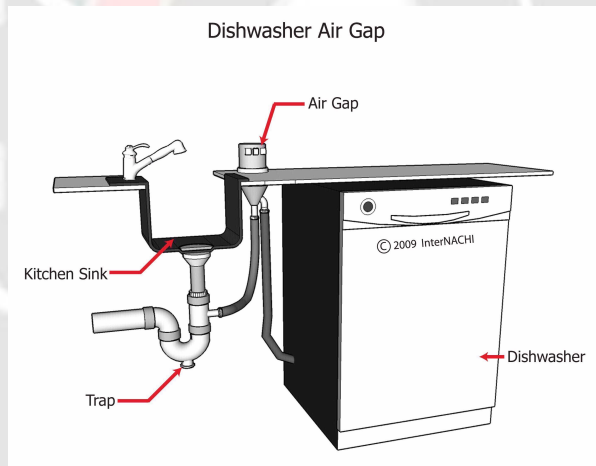
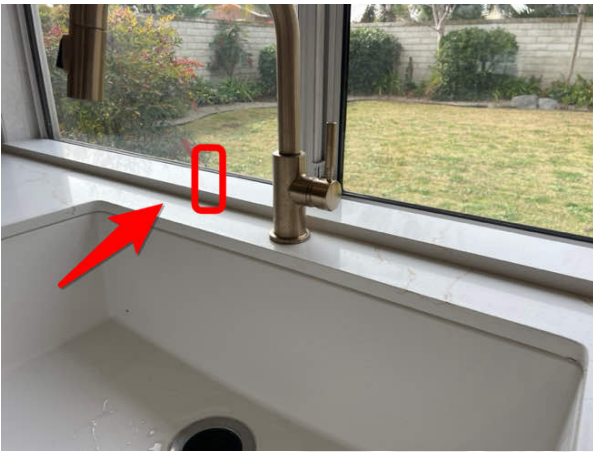
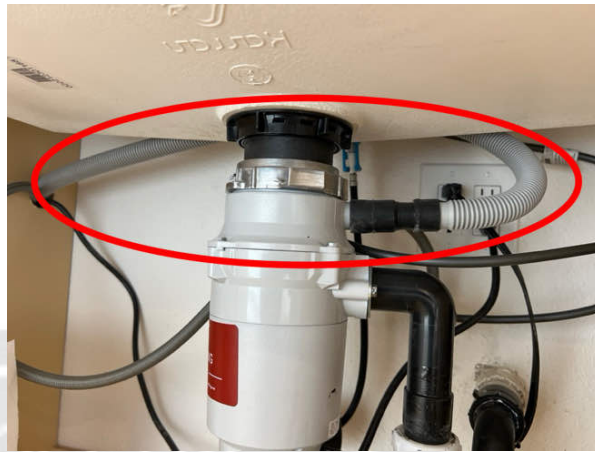
APPLIANCES DISHWASHER

REP 146: The dishwasher was not properly connected to an approved air gap. This can allow bacteria from the garbage disposal to be flushed back into the dishwasher and contaminate dishes. Dishwasher drain line is not configured in a high loop orientation. Consult with a plumbing contractor for proper installation of an approved air gap.

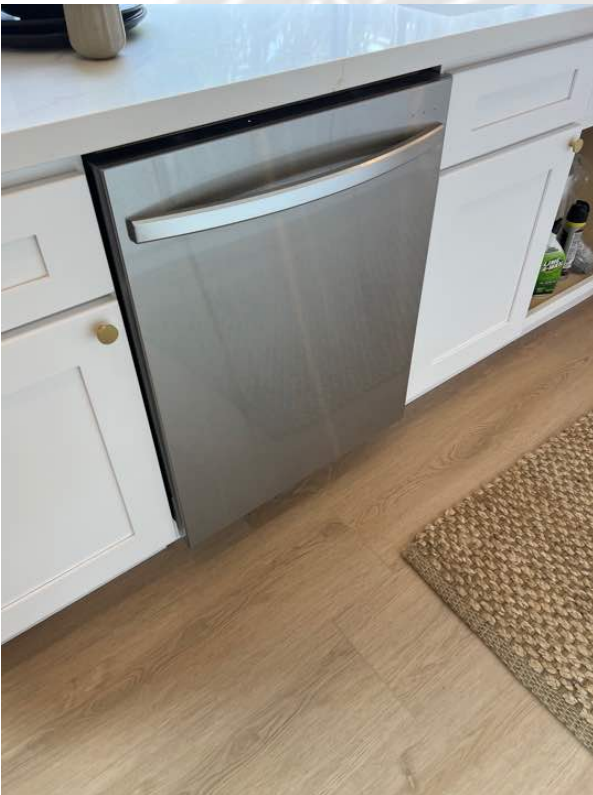
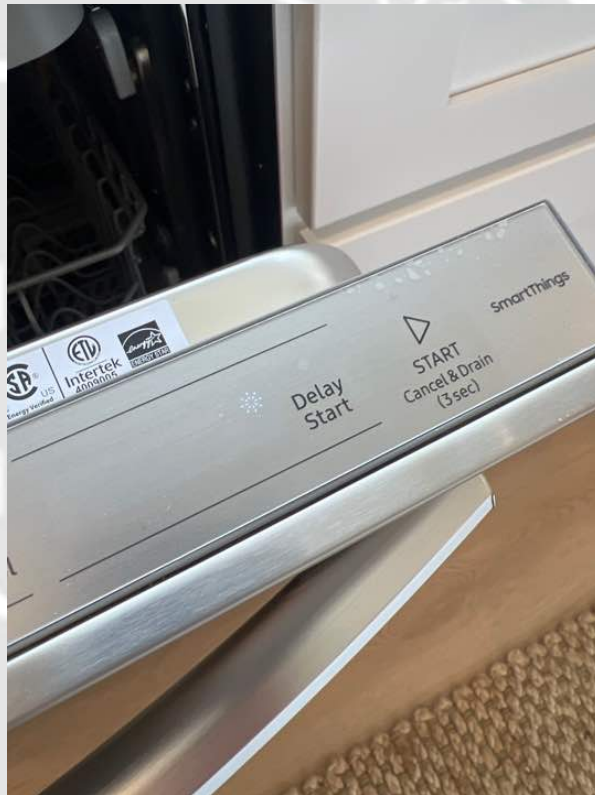
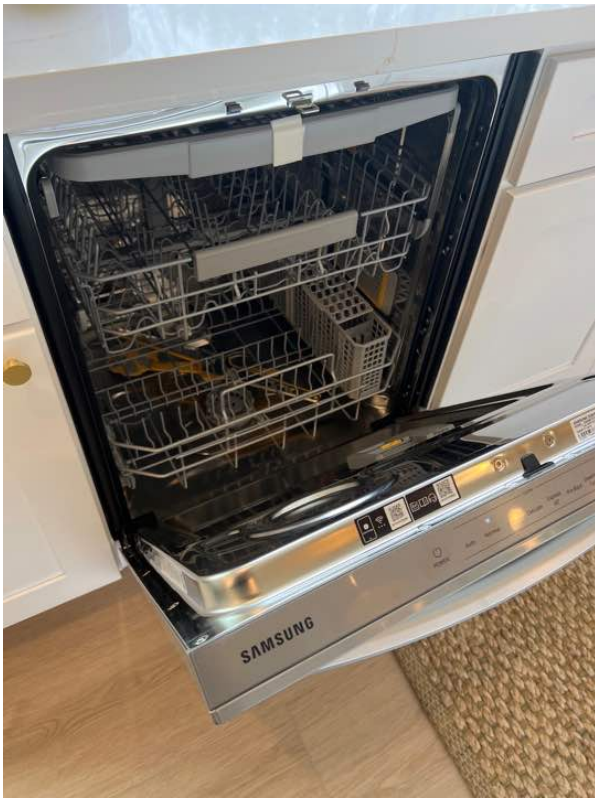
REP 147: Dishwasher did not respond normally to testing controls. Consult with an appliance repairman for further evaluation and recommendations.

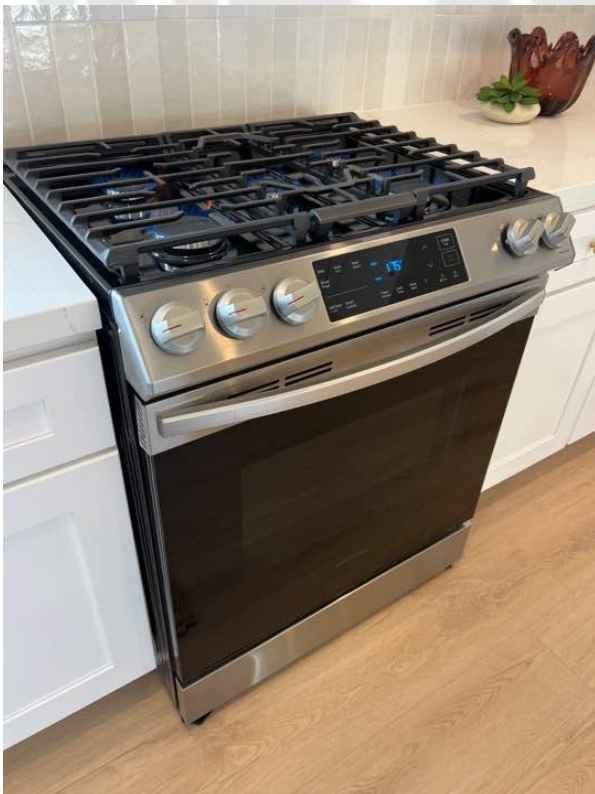
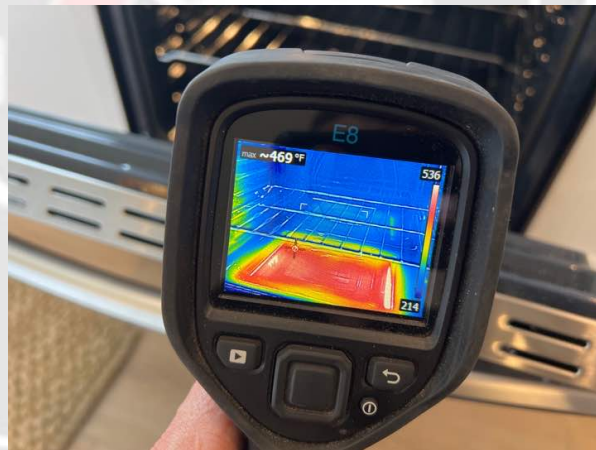
APPLIANCES RANGE

148: The range was thoroughly tested. Temperatures were satisfactory. The unit was found to be functional.

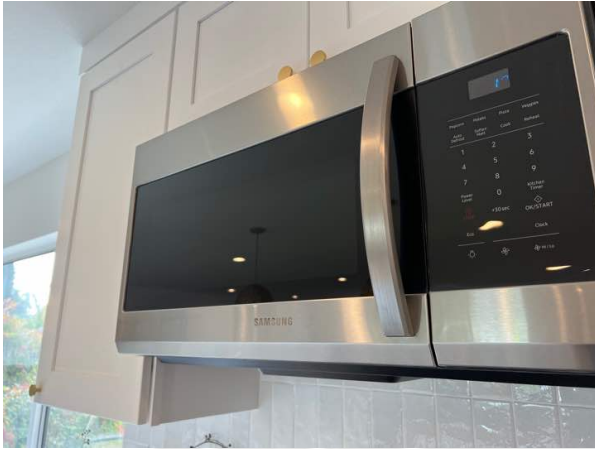
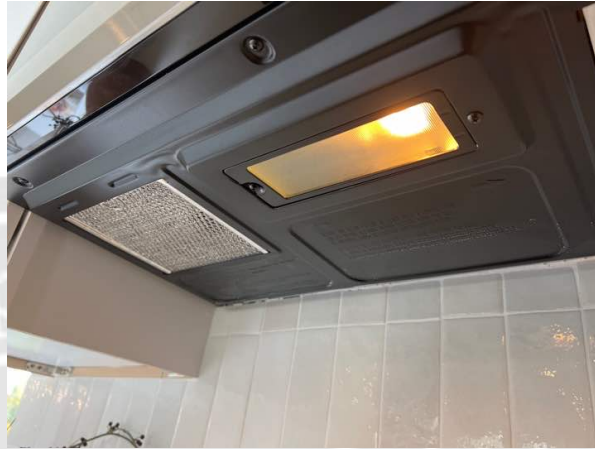
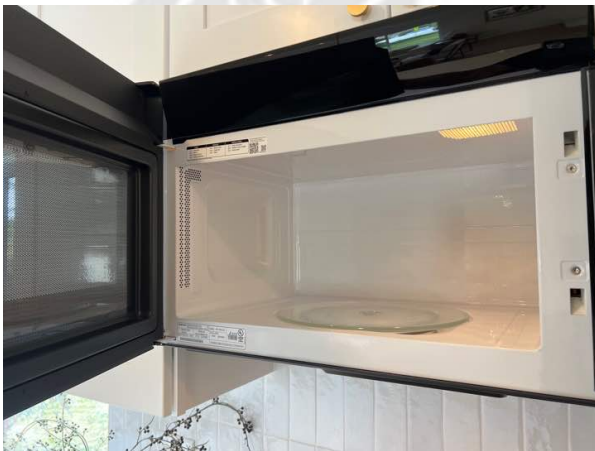
APPLIANCES MICROWAVE/VENT HOOD

149: The microwave/vent hood was tested and found to be functional on the day of inspection. Testing the microwaves ability to cook food or heat liquids is outside of the scope of the general home inspection. Microwave was not duct to the outside air.

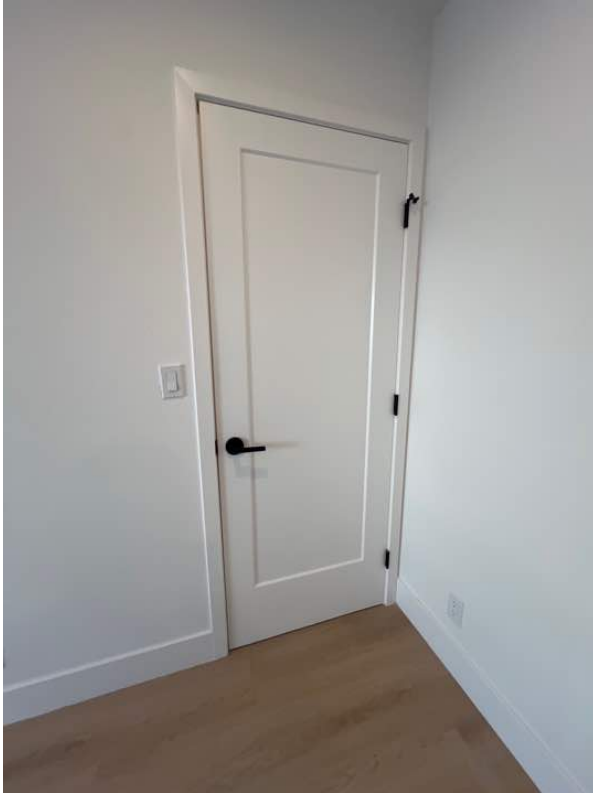
BEDROOM #1 PRIVACY DOOR

150: The door was in satisfactory condition.

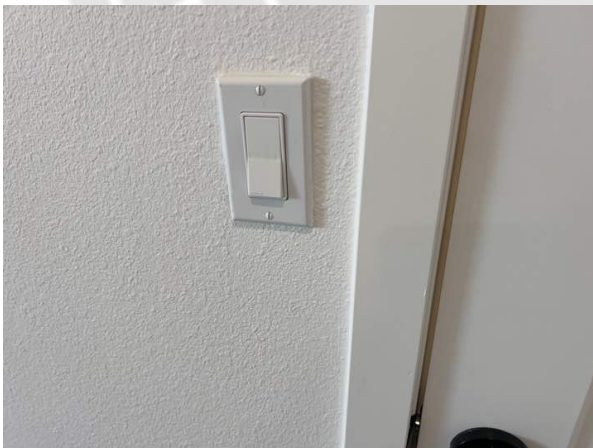
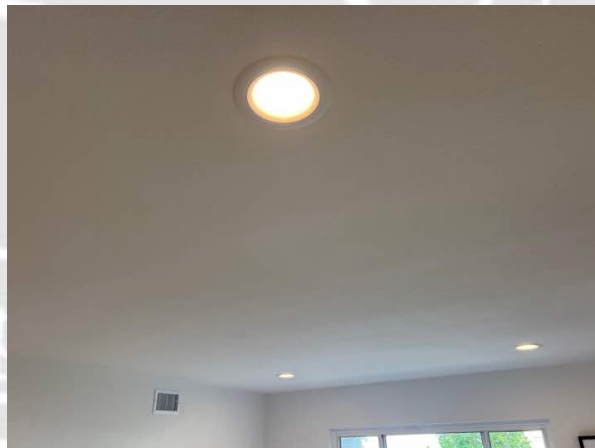
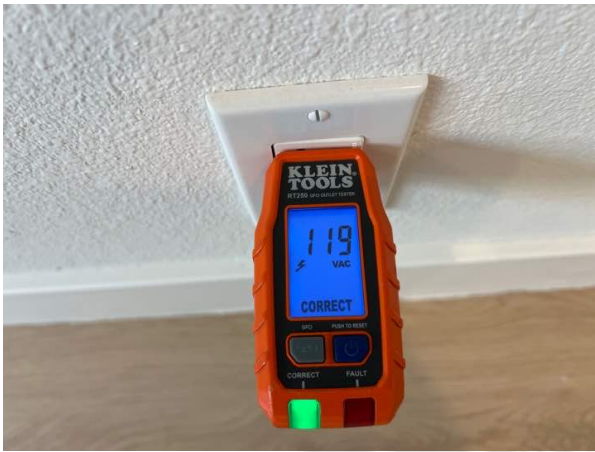
BEDROOM #1 OUTLETS LIGHTS AND SWITCHES

151: Plugs lights and switches were satisfactory throughout.

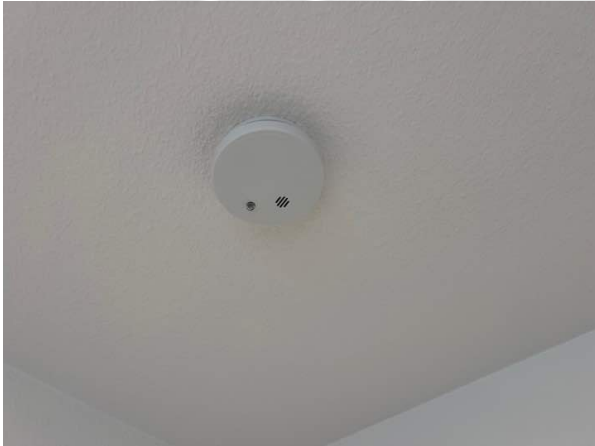
BEDROOM #1 SMOKE DETECTOR

152: Smoke detector present and functional.

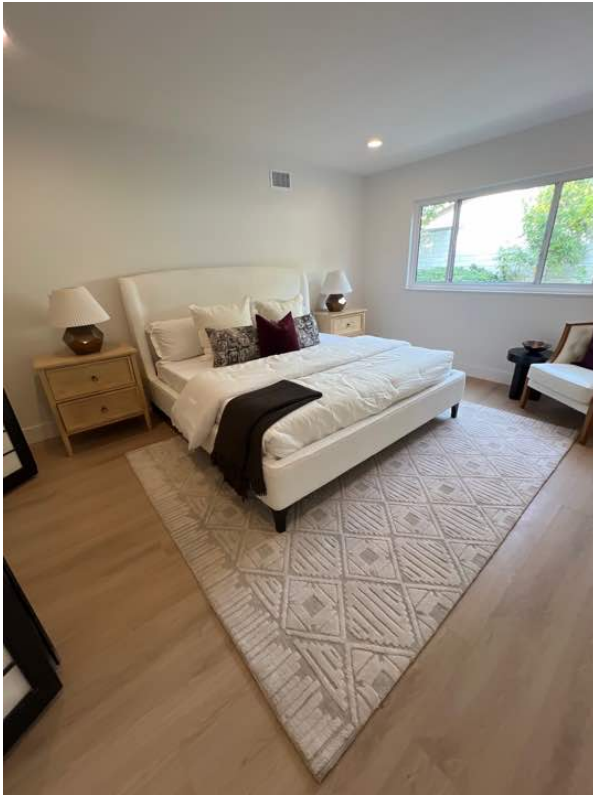
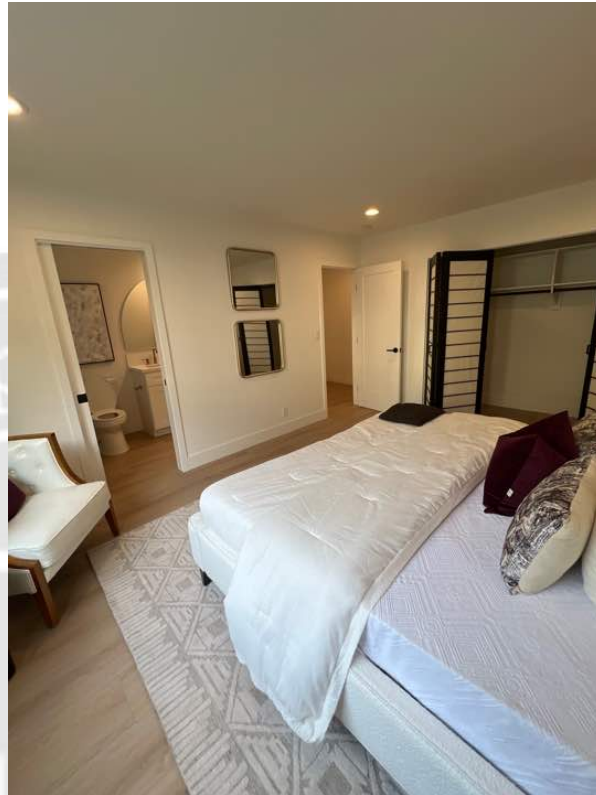
BEDROOM #1 GENERAL CONDITION

153: Bedroom was satisfactory.

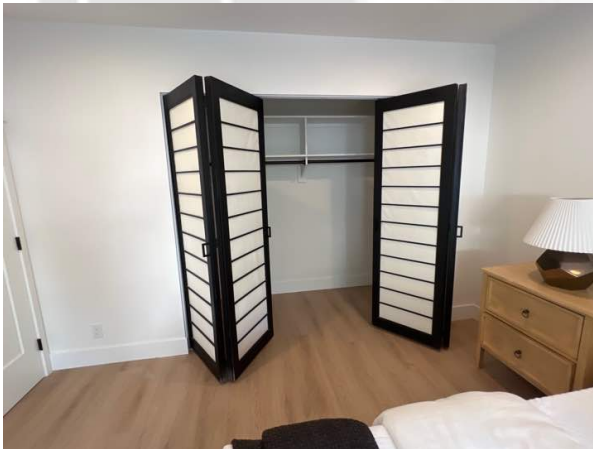
BEDROOM #1 WARDROBE DOORS

154: The door was in satisfactory condition.

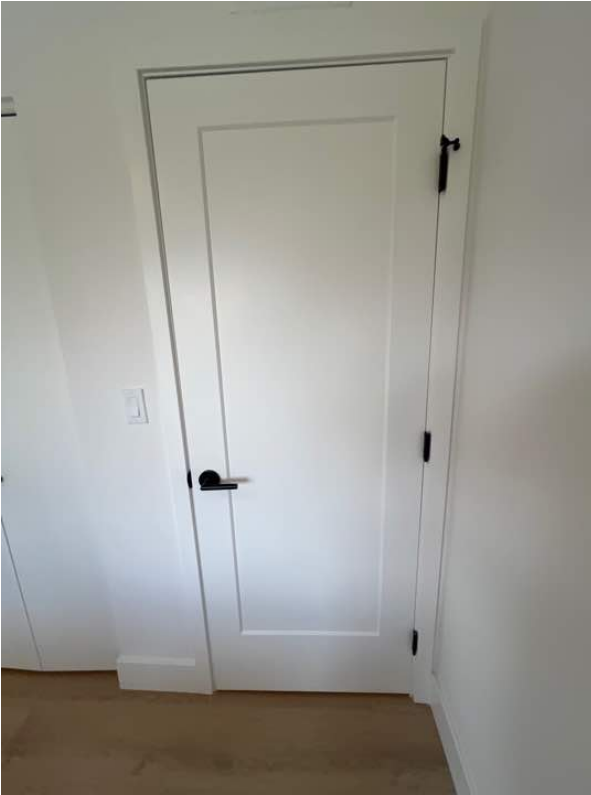
BEDROOM #1 PRIVACY DOOR

155: The door was in satisfactory condition.

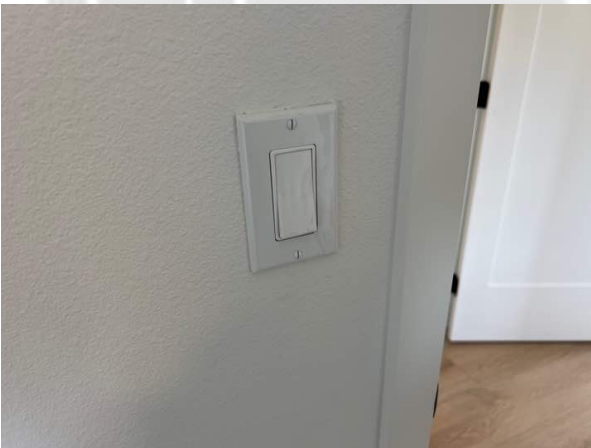
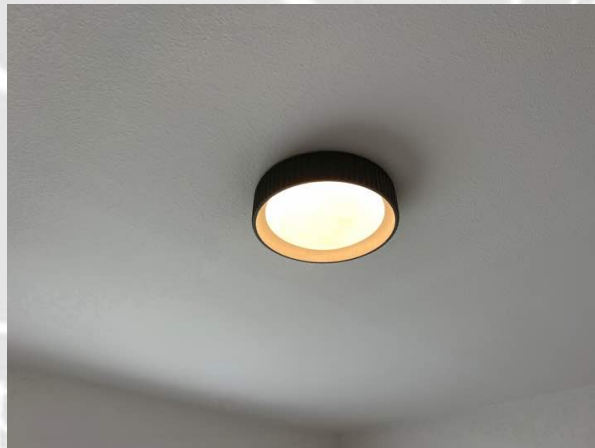
BEDROOM #1 OUTLETS LIGHTS AND SWITCHES

156: Plugs lights and switches were satisfactory throughout.

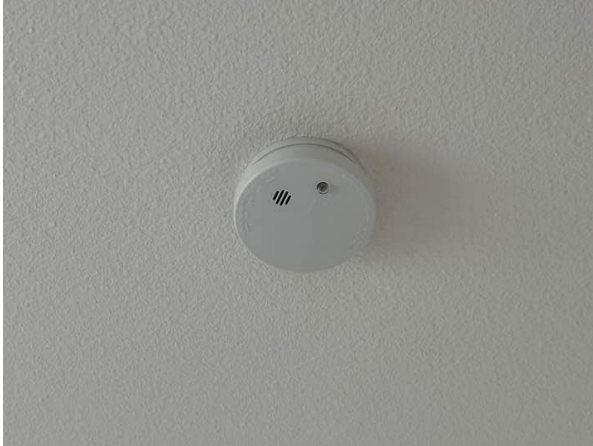
BEDROOM #1 SMOKE DETECTOR

157: Smoke detector present and functional.

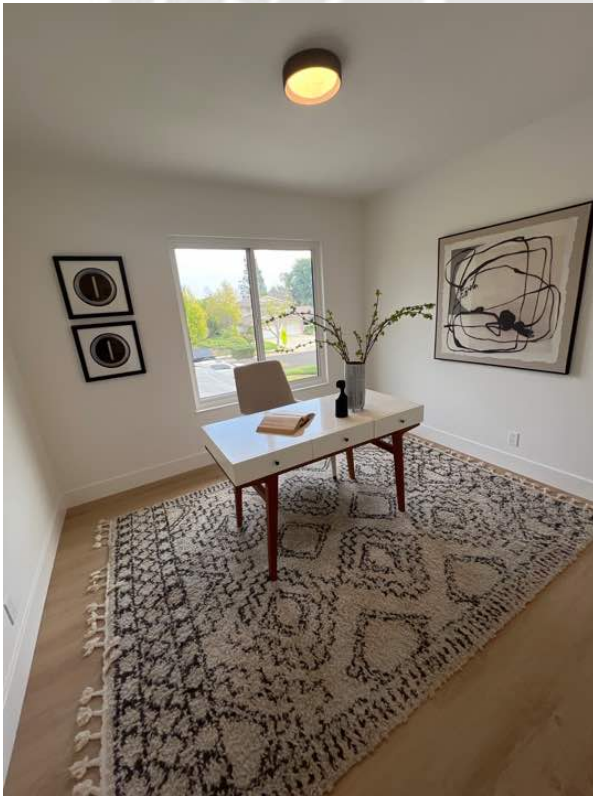
BEDROOM #1 GENERAL CONDITION

158: Bedroom was satisfactory.

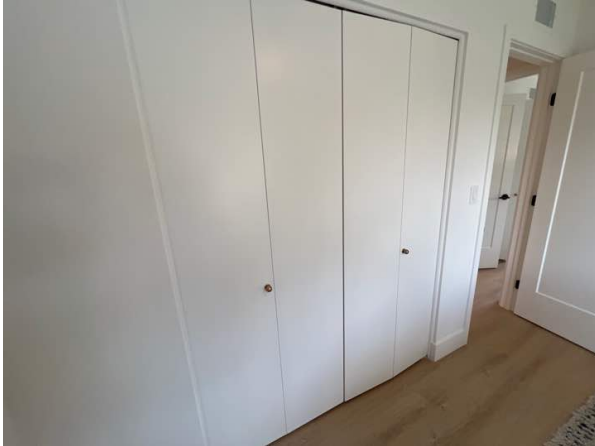
BEDROOM #1 WARDROBE DOORS

159: The door was in satisfactory condition.

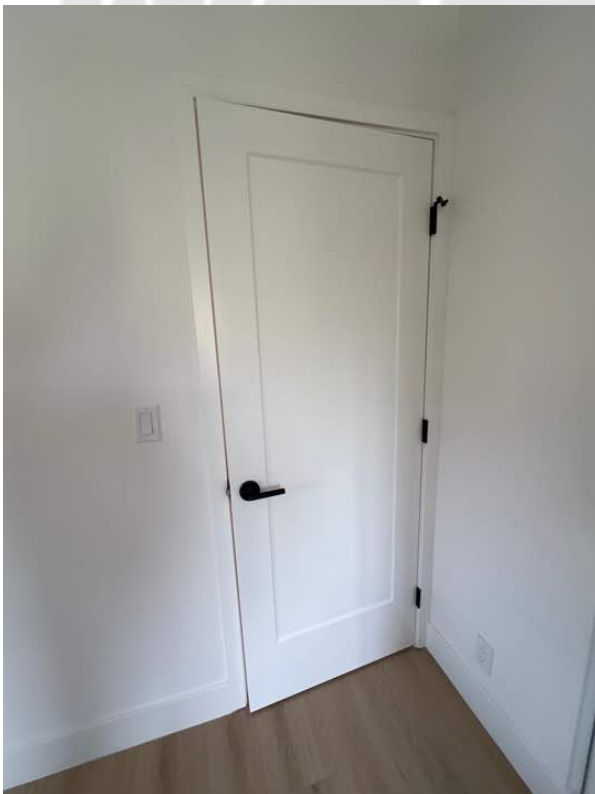
BEDROOM #1 PRIVACY DOOR

REP 160: The privacy door needs adjustment to function normally. Door rubs at door jamb. Does not close.

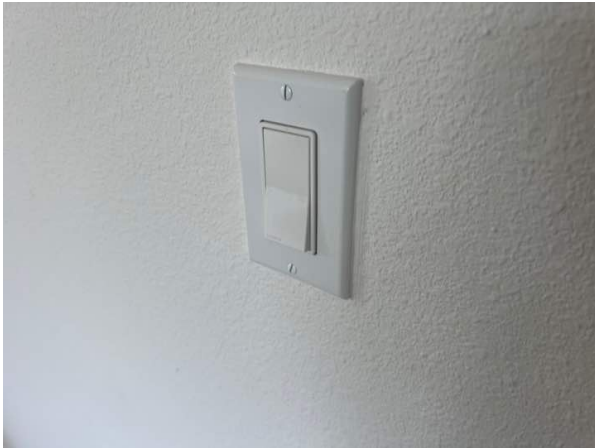
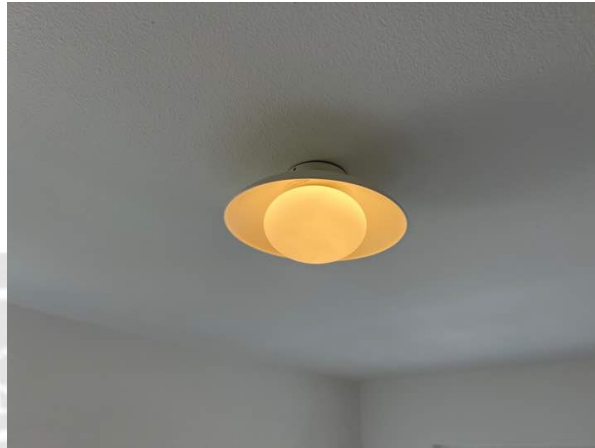
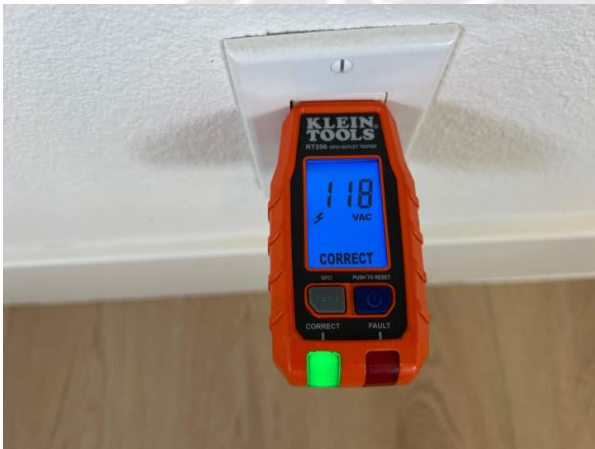
BEDROOM #1 OUTLETS LIGHTS AND SWITCHES

161: Plugs lights and switches were satisfactory throughout.

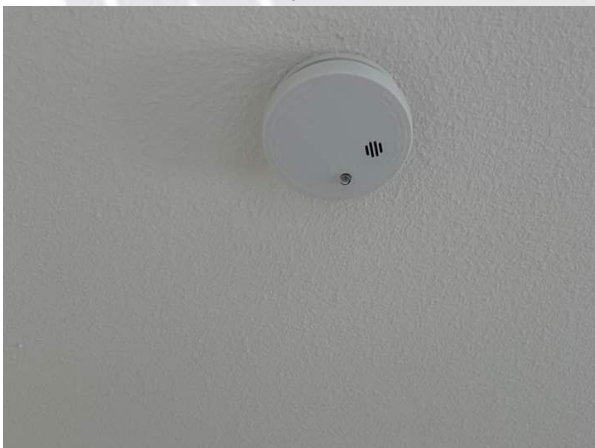
BEDROOM #1 SMOKE DETECTOR

162: Smoke detector present and functional.

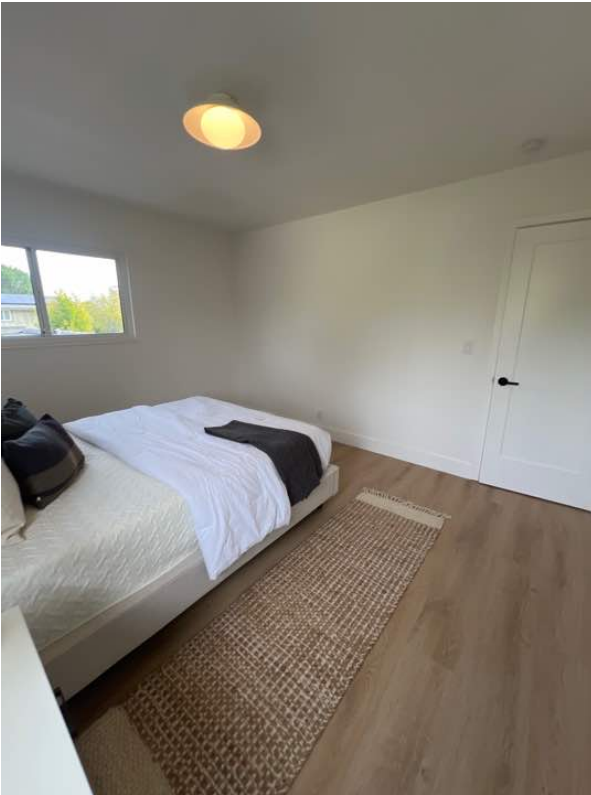
BEDROOM #1 GENERAL CONDITION

163: Bedroom was satisfactory.

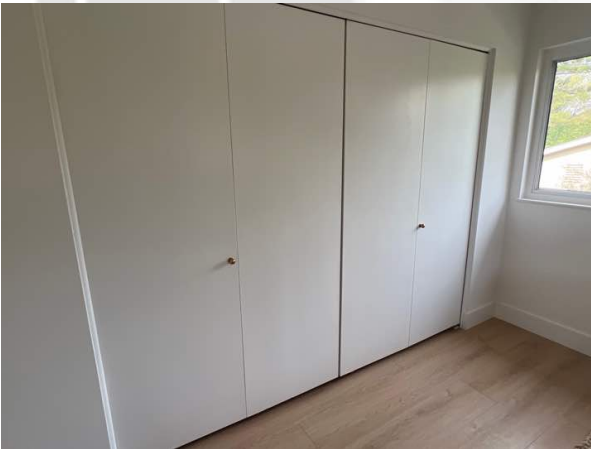
BEDROOM #1 WARDROBE DOORS

164: The door was in satisfactory condition.

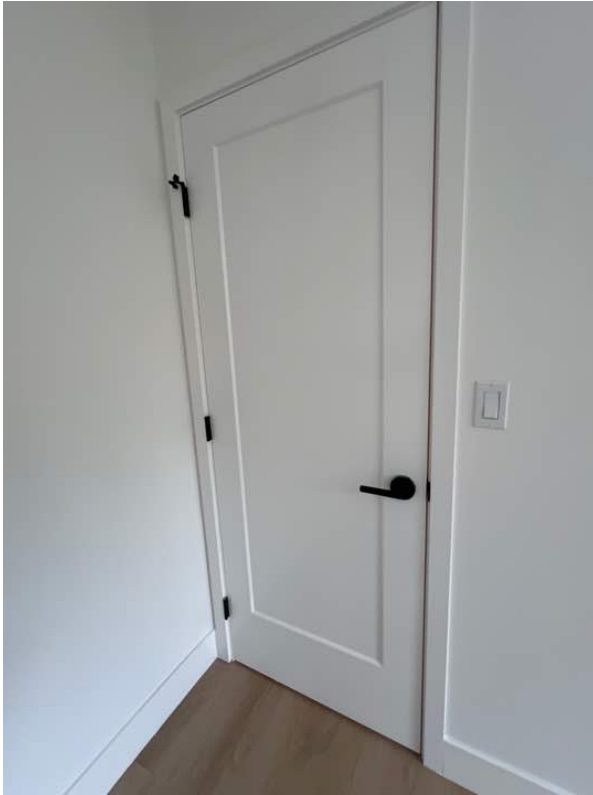
BEDROOM #1 PRIVACY DOOR

165: The door was in satisfactory condition.

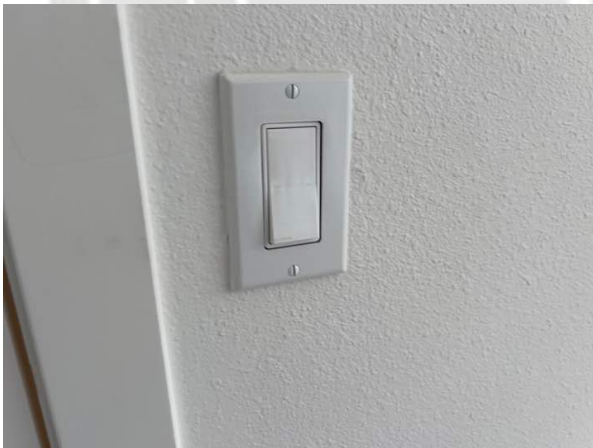
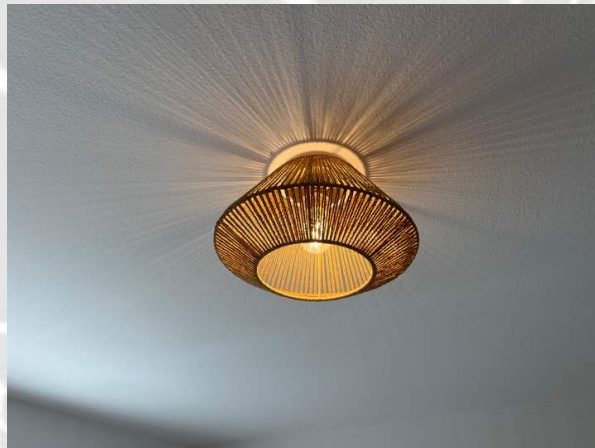
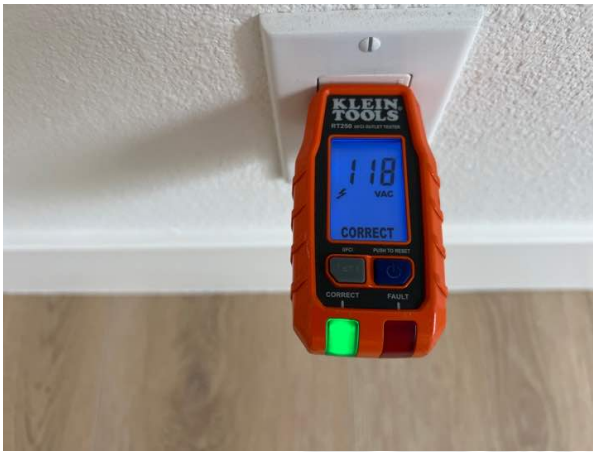
BEDROOM #1 OUTLETS LIGHTS AND SWITCHES

166: Plugs lights and switches were satisfactory throughout.

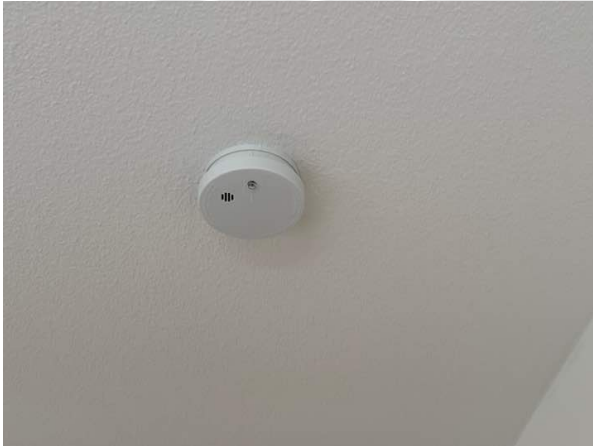
BEDROOM #1 SMOKE DETECTOR

167: Smoke detector present and functional.

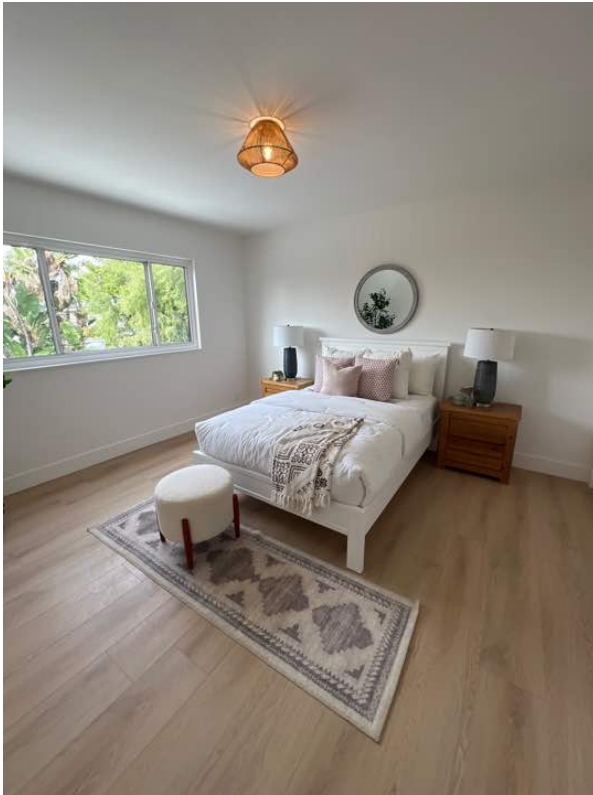
BEDROOM #1 GENERAL CONDITION

168: Bedroom was satisfactory.

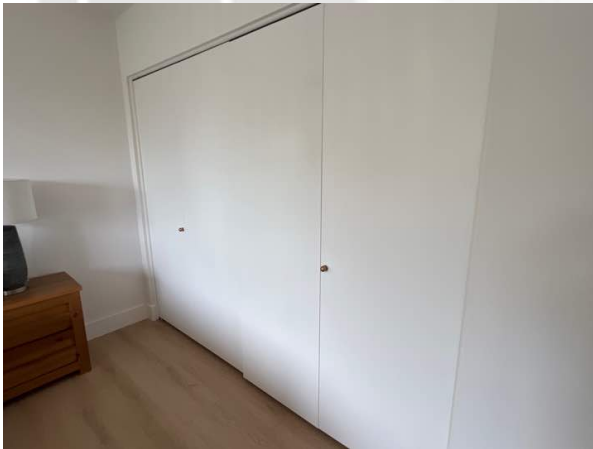
BEDROOM #1 WARDROBE DOORS

169: The door was in satisfactory condition.

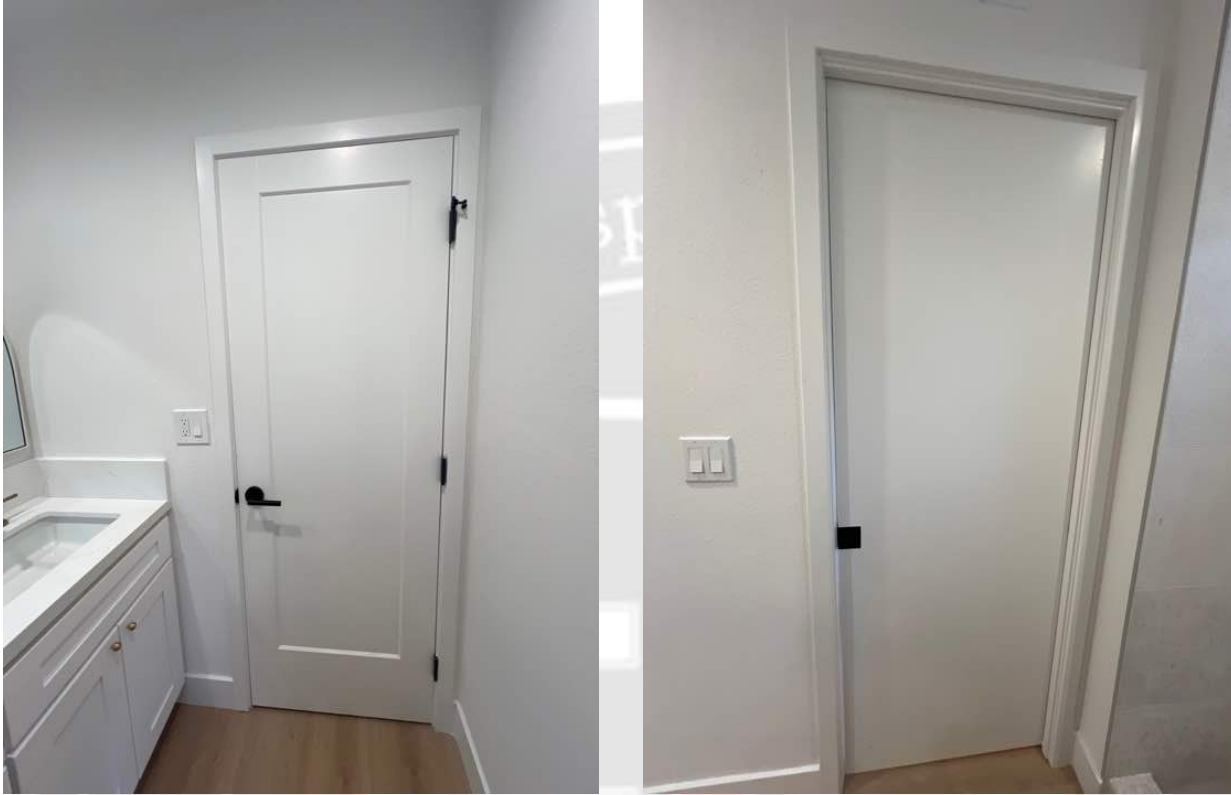
BATHROOM #1 PRIVACY DOOR

170: The door was in satisfactory condition.

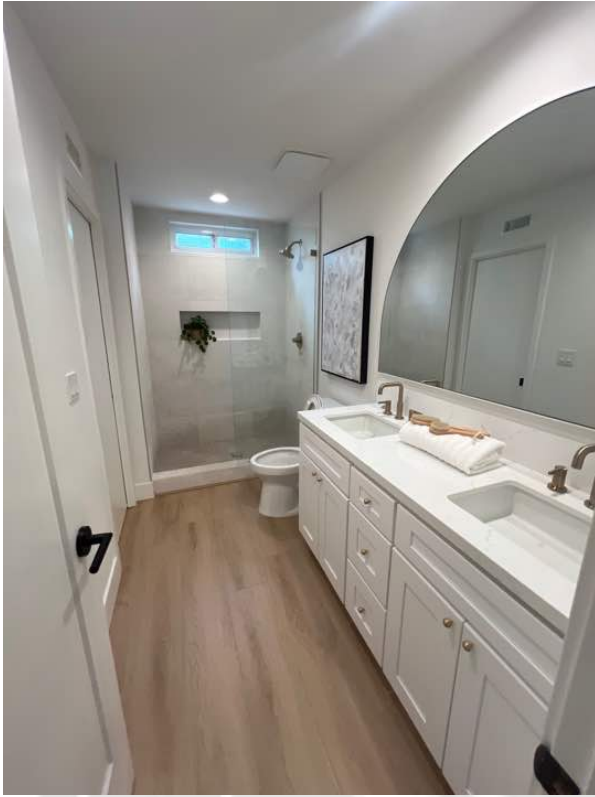
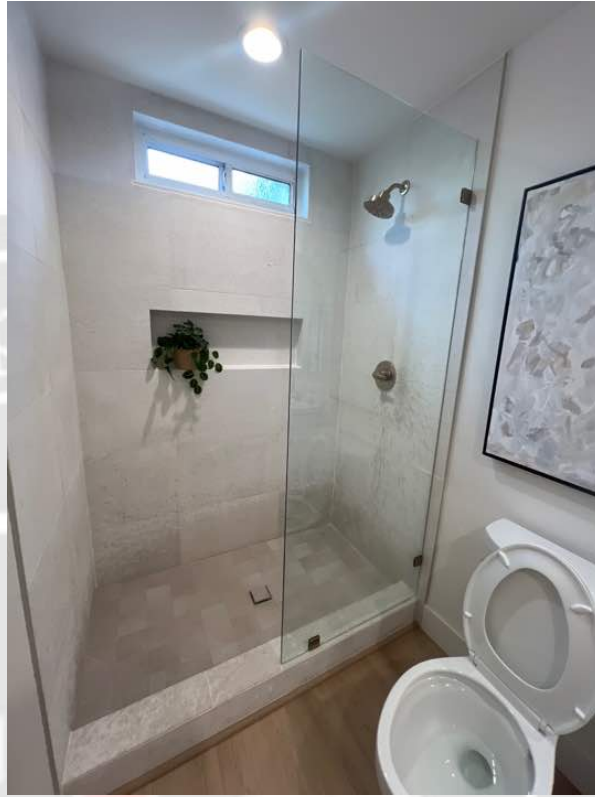
BATHROOM #1 OVERALL CONDITIONS

171: The floor, walls and ceiling were in satisfactory condition. There were no significant deficiencies noted.

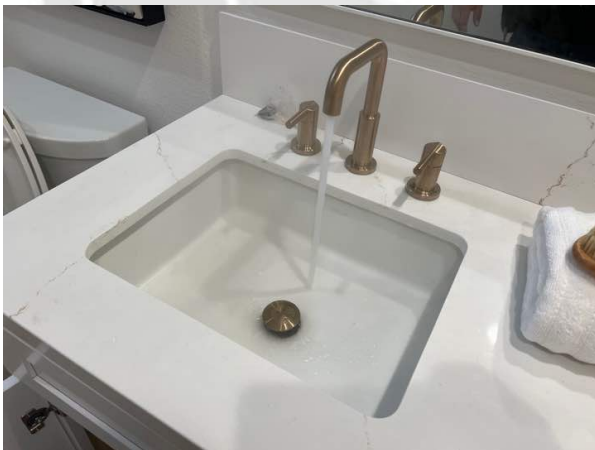
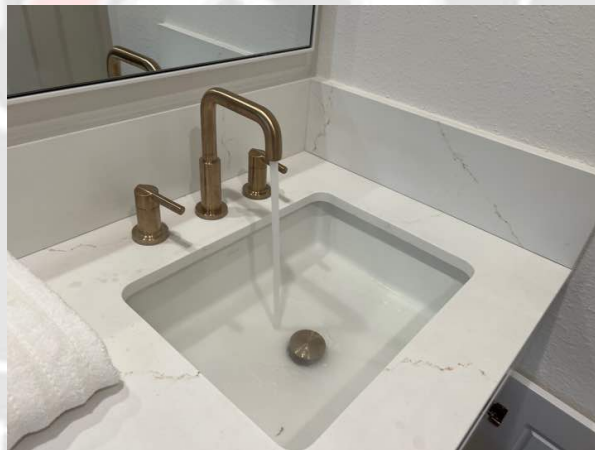
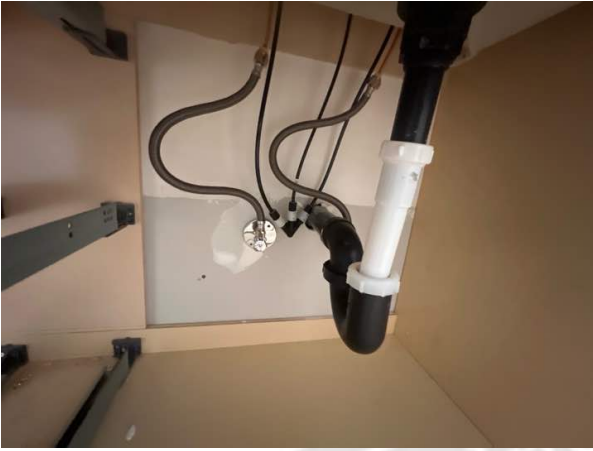
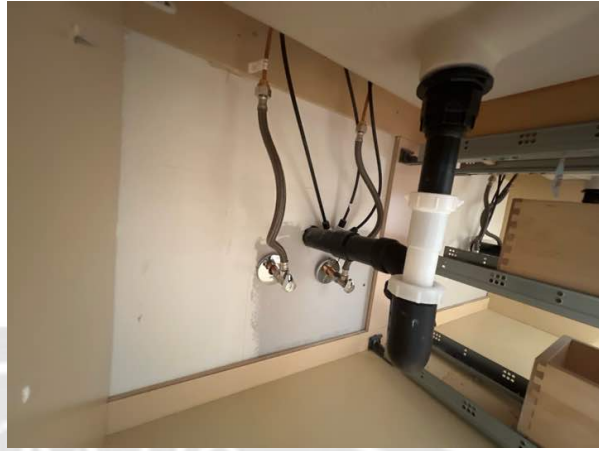
BATHROOM #1 SINK AND PLUMBING

172: Sink and faucet were functional. Hot and cold water were present.

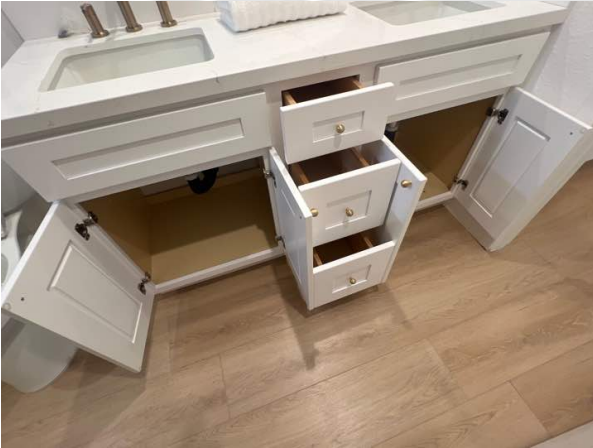
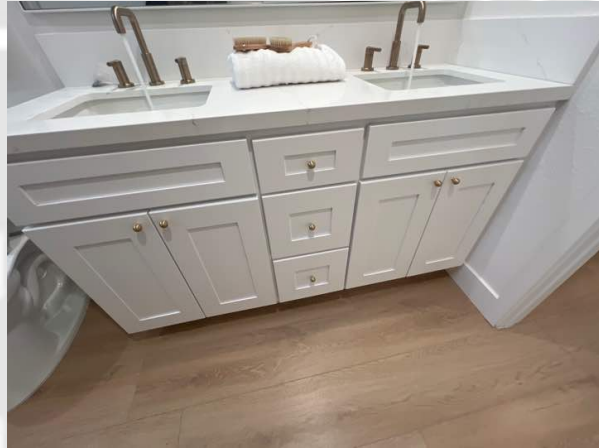
BATHROOM #1 CABINET CONDITIONS

173: Bathroom cabinets are in new condition.

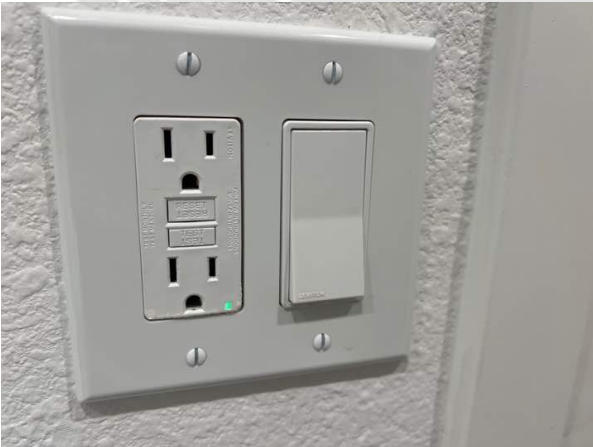
BATHROOM #1 GFCI OUTLETS

174: GFCI receptacle was present and functional.
