Inspection Report

Lynridge Dr
Yorba Linda, California
92886

Inspected By
David Salvato
California Inspection Authority INC.
(949) 981-8320
CIAHomeInspection@gmail.com
Inspecting The Finest Homes In California
www.CIAHomeInspection.com

Wednesday
December 27, 2023

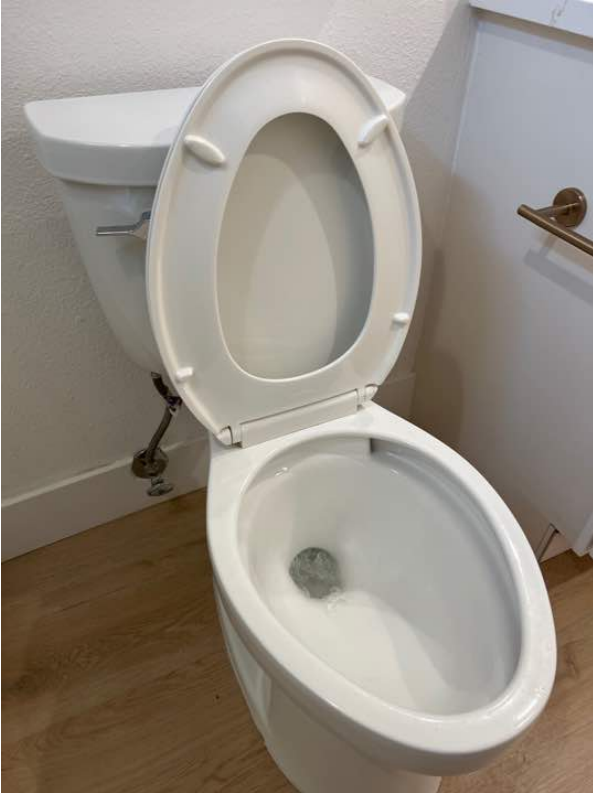
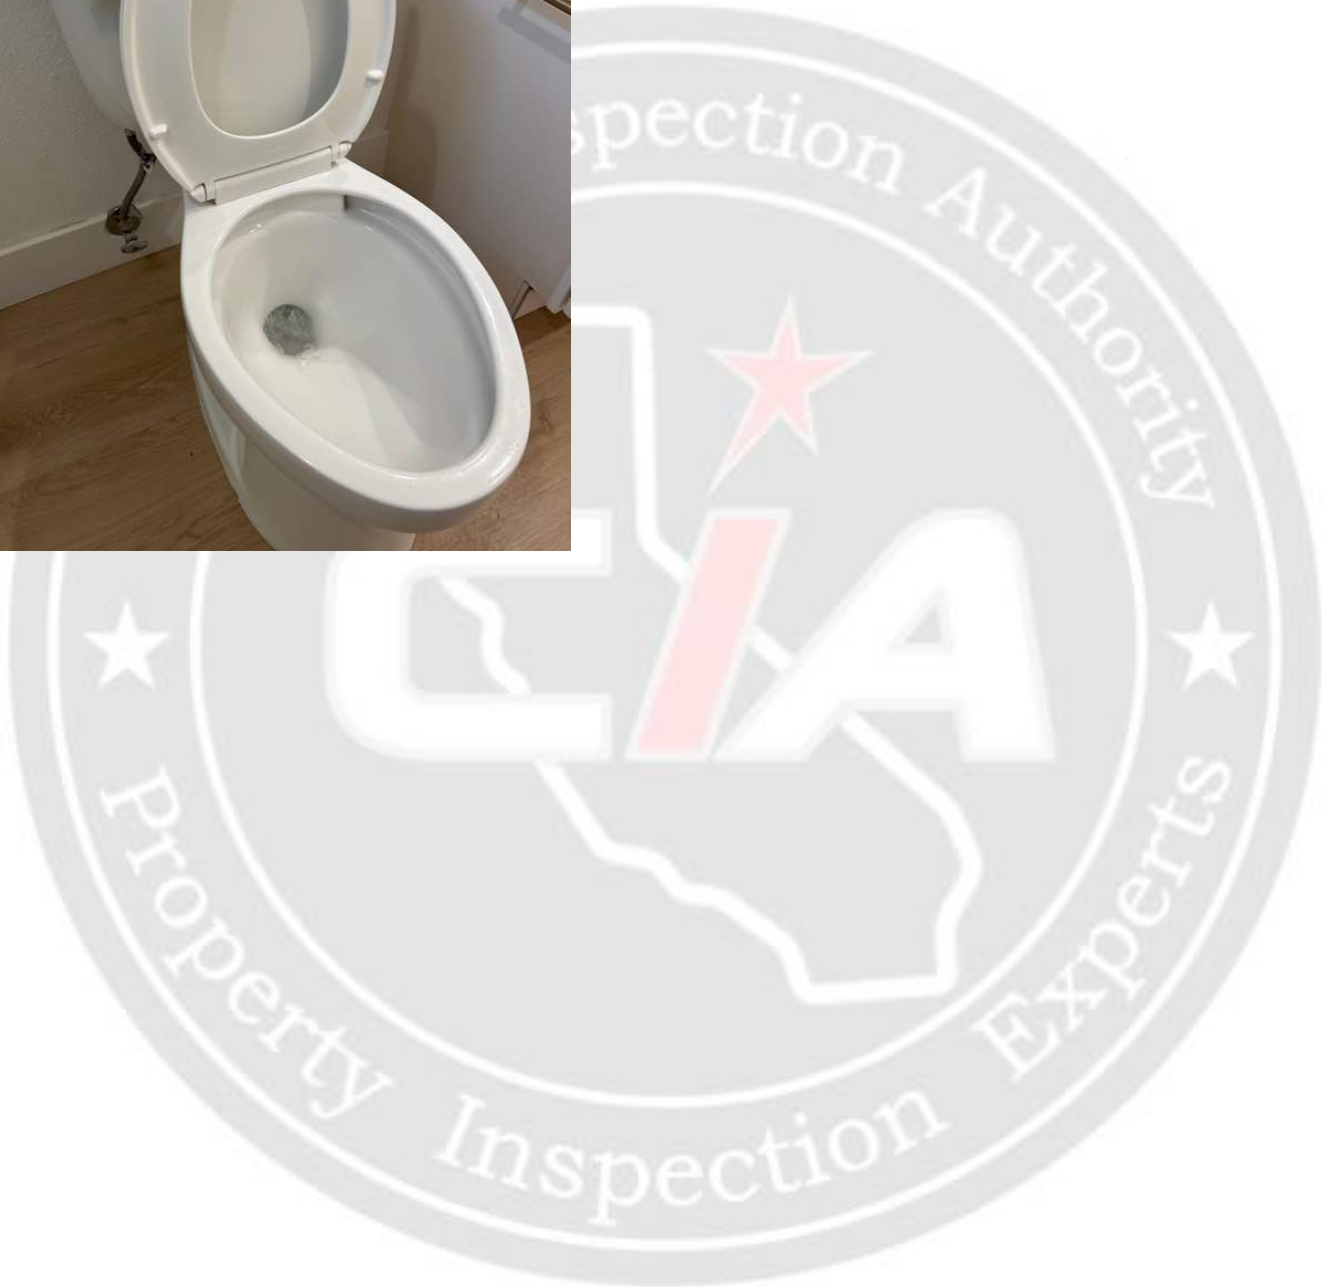
BATHROOM #1 TOILET

175: The toilet was functional and in satisfactory condition.

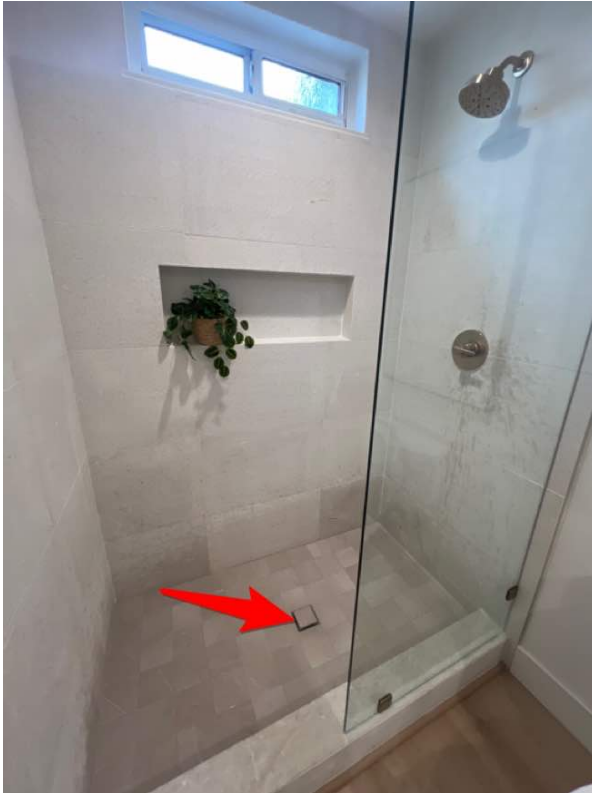
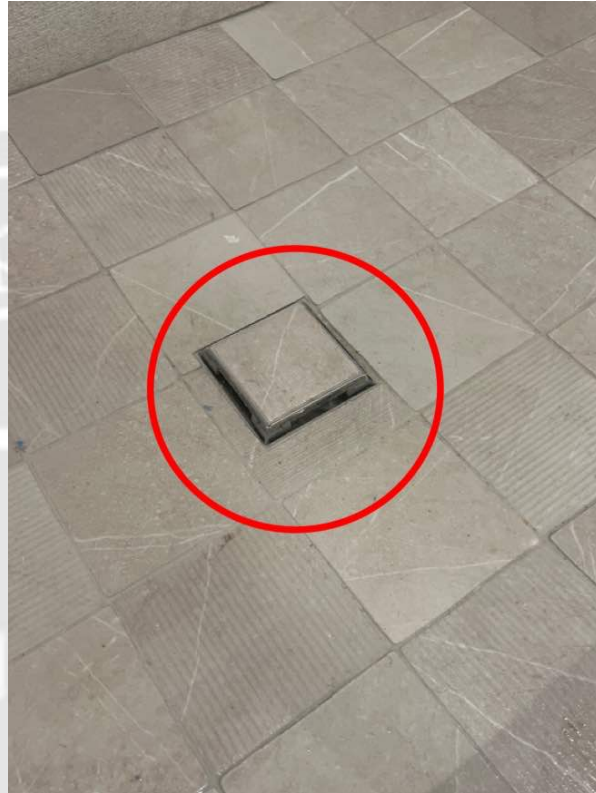
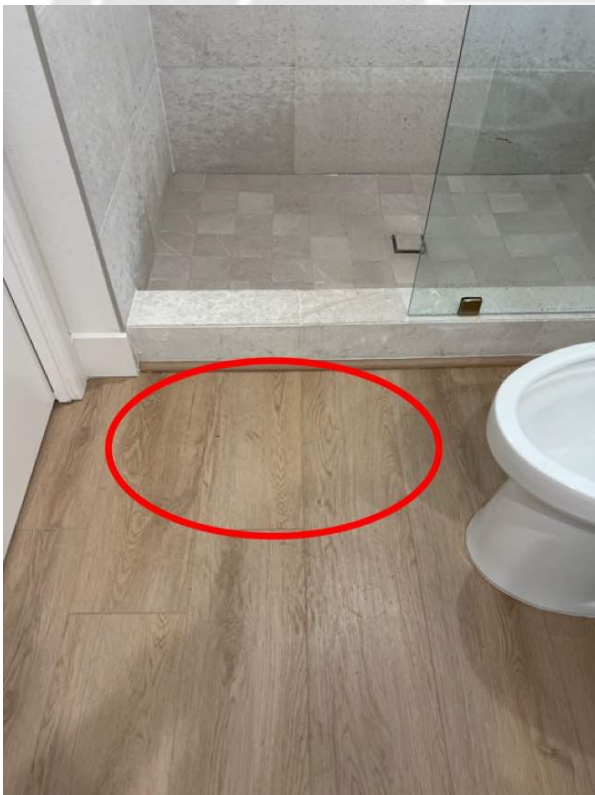
BATHROOM #1 TUB AND SHOWERS

SAF 176: Shower was functional. It should be noted that during the testing of the shower water was splashing onto the flooring outside of the shower enclosure. This poses a slip and fall hazard. A shower door is recommended. Drain assembly cover did not flush within the shower. This is a safety hazard for tender feet.

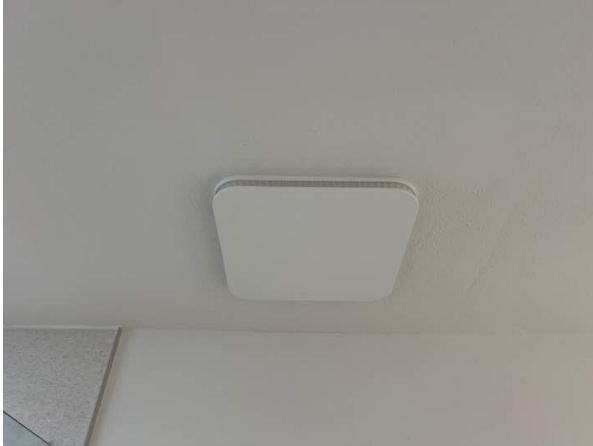
BATHROOM #1 VENTILATOR CONDITIONS

177: The bathroom ventilator was tested and found to be functional on the day of inspection.

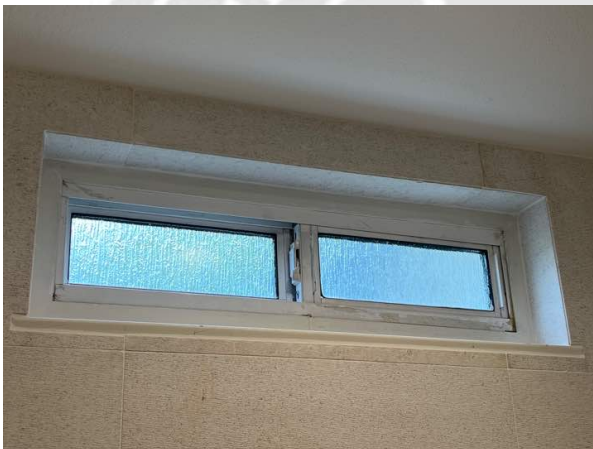
WINDOW CONDITIONS WINDOWS

178: The window was functional.

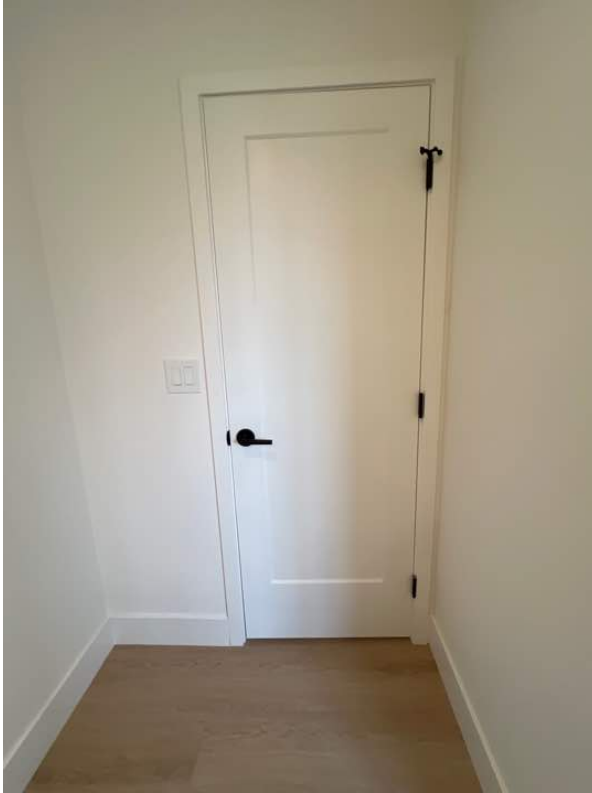
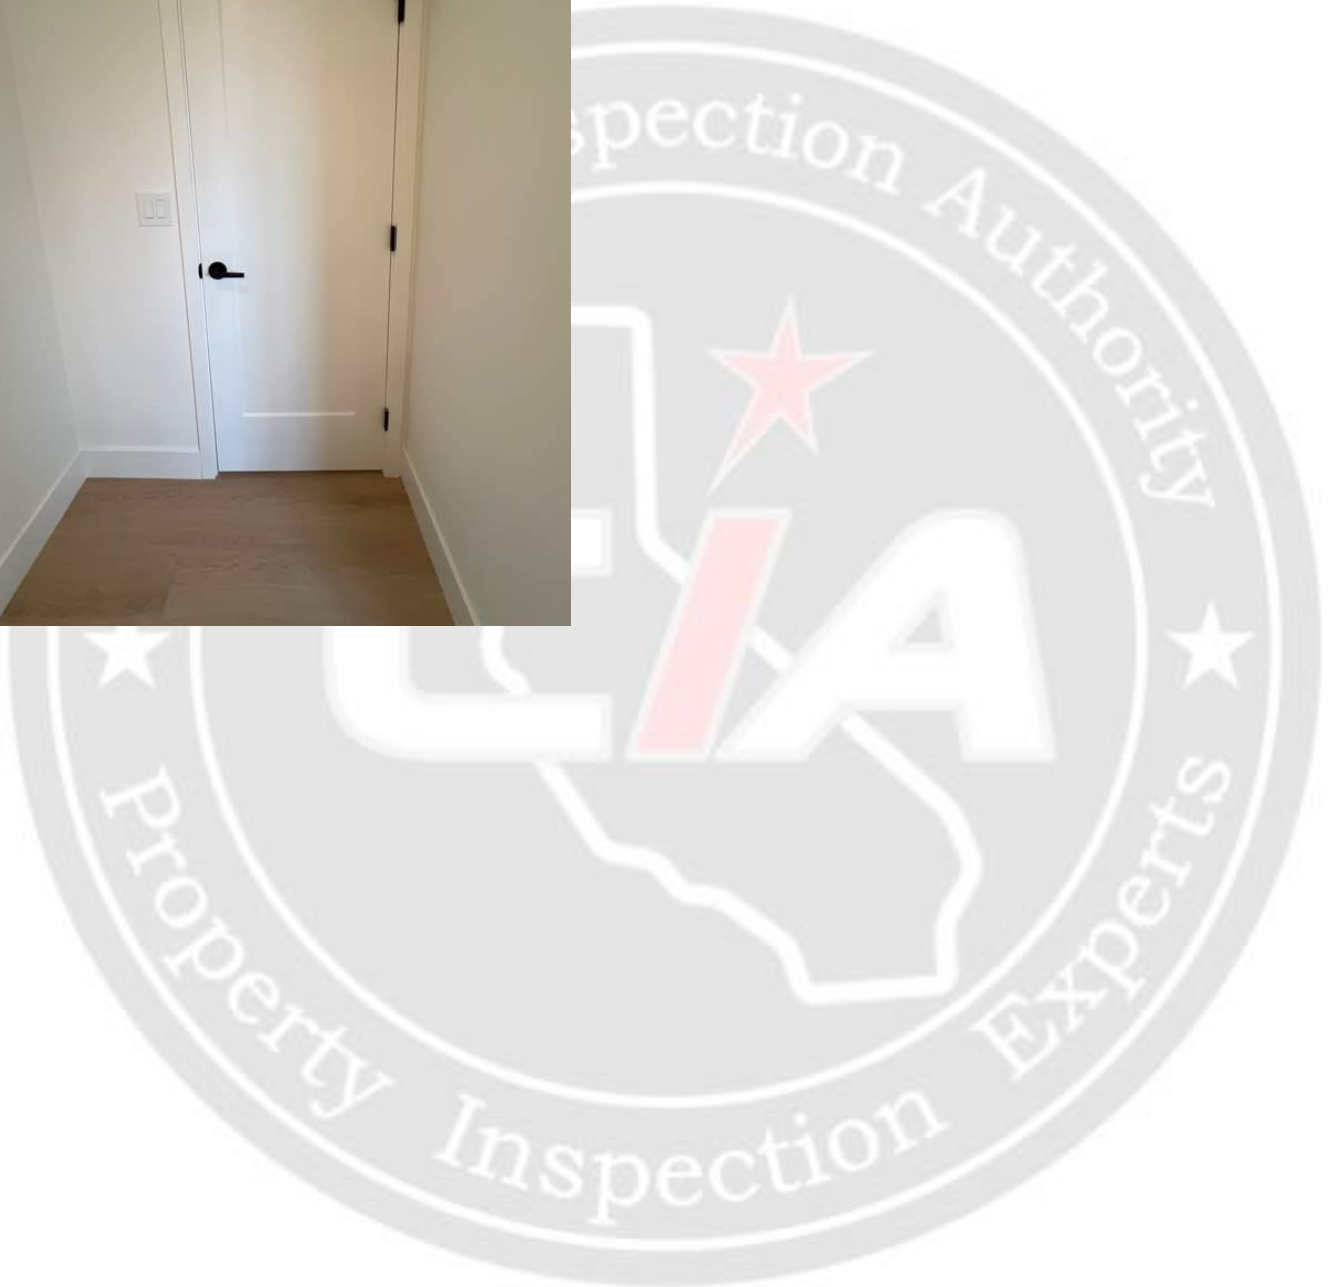
BATHROOM #1 PRIVACY DOOR

179: The door was in satisfactory condition.

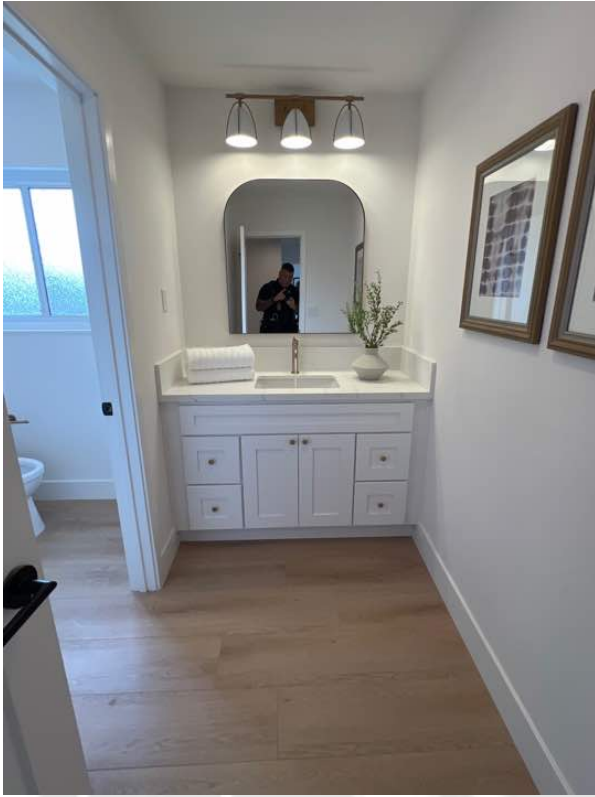
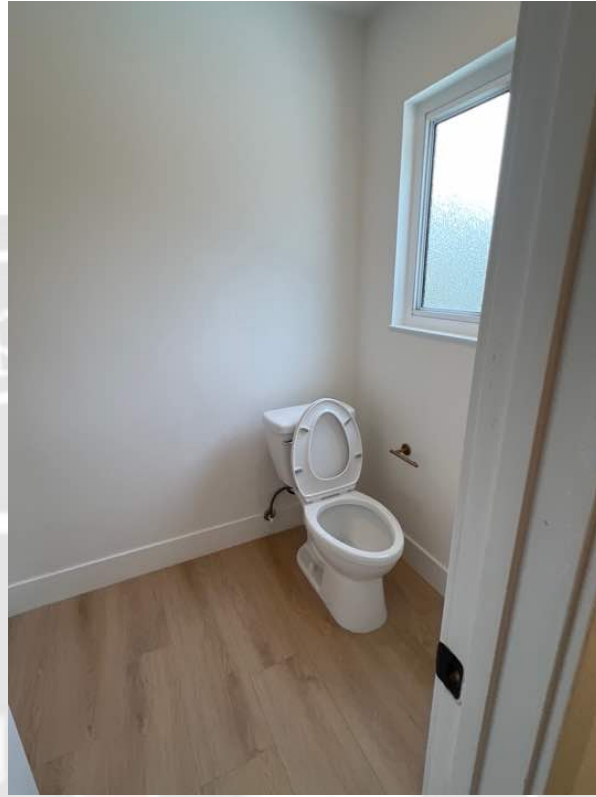
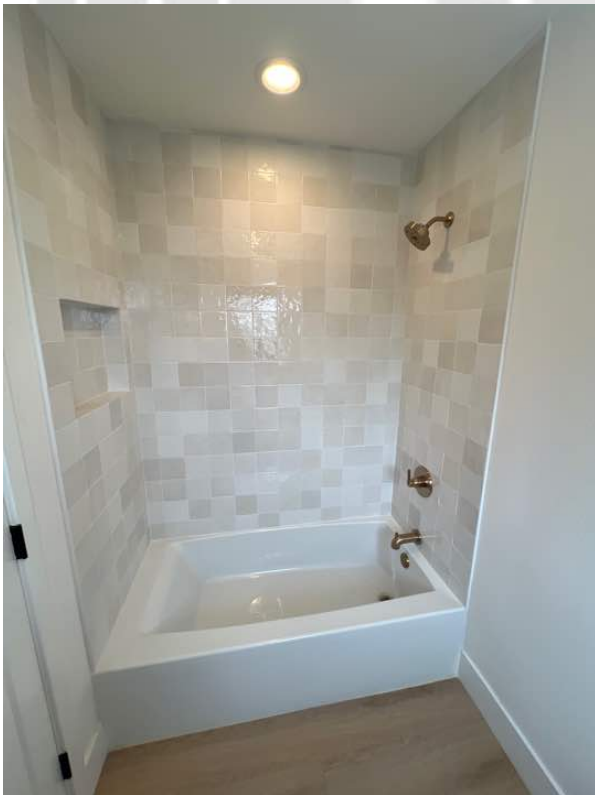
BATHROOM #1 OVERALL CONDITIONS

180: The floor, walls and ceiling were in satisfactory condition. There were no significant deficiencies noted.

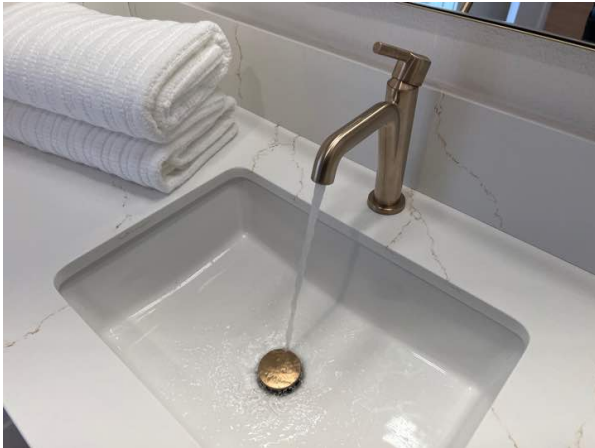
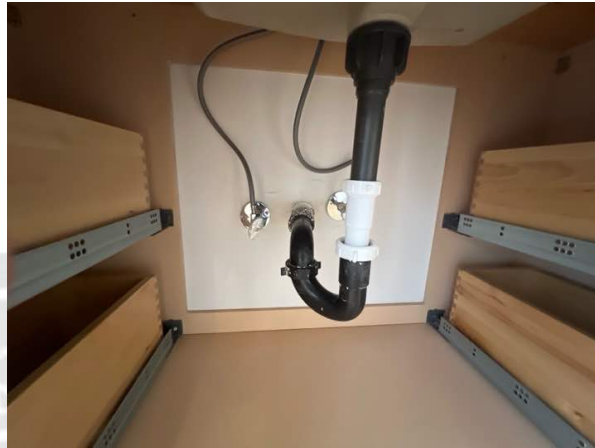
BATHROOM #1 SINK AND PLUMBING

181: Sink and faucet were functional. Hot and cold water were present.

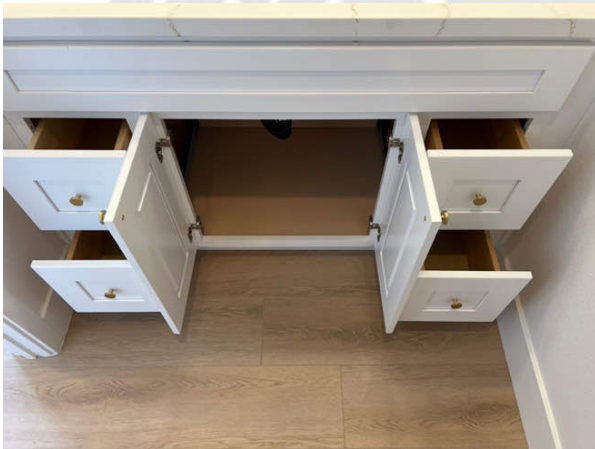
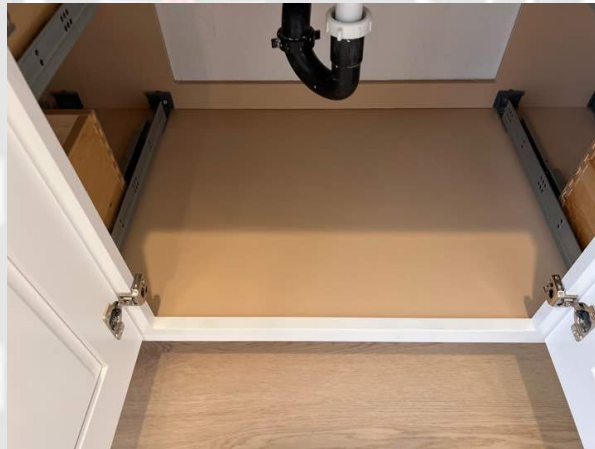
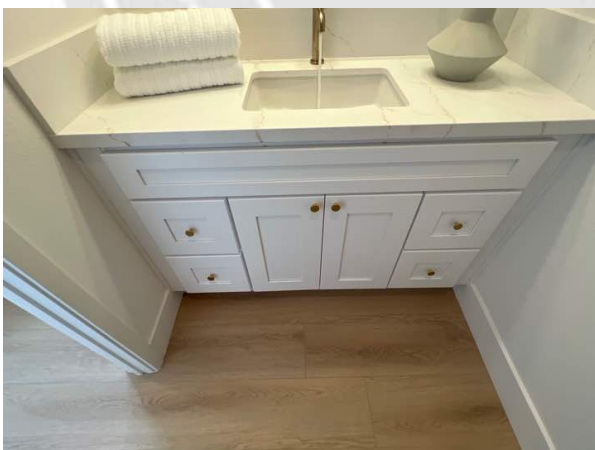
BATHROOM #1 CABINET CONDITIONS

182: Bathroom cabinets are in new condition.

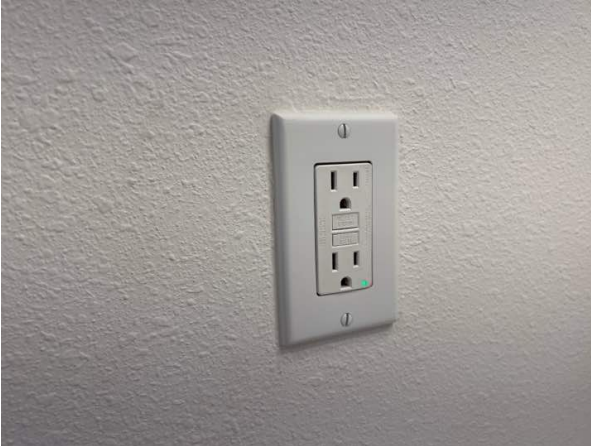
BATHROOM #1 GFCI OUTLETS

183: GFCI receptacle was present and functional.

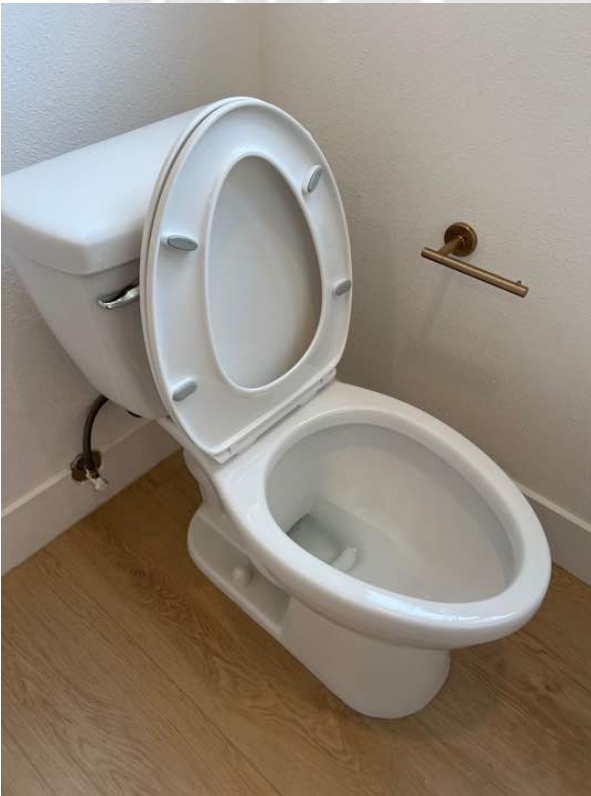
BATHROOM #1 TOILET

184: The toilet was functional and in satisfactory condition.

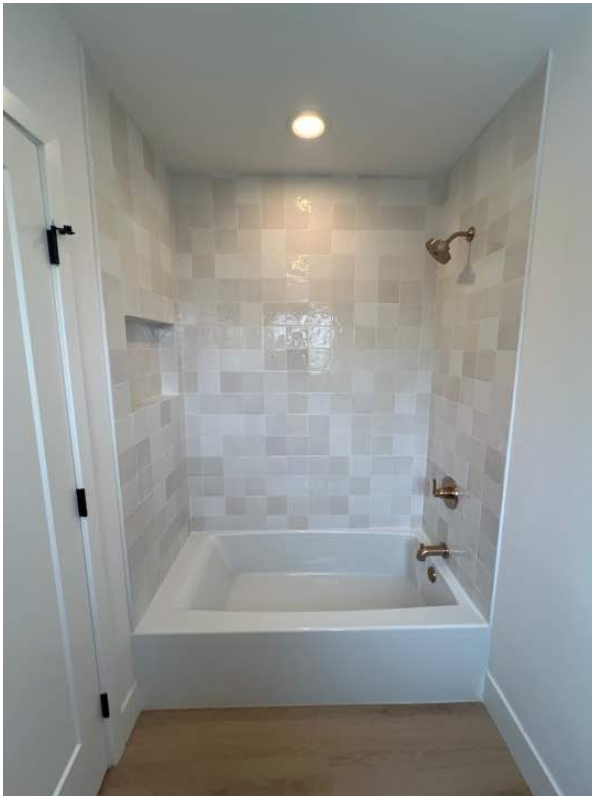
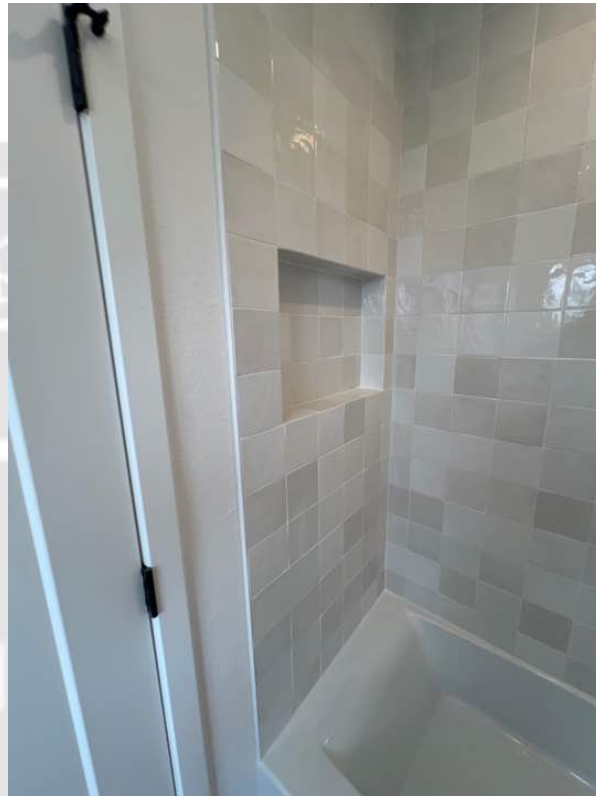
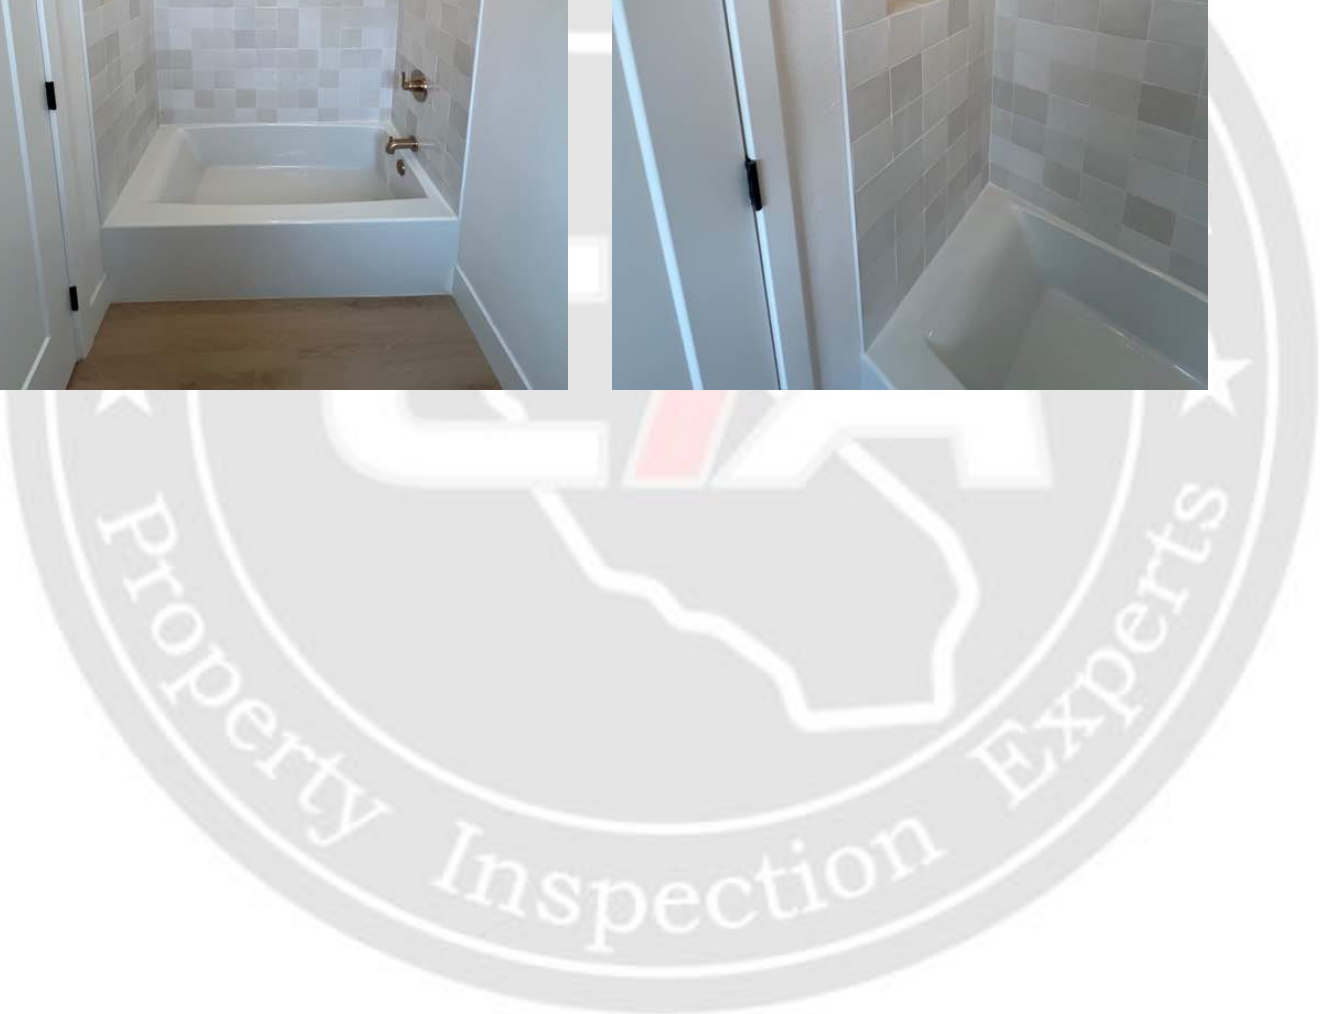
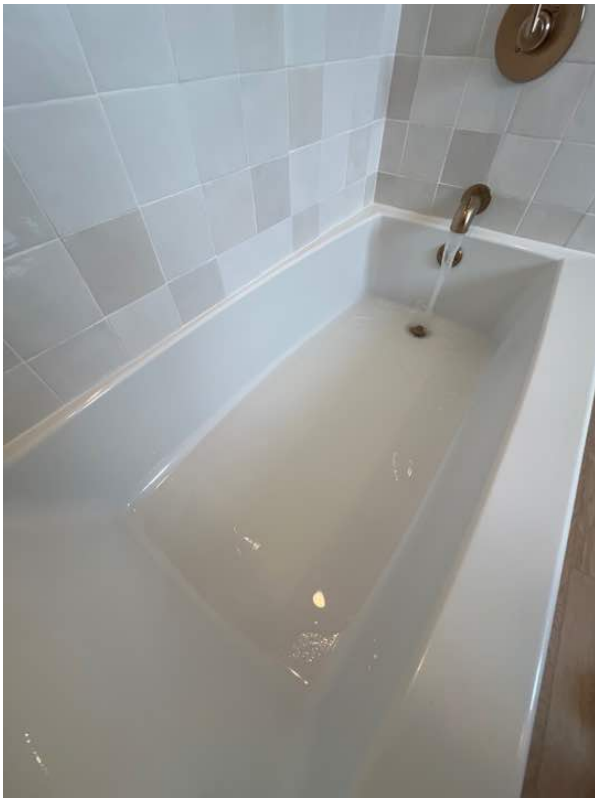
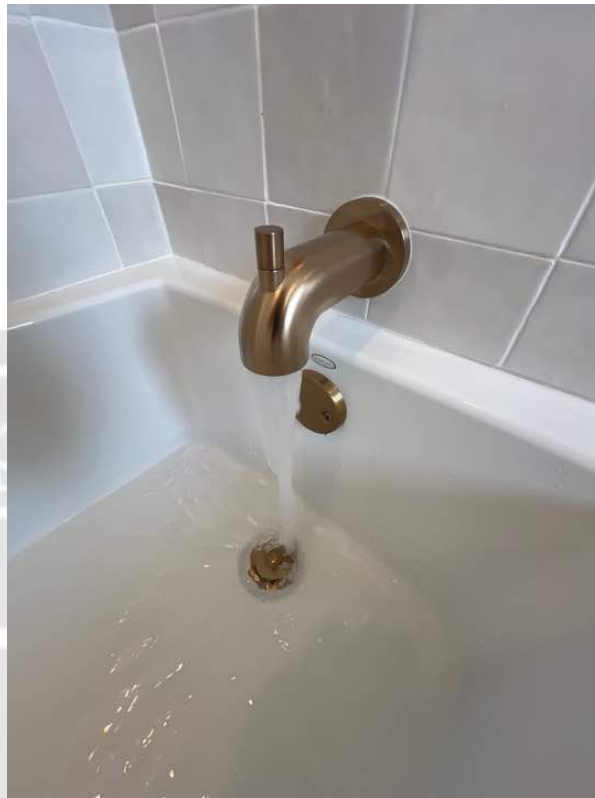
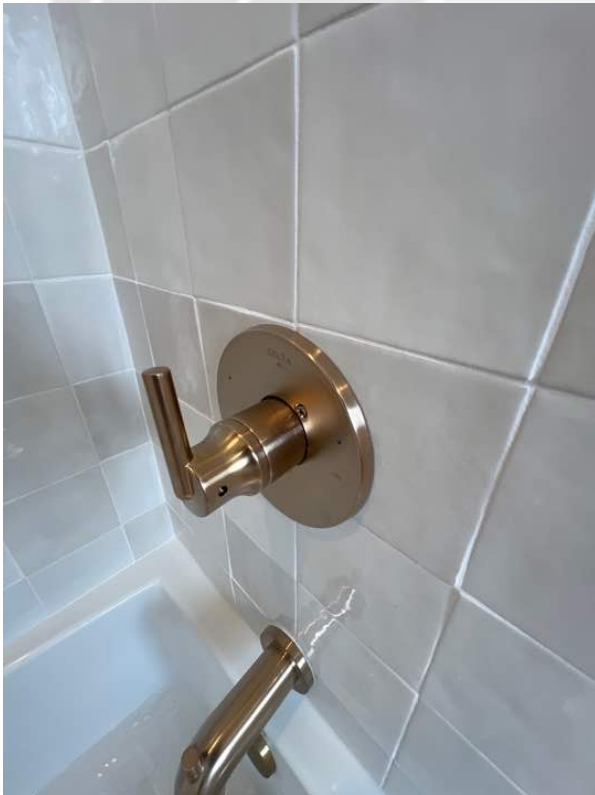
BATHROOM #1 TUB AND SHOWERS

185: Tub and shower are showing signs of normal wear and tear. It should be noted that the tub overflow drain was not tested by filling the tub water above it to see if it leaks. Seals tend to dry out and can leak over time. It is recommended that the seals be checked and or replaced to prevent leakage as part of regular home maintenance.

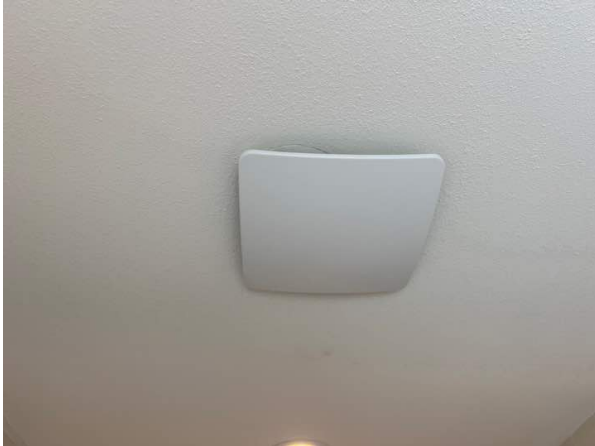
BATHROOM #1 VENTILATOR CONDITIONS

186: The bathroom ventilator was tested and found to be functional on the day of inspection.

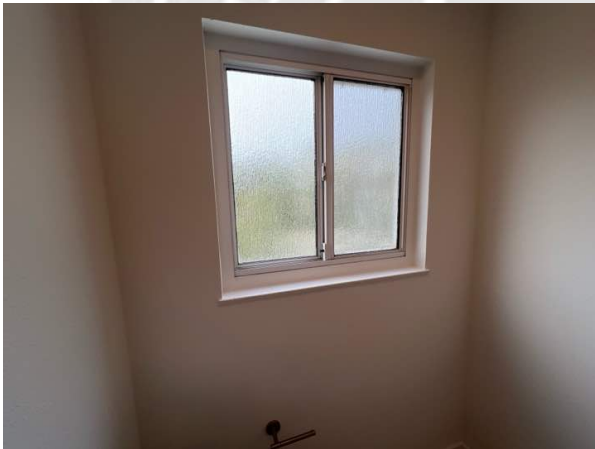
WINDOW CONDITIONS WINDOWS

187: The window was functional.

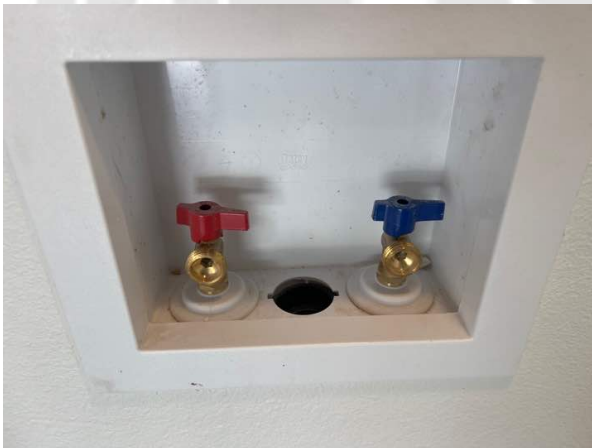
LAUNDRY WATER CONNECTION

189: Laundry connections were in satisfactory condition.

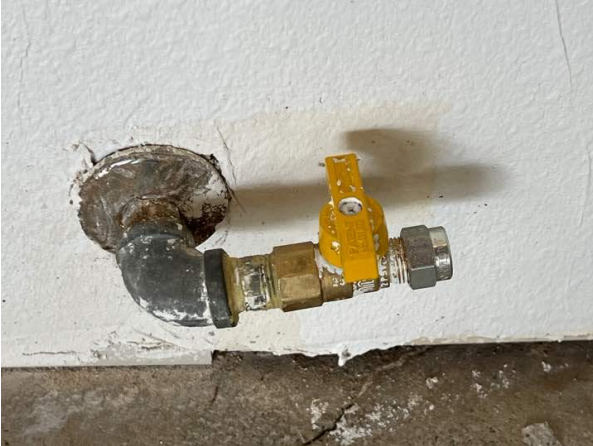
LAUNDRY GAS CONNECTION

190: The gas line connection was satisfactory.

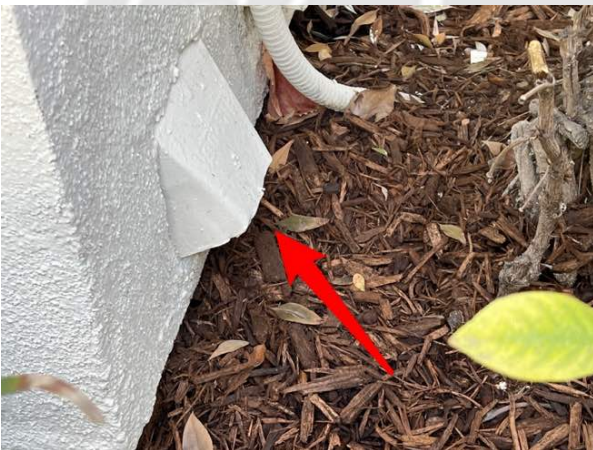
LAUNDRY DRYER VENT

REP 191: The dryer exhaust vent was located at the side of the home and was installed near ground level. Recommend dryer exhaust vent be relocated. Consult with a qualified contractor for resolution.

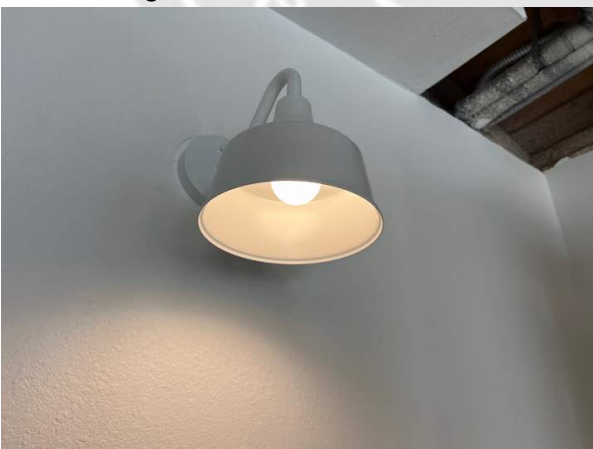
LAUNDRY LIGHTING

192: The light fixture was functional.

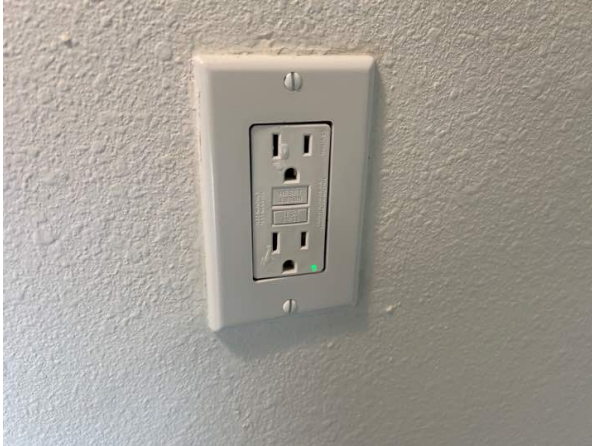
193: The laundry area receptacle was tested and found to be functional on the day of inspection.

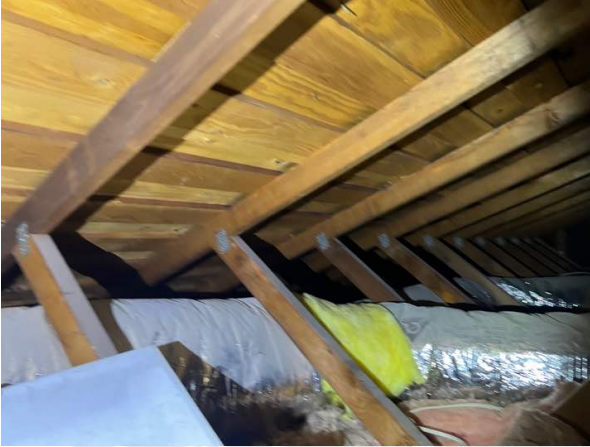
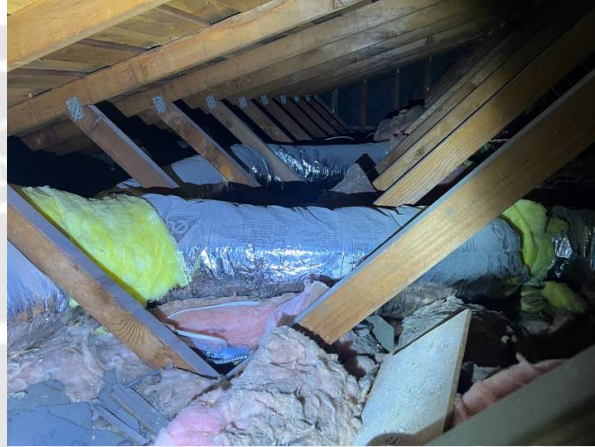
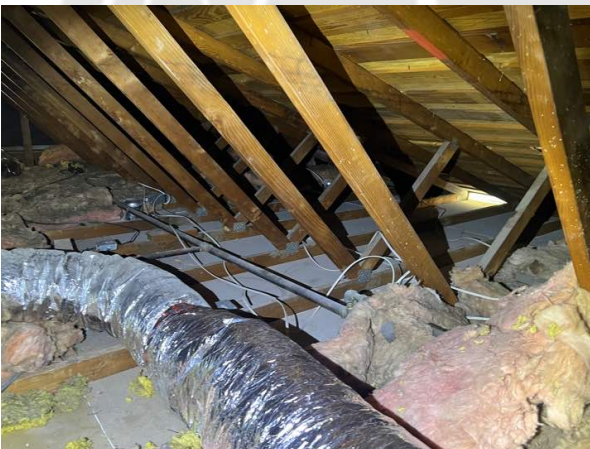
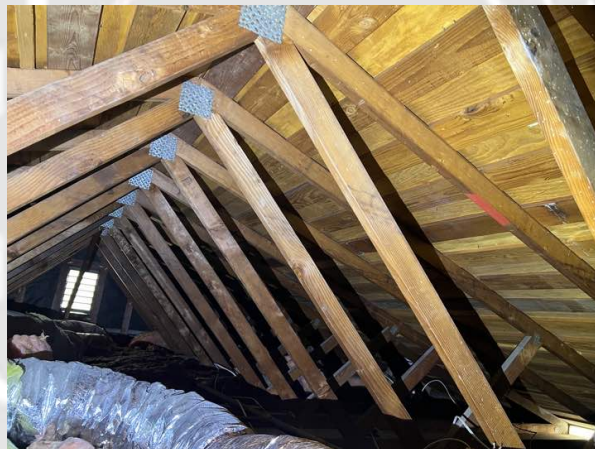
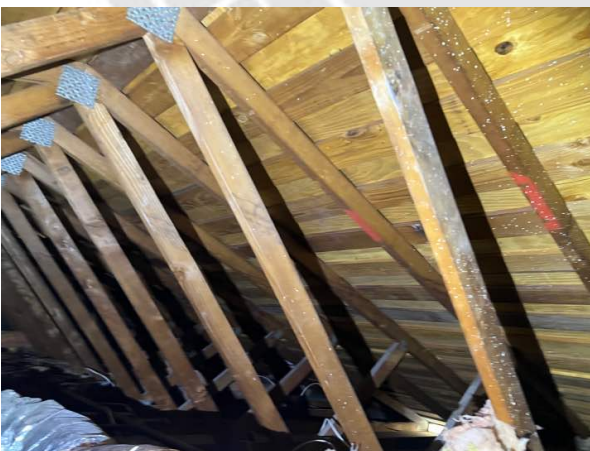
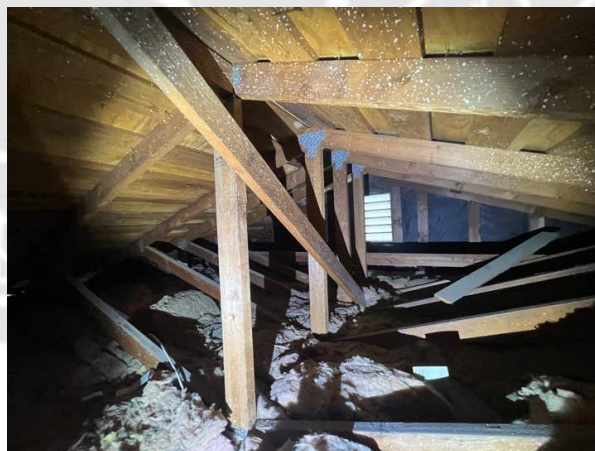
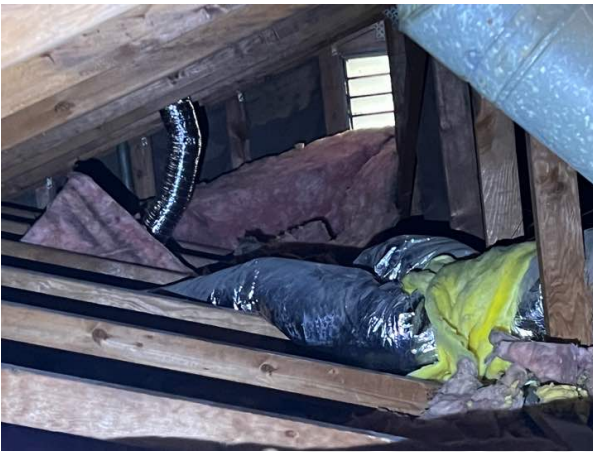
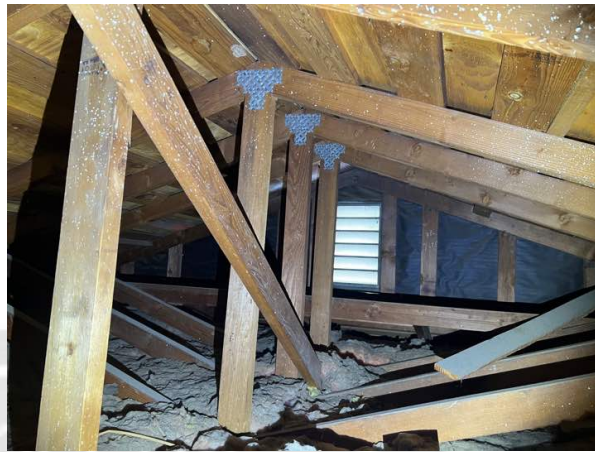
195: The roof trusses were in good condition. There were no apparent signs of alterations. There was no rust or corrosion noted at roof truss plates.

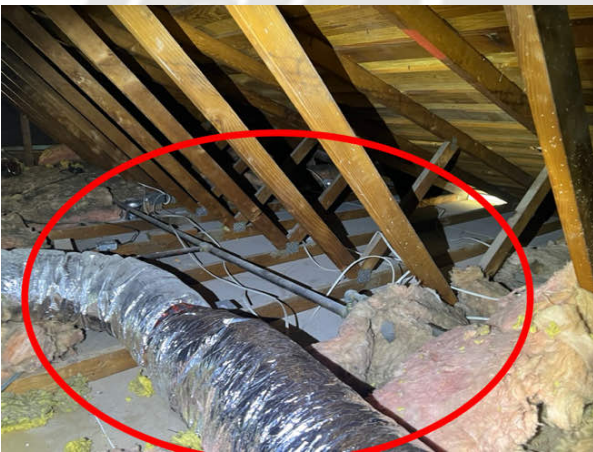
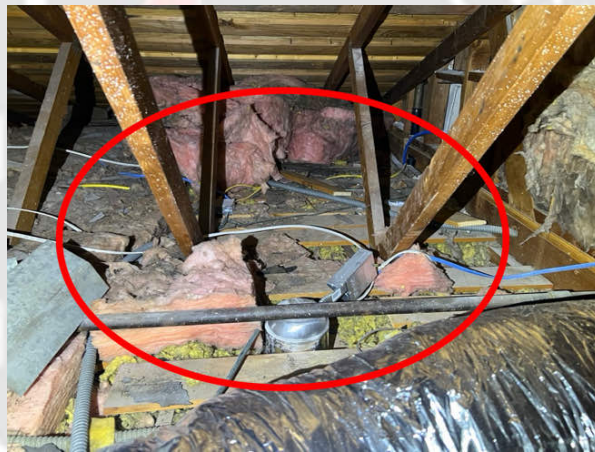
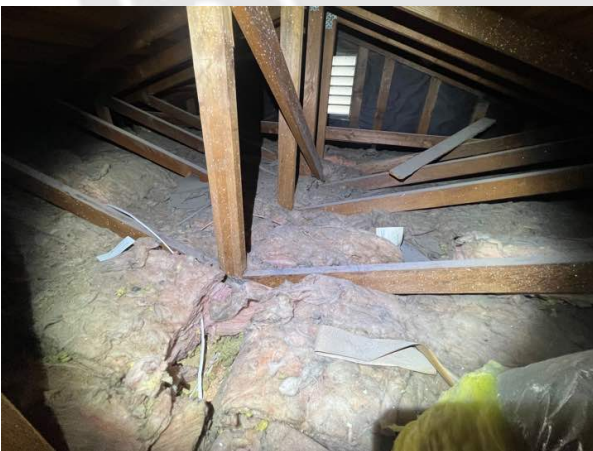
MANT 196: Large amounts of missing insulation were noted at the first floor attic area above the kitchen. This concrete cold spots which can lead to moisture and energy loss. It is suggested that all areas be properly insulated. Insulation should be installed to a thickness of 16 inches for energy savings and comfort.

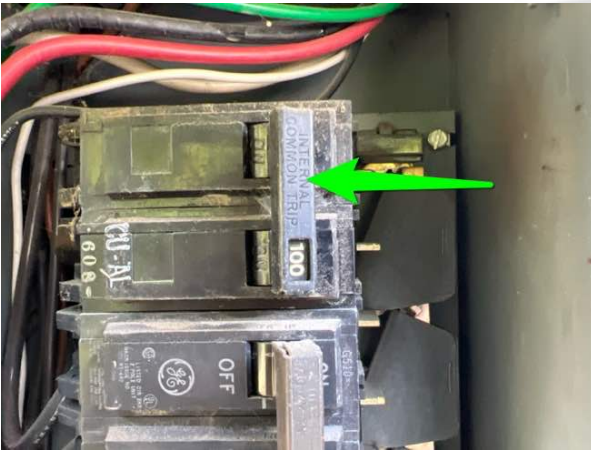
1: The main service disconnect switch is located at the main electrical panel.

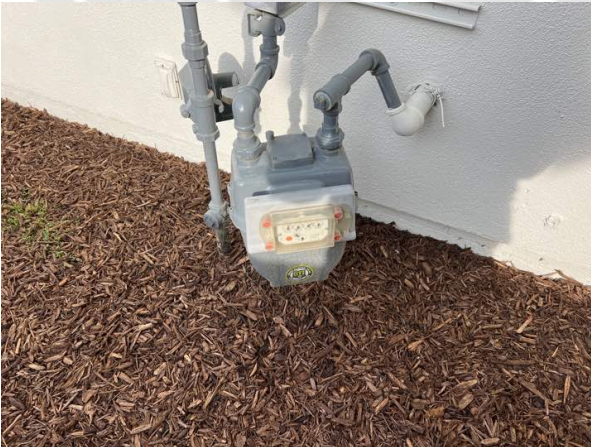
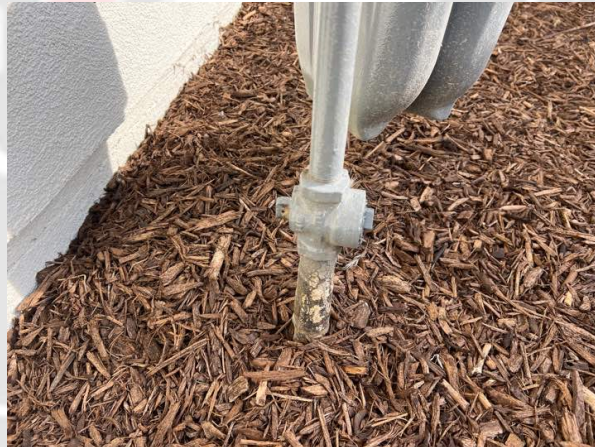
2: Natural gas service is provided to the home via public utility. Having a gas shut off wrench located at the gas utility will aid in the event of emergency shut off needs.

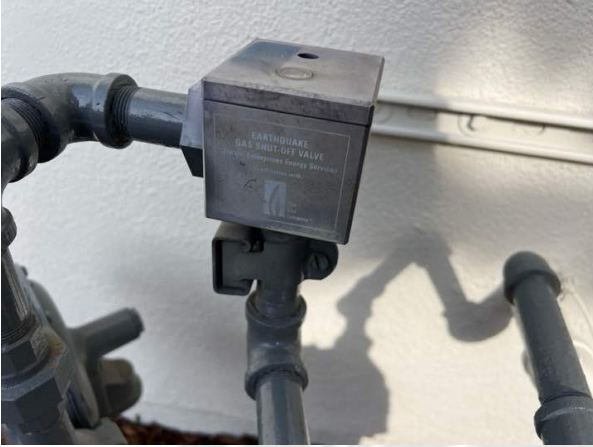
WARN 3: Seismic shut off valve has been installed. This valve may need to be reset in the event of an earthquake. This will restore gas once the system has been inspected.

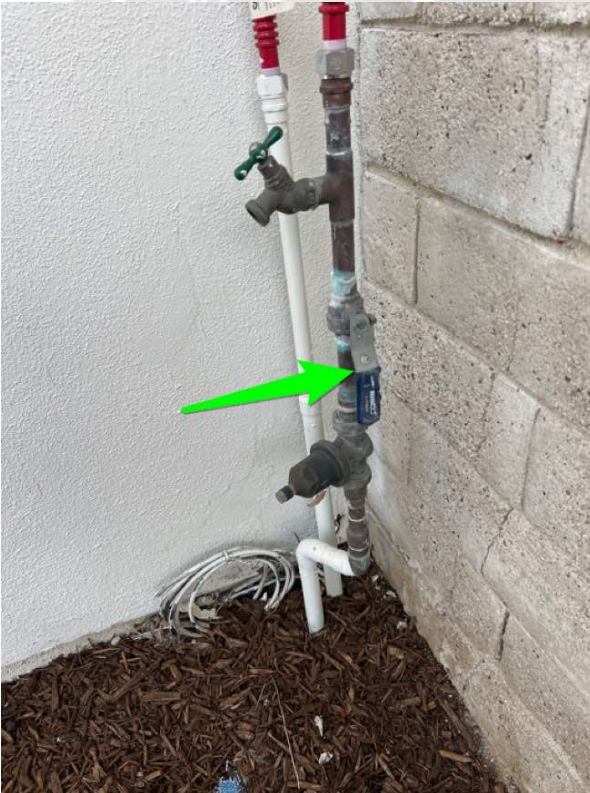
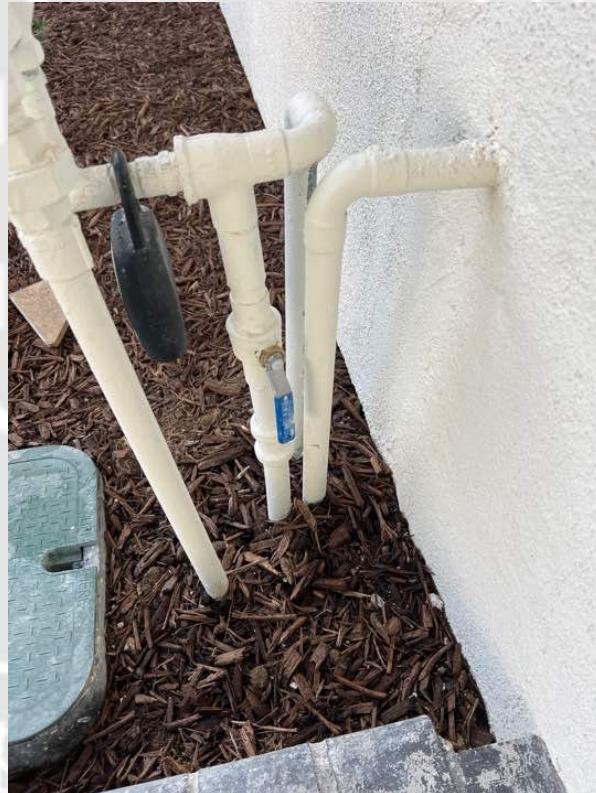
4: The main shutoff valve is located at the side of the home.
